# Slingsby Sport Vega Glider T65D, BGA 2758

<b>AAIB Bulletin No: 7/2004</b>	<b>Ref: EW/C2002/06/05</b>	<b>Category: 3</b>
<b>Aircraft Type and Registration:</b>	Slingsby Sport Vega Glider T65D, BGA 2758	
<b>Year first registered</b>	1981	
<b>Date &amp; Time (UTC):</b>	23 June 2002 at 1248 hrs	
<b>Location:</b>	Wormingford Airfield, Colchester	
<b>Type of Flight:</b>	Private	
<b>Persons on Board:</b>	Crew - 1	Passengers - None
<b>Injuries:</b>	Crew - Serious	Passengers - N/A
<b>Nature of Damage:</b>	Glider destroyed	
<b>Commander's Licence:</b>	BGA Gold C, Diamond Height and Goal badges	
<b>Commander's Age:</b>	22 years	
<b>Commander's Flying Experience:</b>	415 hours	
<b>Information Source:</b>	BGA accident report and further AAIB investigation of restraint issues

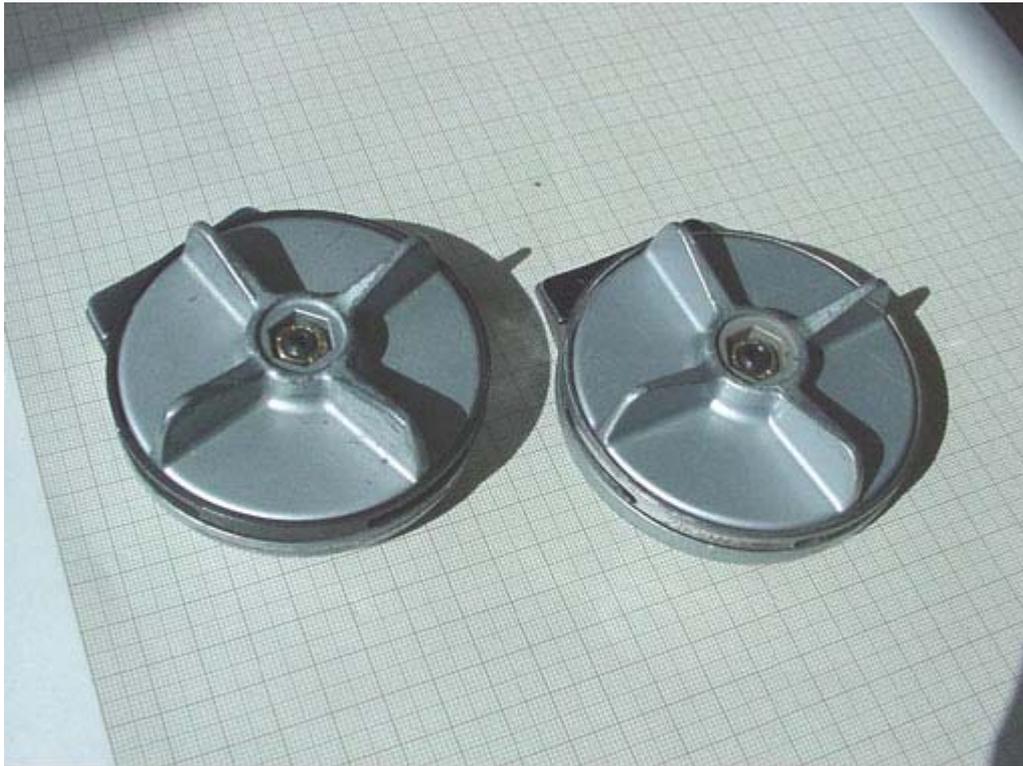
**Figure 1 - Failed buckle and example buckle**

The rotary buckle is an all-metal device consisting of a housing with five slotted sockets to accommodate end fittings for two shoulder restraints, two lap belts and one crotch strap. Release of the end fittings is accomplished by rotating the four-vaned handle (see Figure 1) in either direction. The release mechanism for the crotch strap or either of the lap belts can be inactivated so that, with rotation of the handle, the buckle will remain attached to one item of webbing. The two shoulder restraints can also be released separately by pushing forward on the tab located between the shoulder fittings.

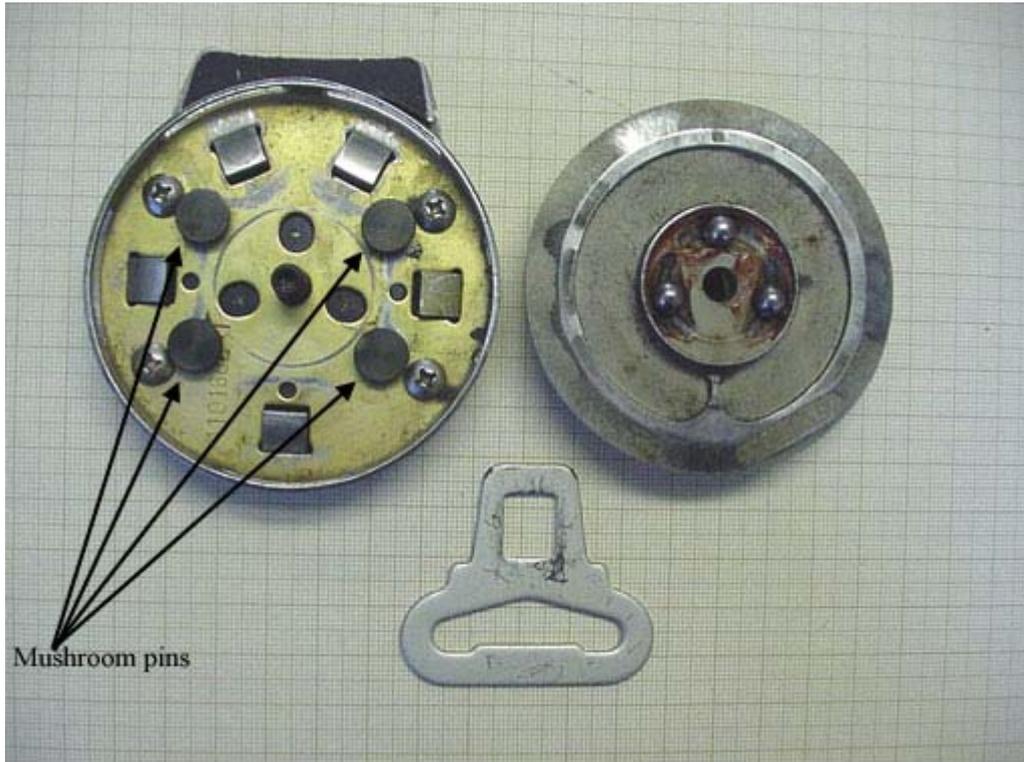
Figure 2 - Example buckle with one harness fitting

The rotary buckle is a simple fabricated device in which each belt plug-in fitting is restrained by a restraining dog (retracted by rotation of the four-vane handle), and a combination of the 'mushroom' pins shown in Figure 2 (an example with the pins in place).

It was noted that the shoulder restraint fittings only have one locating mushroom pin (Figure 2) but are held in place because of the restriction on their movement by the smaller spacing between the restraining dog and the head of the mushroom pin. Under load, the geometry of the harness would make the shoulder fittings more likely to maintain their 'flat' attitude to the buckle, whereas the lap fittings would be liable to tilt away from the body plate because of the direction of the applied force. It is this tilting that would tend to pry the mushroom pins from the body plate and, together with the increased freedom of movement, would allow the fitting to ride over the restraining dog if the mushroom pin became detached.

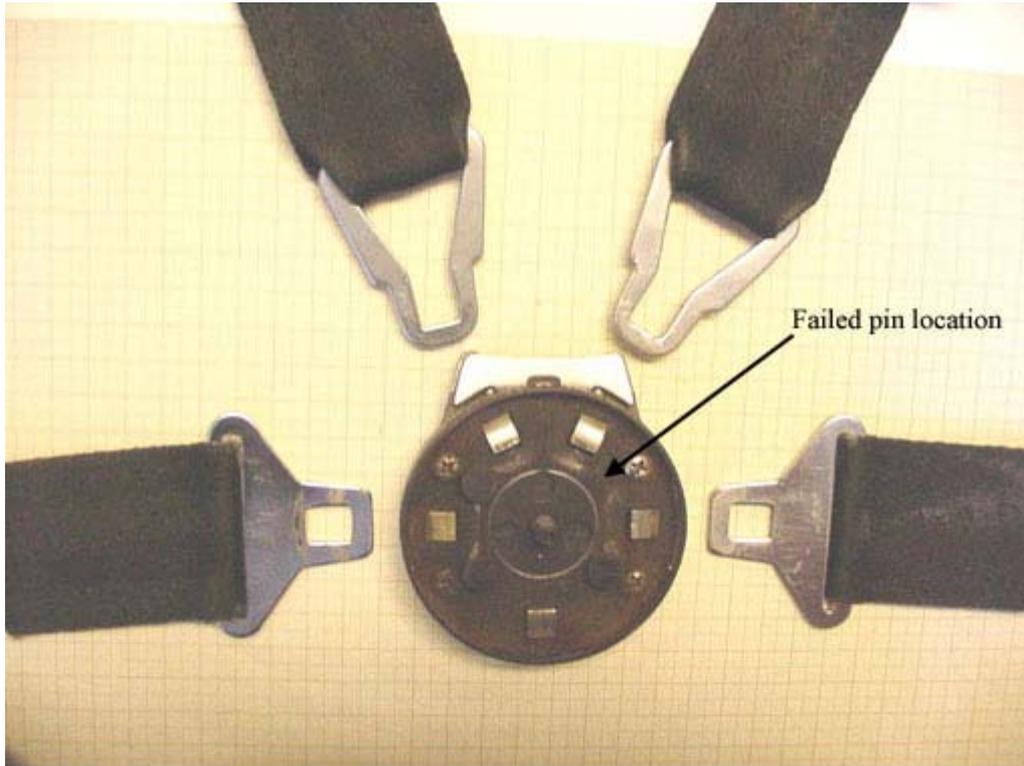
**Figure 3 - Failed buckle with harness fittings**

The buckle had failed (Figure 3 - failed buckle and end fittings) by the left-hand lap fitting pulling out of the buckle, which created witness marks on the fitting and on the remaining mushroom pin with which it was in contact (Figure 4).

Although the lap fitting from the failed buckle had a different pattern to the example fitting, it could not be determined whether this induced the pin failure. The metallurgist considered that of greater significance was the way in which the mushroom pins had been riveted in the failed buckle, when compared with example buckle (Figure 2) from the same manufacturer. On the example buckle the stems of the mushrooms were drilled before riveting and exhibited a greater spreading and hence a greater resistance to pull-out.

The manufacturer's limited examination of the rotary buckle and other hardware in the USA confirmed that the rotary buckle was of their manufacture but that the other hardware was not. The examination also noted that the buckle was manufactured before December 1980 and thus had a lower rated strength than later buckles. There were additional negative comments on the apparent lack of servicing of the buckle, which had become worn and exceeded the wear limits of the Component

Maintenance Manual, and the method of attaching the webbing to the fuselage structure, with a bolt piercing a double lay of the webbing.

The British Gliding Association should review the document *'Maintenance of seat harnesses and belts'* so as to reflect best industry practice and to provide clearer guidance for airworthiness inspection.

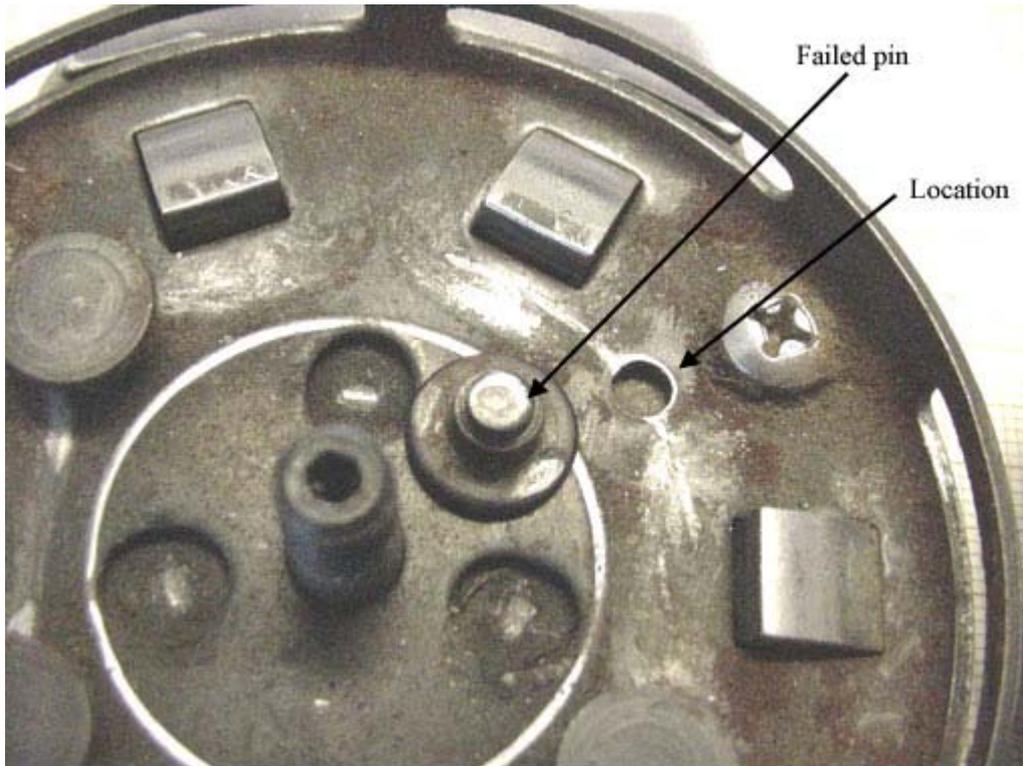
**Figure 4 - Failed mushroom pin**

In order for this to occur, the detached mushroom pin could not have been in place at the time of failure and the physical evidence indicated that it had been loose for some time. The arcs of scoring (Figure 4) show the rotational movement of the pin when the buckle was operated.
