Aircraft Type and Registration:	Piper PA-28-161 Cherokee Warrior II, G-BNOD	
No & Type of Engines:	1 Lycoming O-320-D3G piston engine	
Year of Manufacture:	1987	
Date & Time (UTC):	15 September 1993 at 1418 hrs	
Location:	Near Sanquhar, Ayrshire	
Type of Flight:	Training (Approved CPL/IR Course)	
Persons on Board:	Crew - 1	Passengers - None
Injuries:	Crew - Fatal	Passengers - N/A
Nature of Damage:	Aircraft destroyed	
Commander's Licence:	Student Pilot	
Commander's Age:	20 years	
Commander's Flying Experience:	90 hours (of which 43 were on type) Last 90 days - 63 hours Last 28 days - 38 hours	
Information Source:	AAIB Field Investigation

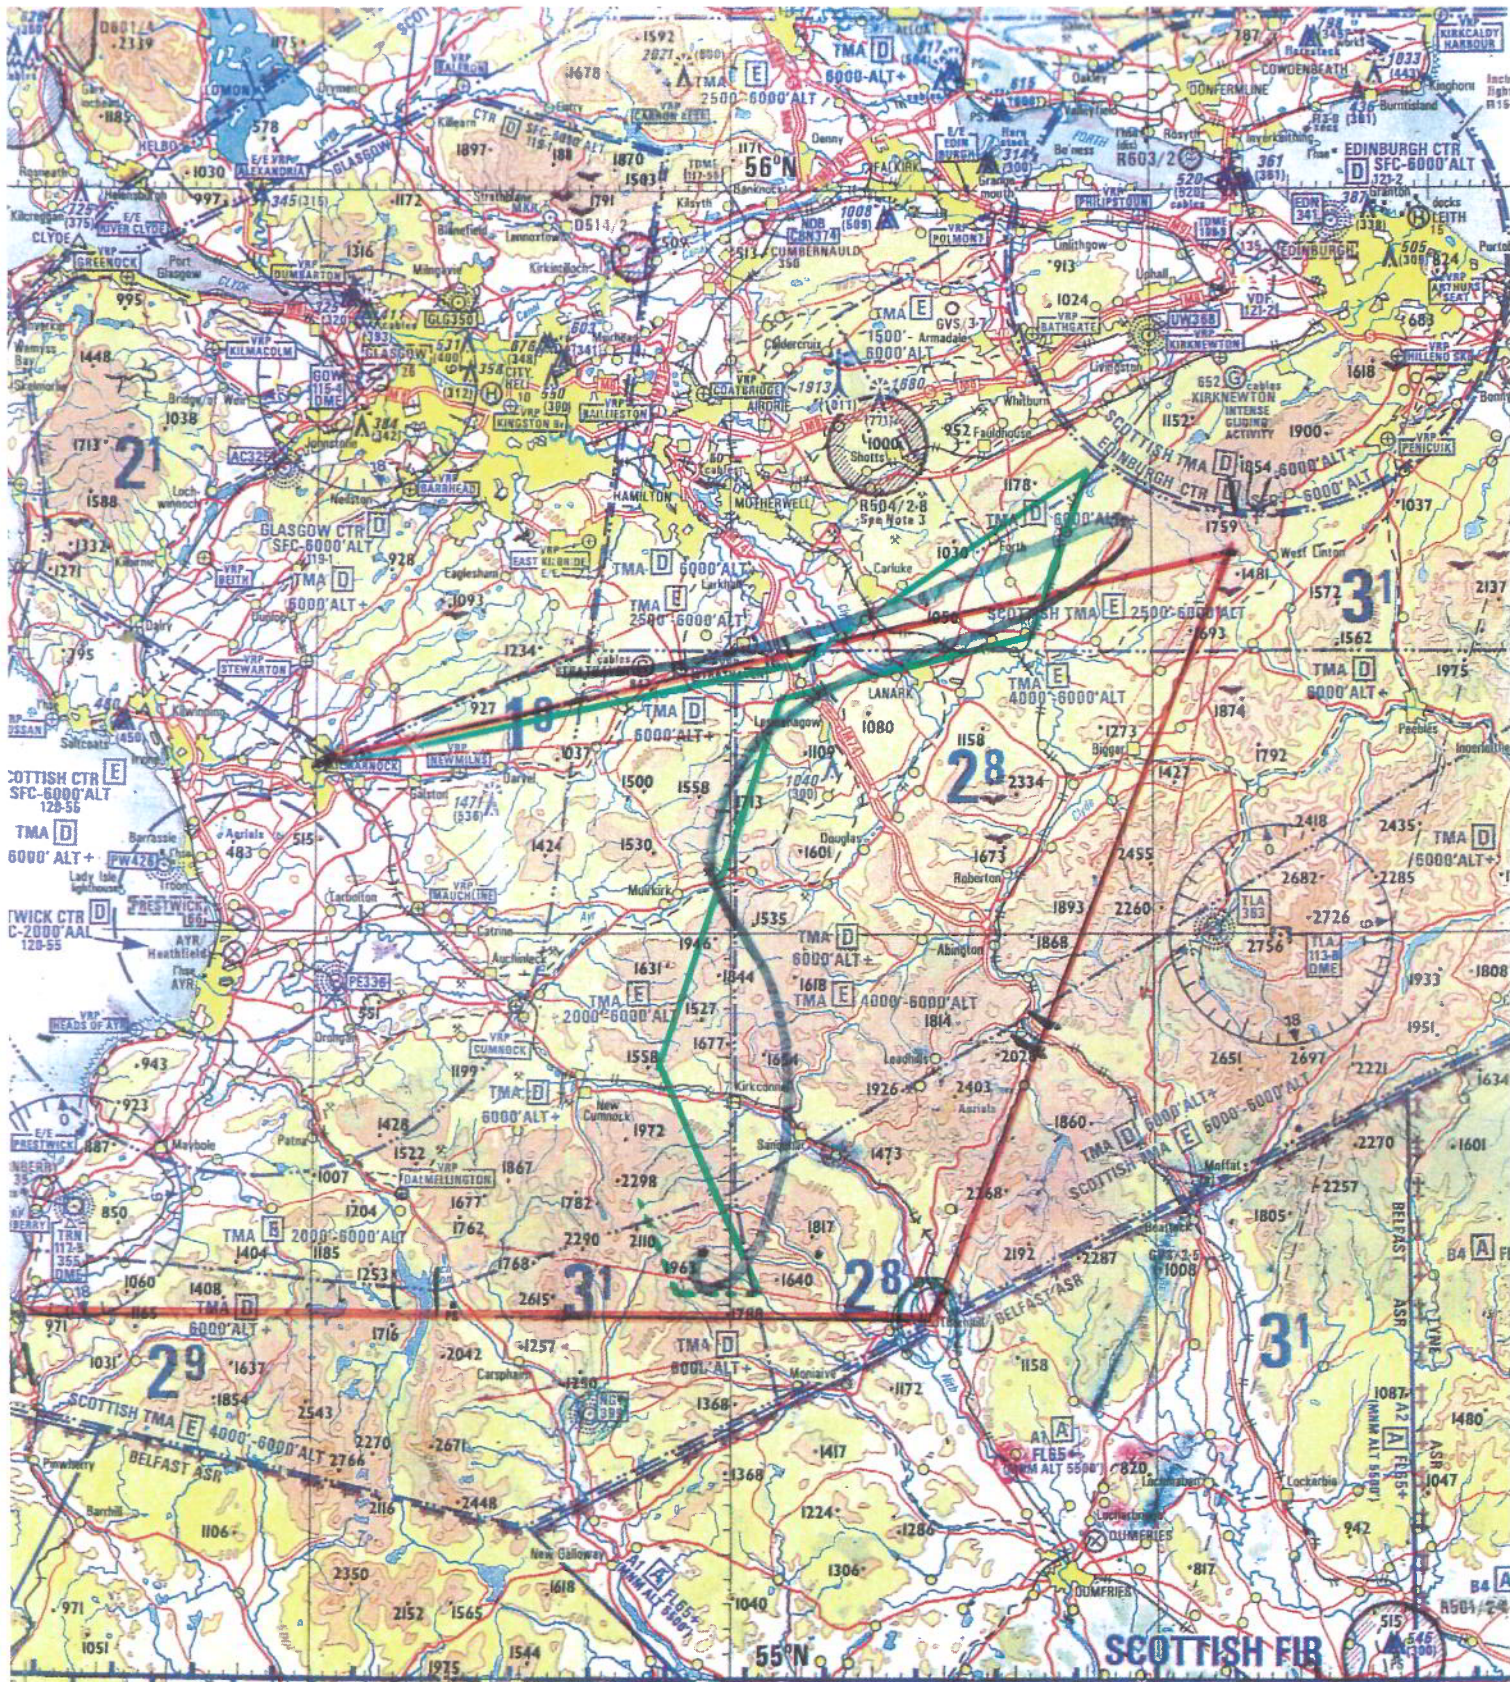
Figure 1

airborne log kept by the student during the flight, and which was recovered from the aircraft wreckage, indicate that the flight progressed normally until 'OD' was some 5 nm to the west of West Linton. At this point 'OD' turned right onto a south westerly track rather than the southerly track required for Thornhill. There is no indication on either the recording of the student's radio transmissions or his log of the reason for this early turn but analysis of his log indicates that at this point he may have misread his watch by 5 minutes. The flight had been planned at 3,000 feet but radar information indicates that 'OD's' height varied between 1,800 and 4,000 feet amsl during this period. Shortly after the turn onto a south westerly track, 'OD' turned a further 60° to the right. Information from the student's log and from the recording of his radio transmissions, indicate that this was the start of a standard hazard avoidance manoeuvre which involves turning 60° off heading for a set time before turning 120° back towards track for the same time before resuming the original track. In the event, the student flew the first 60° leg for 5 minutes until, at a position 5 miles to the west of Lanark, he turned onto a heading that would cause him to fly parallel to his planned track for Thornhill. During this period of the flight, 'OD's' height was fairly steady at 2,400 feet amsl, but due to the height of the terrain below the aircraft, its height above the ground gradually reduced to about 500 feet. Having flown this parallel track for 6 minutes the student turned left onto a south easterly track which his log indicates was to regain his original track. This heading was maintained for 4 minutes while descending to 2,000 feet amsl which again put the aircraft within 500 feet of the ground. The headings referred to in this paragraph are those that appeared on the student's log. The actual headings flown were less precise (see Figure 1).
