Aircraft Type and Registration:	Aero L-39C Albatros, G-OALB	
No & Type of Engines:	1 Ivchenko AI-25TL turbofan engine	
Year of Manufacture:	1979	
Date & Time (UTC):	10 December 2004 at 1444 hrs	
Location:	Manston Airfield, Kent	
Type of Flight:	Private	
Persons on Board:	Crew - 1	Passengers - None
Injuries:	Crew - None	Passengers - N/A
Nature of Damage:	Rear canopy damaged	
Commander's Licence:	Commercial Pilot's Licence	
Commander's Age:	61 years	
Commander's Flying Experience:	11,600 hours (of which 7 were on type) Last 90 days - 18 hours Last 28 days - 12 hours	
Information Source:	Aircraft Accident Report Form submitted by the pilot

Synopsis

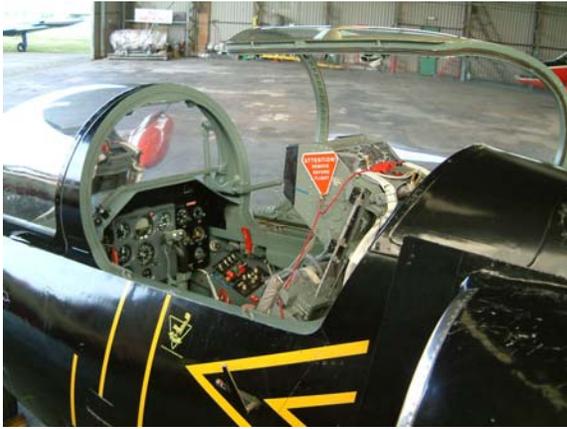
Figure 1

The L-39C Albatros is a tandem two seat jet trainer of Czech origin. The front and rear cockpits are divided by an internal windshield and each has a separate canopy, hinged along its right hand edge as shown in Figure 1. The hinges are designed to disengage when the canopies are shut, to enable them to be jettisoned. The result is that, when closed, the canopy is not attached to the aircraft unless it is also locked. Accordingly, each canopy is locked by rotating a handle that engages two pairs of hooks with two pairs of corresponding pins recessed into the lower edges of the canopy.

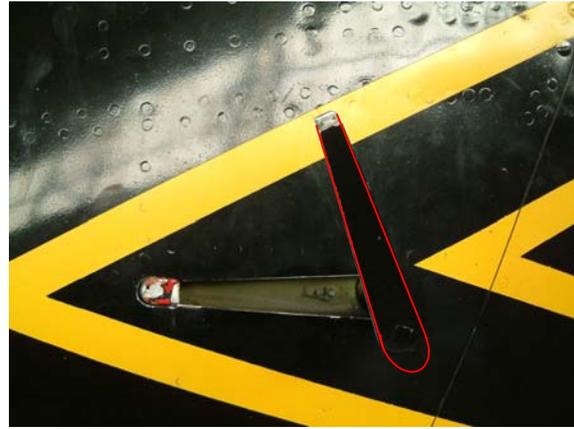
Figure 2

When the canopy is unlocked, the external handle will appear as shown in Figure 2. In order to lock the canopy from outside, the handle must be rotated anti-clockwise, beyond the stowed position. When released it should appear as shown in Figure 3. However, the handle can be stowed, as shown in Figure 4, regardless of whether or not the canopy has been locked. Consequently, visual confirmation that the handle is stowed does not guarantee that the canopy is locked.

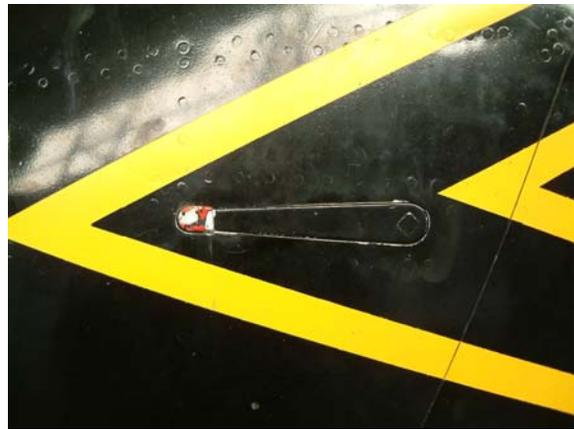
Figure 4

The pilot conceded that he may not have operated the handle correctly to ensure that the canopy was locked prior to takeoff.
