SERIOUS INCIDENT

Aircraft Type and Registration:	Aero AT-3 R100, G-TGUN	
No & Type of Engines:	1 Rotax 912-S2 piston engine	
Year of Manufacture:	2008	
Date & Time (UTC):	12 June 2009 at 1640 hrs	
Location:	Old Sarum Airfield, Wiltshire	
Type of Flight:	Private	
Persons on Board:	Crew - 1	Passengers - 1
Injuries:	Crew - None	Passengers - None
Damage:	Damage to propeller, right wing and engine gearbox	
Commander's Licence:	Private Pilot's Licence	
Commander's Age:	60 years	
Commander's Flying Experience:	192 hours (of which 7 were on type) Last 90 days - 5 hours Last 28 days - 2 hours	
Information Source:	AAIB Field Investigation

Synopsis

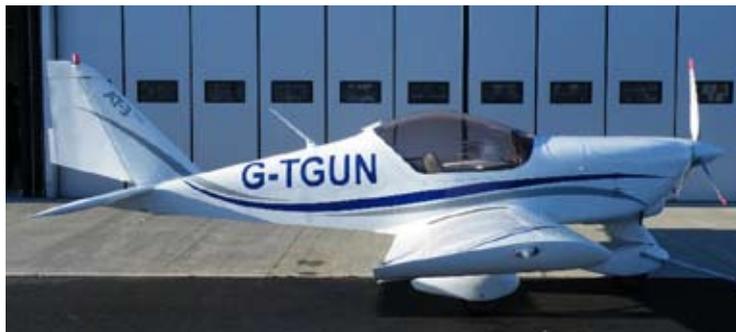
Figure 1

160° the propeller struck the fuel bowser, followed by the right wing. The engine stopped as a result of the propeller strike and the aircraft came to rest. The passenger vacated the aircraft first, followed by the pilot after he had turned off the switches. It was later determined that the parking brake lever had been upright, in the ON position.

Photograph of the incident aircraft, G-TGUN
(photograph courtesy Simon Palmer)

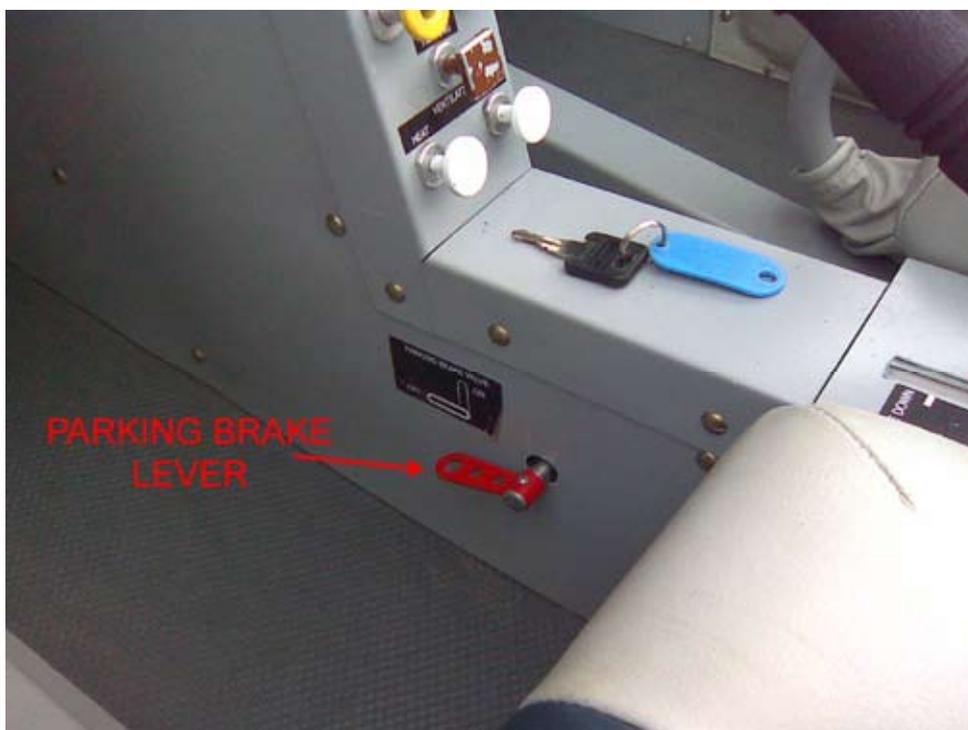
Figure 2

The Aero AT-3 has a hydraulic braking system that operates a disk brake on each main wheel using toe pressure on the rudder pedals. A parking brake lever is fitted to some aircraft, including G-TGUN, and is located on the right side of the pilot's footwell, as shown in Figure 2. The parking brake lever is off when it is in the horizontal position and on when it is in the vertical position. In order to set the parking brake the pilot needs to apply toe brake pressure before moving the lever to ON, because the lever works by trapping

Parking brake lever in the horizontal OFF position; right side of left-seat footwell

The parking brake lever can be moved to the 'ON' position and will stay in the 'ON' position even if no hydraulic pressure is applied to the brake pedals prior to moving the lever. In this situation the parking brake is off despite the parking brake lever indicating ON. Early versions of the parking brake valve incorporated a

bypass valve, to enable the toe brakes to apply hydraulic pressure even when the parking brake lever was in the ON position. This particular type of valve suffered from leaks, so the aircraft manufacturer changed the valve to a new type that did not incorporate a bypass valve. The parking brake valve fitted to G-TGUN did not contain a bypass valve. Therefore, on G-TGUN if the parking brake lever was in the ON position, the toe brakes had no effect on braking.

that the parking brake operated satisfactorily when the parking brake lever was moved to the ON position while applying foot pressure to the toe brakes. When the parking brake lever was moved to ON without applying foot pressure, the parking brake was not applied. He also determined that it was possible inadvertently to select the parking brake lever to the ON position. His report stated that:

'This was possible with both foot contact, or clothing contact, especially when exiting from the aircraft. Such contact could easily select the lever to the up (ON) position thereby trapping zero foot-motor pressure, the result would be to indicate a Parking Brake "ON" condition without any pressure at the brake which is UNACCEPTABLE.'

The pilot had intended to start the engine with the parking brake off, and was holding the toe brakes to prevent the aircraft from moving forwards after start. This was in accordance with the flying school's procedures and its checklist. The fact that the aircraft moved forwards after engine start, and did not respond to toe brake application, indicates that the parking brake lever was probably in the ON position and had been moved to the ON position without toe brake pressure applied. Based on the observations by the CAA test pilot, it is likely that the parking brake lever had been inadvertently moved to the ON position while the pilot was exiting the aircraft in order to refuel it – his right leg or clothing could have brushed against the lever and moved it.

It is recommended that the European Aviation Safety Agency (EASA) require that the Aero AT-3 brake system be modified such that the toe brakes remain functional regardless of whether the parking brake is off or on.

Following this investigation, the aircraft manufacturer stated that they intend to provide warning placards for all affected aircraft which state 'LEFT SEAT TOE BRAKES ARE INOPERATIVE WHEN PARKING BRAKE LEVER IS "ON"'. They also intend to amend the Flight Manual to include the same warning and additional information explaining the operation of the braking system.

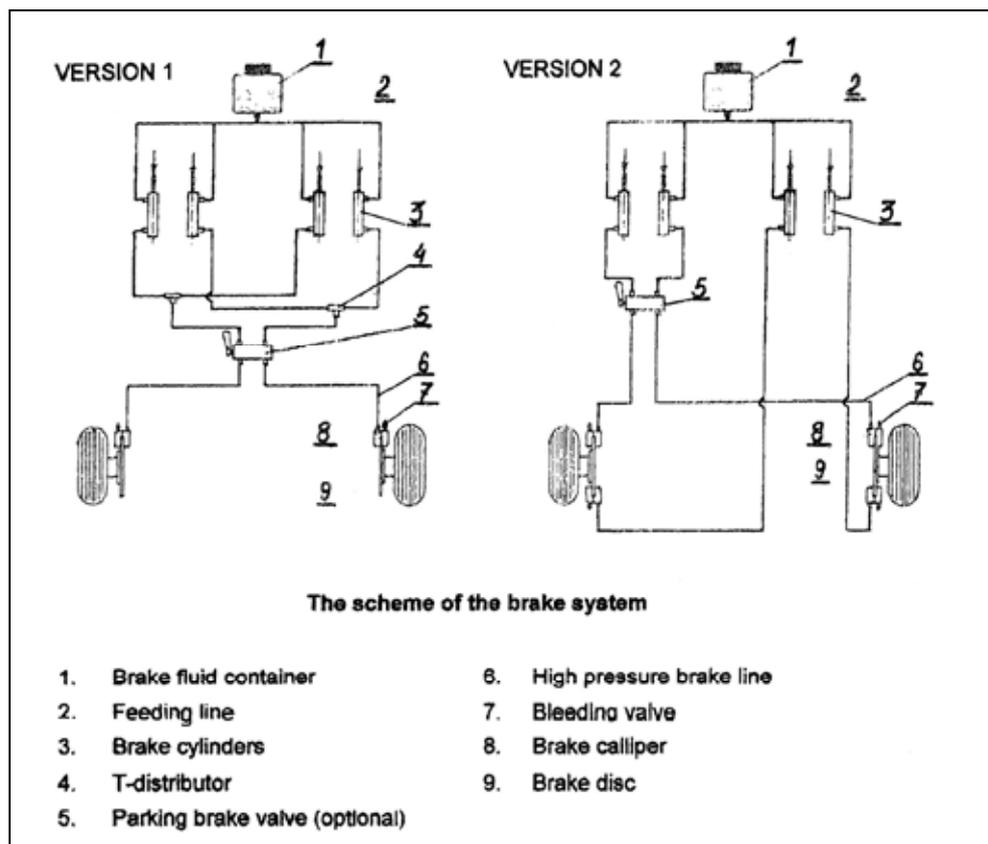
Figure 3

hydraulic pressure in the brake lines. The aircraft maintenance manual depicts two different versions of the braking system: Versions 1 and 2 as shown in Figure 3. Version 1 was fitted to early models of AT-3, while Version 2 was fitted to G-TGUN. In Version 1 there is one set of callipers per brake disk, and the left-seat and right-seat pedals operate the same pair of callipers. The brake pedals from both seats are routed

Brake system diagram extracted from Aero AT-3 Maintenance Manual (G-TGUN brake system was as 'Version 2' above with optional parking brake valve)

through the parking brake valve, so either set of pedals can be used to apply the parking brake. In Version 2 there are two sets of callipers per brake disk, and the front callipers are operated by the left-seat pedals while the rear callipers are operated by the right-seat pedals. Only the left-seat pedals are routed through the parking brake lever, so only the left-seat pilot can apply pressure to operate the parking brake.

The Flight Manual for G-TGUN (version from September 2004) contained a brief description of the braking system in the main body of the manual and a brief description of the parking brake in a supplement at the end of the manual. The accompanying diagram in both sections was for the 'Version 1' system, even though G-TGUN was fitted with the 'Version 2' system. This diagram gives the reader the incorrect impression that the parking brake could be applied from the right-seat pedals when that was not the case. The Flight Manual's description of the parking

It is recommended that the European Aviation Safety Agency (EASA) require Aero Sp to update the Flight Manual for the Aero AT-3 to explain the operation of the braking system clearly and to include a warning that the toe brakes become inoperative when the parking brake lever is selected on.

It is recommended that the European Aviation Safety Agency (EASA) require Aero Sp to provide warning placards, to be installed in all affected Aero AT-3 aircraft, which state that the toe brakes become inoperative when the parking brake lever is selected on.
