**SERIOUS INCIDENT**

<b>Aircraft Type and Registration:</b>	Airbus A319-131, G-EUPX
<b>No &amp; Type of Engines:</b>	2 International Aero Engine V2522-A5 turbofan engines
<b>Year of Manufacture:</b>	2001 (Serial no: 1445)
<b>Date &amp; Time (UTC):</b>	25 April 2012 at 1113 hrs
<b>Location:</b>	Runway 09L, London Heathrow Airport
<b>Type of Flight:</b>	Commercial Air Transport (Passenger)
<b>Persons on Board:</b>	Crew - 5                      Passengers - 112
<b>Injuries:</b>	Crew - None                      Passengers - None
<b>Nature of Damage:</b>	Tyres scuffed
<b>Commander's Licence:</b>	Airline Transport Pilot's Licence
<b>Commander's Age:</b>	52 years
<b>Commander's Flying Experience:</b>	7,700 hours (of which 5,000 were on type) Last 90 days - 150 hours Last 28 days - 34 hours
<b>Information Source:</b>	AAIB Field Investigation

**Synopsis**

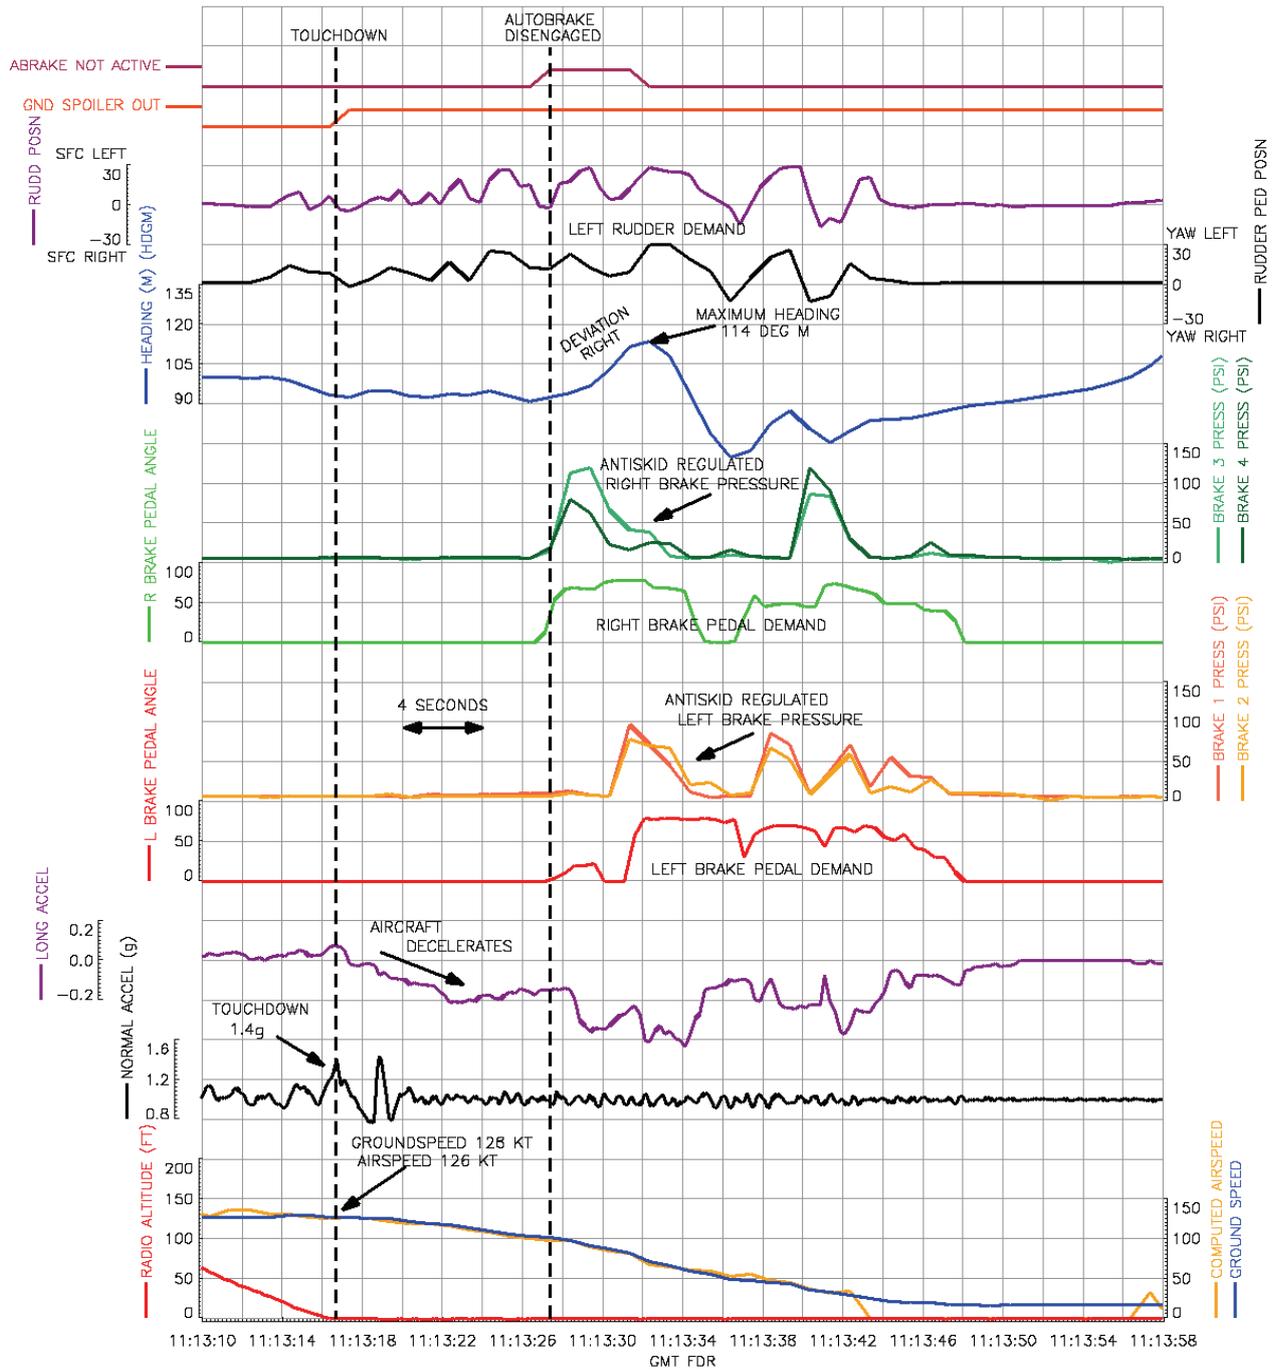
**Figure 1**  
G-EUPX FDR and FDM data

Aircraft touchdown was recorded at a normal acceleration of 1.4g, computed airspeed of 126 kt and groundspeed of 128 kt (Figure 1). Approximately 10 seconds after touchdown, the CVR recorded one

of the flight crew announce ‘DECEL’, signifying that deceleration has been felt by the crew and has been confirmed by a speed trend on the primary flight display. The Autobrake system did not apply any brake pressure to achieve this as the effect of the aerodynamic braking and engine reverse thrust was sufficient.

Just after ‘DECEL’ was announced, the FDR recorded deflection of both brake pedals but significantly more on the right pedal, which disengaged the Autobrake. An increase in brake pressure on both right main landing gear brakes (brakes 3 and 4) was recorded, although the antiskid system limited the pressure to prevent the wheels

from skidding. Four and a half seconds after the right pedal was depressed, the left brake pedal was applied along with left rudder, which slowed the yaw rate and returned the aircraft back to the runway centreline.
