ACCIDENT

Aircraft Type and Registration:	Piper PA-34-220T Seneca III, G-LENY	
No & Type of Engines:	2 Teledyne Continental TSIO-360-KB piston engines	
Year of Manufacture:	1982	
Date & Time (UTC):	19 December 2007 at 1709 hrs	
Location:	4 nm south of Oxford (Kidlington) Airport	
Type of Flight:	Commercial Air Transport	
Persons on Board:	Crew - 1	Passengers - None
Injuries:	Crew - 1 (Serious)	Passengers - N/A
Nature of Damage:	Aircraft destroyed	
Commander's Licence:	Commercial Pilot's Licence	
Commander's Age:	52 years	
Commander's Flying Experience:	4,268 hours (of which 1010 were on type) Last 90 days - 164 hours Last 28 days - 46 hours	
Information Source:	AAIB Field Investigation

Synopsis

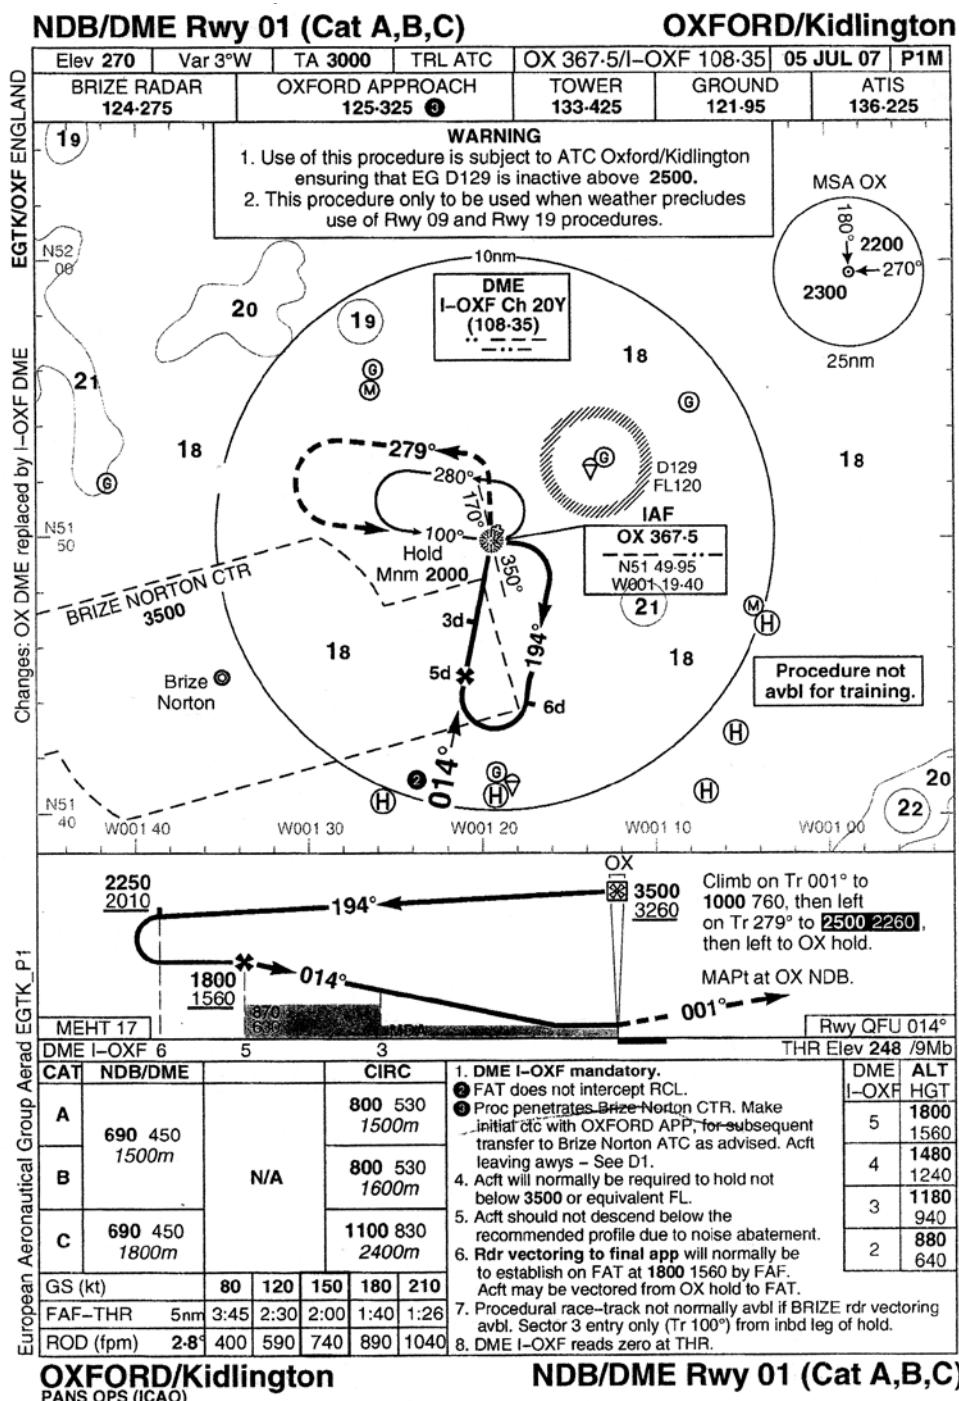
Runway 01 was served by an NDB/DME approach, shown at Figure 1 in the same format as that available to the pilot. The procedure involved a descent to the intermediate altitude of 1,800 ft as the aircraft

Runway 01 Approach Chart

established on the inbound course of 014°(M). Final descent started at the Final Approach Fix (FAF), which was at 5 DME. A step-down fix existed at 3 DME with an associated MDA of 870 ft amsl. The procedure

MDA after the step-down fix was 690 ft amsl, equating to 450 ft above the runway threshold. The associated minimum required visibility was 1,500 m.

The Runway 01 approach chart contained information which assisted pilots to fly a CDA, and a note on the chart specifically stated that pilots should employ this technique for noise abatement reasons. Had the pilot observed this instruction and adhered to the published range/altitude profile, the aircraft would have remained above the step-down MDA of 870 ft until after the 3 DME point.

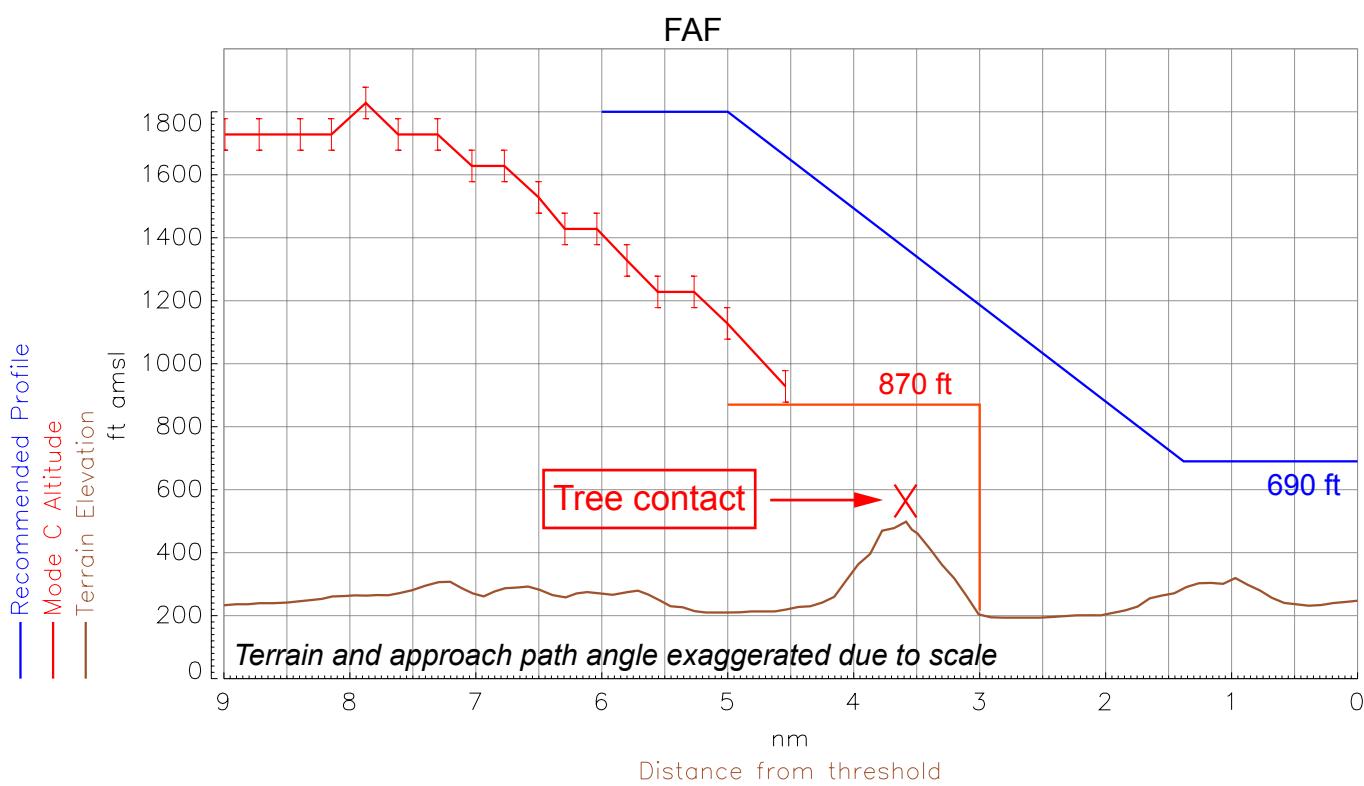
Figure 2
Approach profile

Mode C values in this report have been converted to a corrected altitude. Figure 2 shows the aircraft's vertical profile from before the FAF; vertical error bars represent the Mode C resolution limitation.

The aircraft maintained level flight until starting to descend at about 7.3 nm from the runway threshold (equivalent to 7.3 DME), at which point it was established on the inbound radial. At 5.5 DME the aircraft track started to drift slightly right of track, and at the 5 DME FAF, when the final descent should have commenced, the aircraft was indicating 1,144 ft altitude, 656 ft below the recommended approach profile. It had also just started to drift to the right of the inbound track. To this point, the rate of descent was about 500 ft/min.

The aircraft continued to descend at a slightly increased rate until the last radar return, at 1708:36 hrs. The aircraft was at 4.5 nm range and 944 ft altitude, 696 ft below the recommended profile. This was just before the pilot made his last radio transmission. Based on the observed

rate of descent, the aircraft would have descended below the step-down MDA of 870 ft just after the last radar return, at about 4.4 nm. The last radar position placed the aircraft 1,700 m from the point of first impact with the trees, at an altitude of 944 ft and 130 m right of the inbound course.

Between the last radar return and the first contact with the trees, the rate of descent would have been between 700 and 900 ft/min. As Figure 2 shows, the radar data does suggest a slight increase in rate of descent in the latter stage. Based on the average groundspeed at that point, the aircraft would have hit the trees 30 seconds later. The average rate of descent from starting descent at 7.3 DME to the point of impact was about 600 ft/min, which would have been the rate required to follow the recommended profile from the FAF.

If the final descent rate was as predicted, the aircraft descended through the procedure MDA of 690 ft about 650 m and 11 seconds before the first point of contact. Had the aircraft levelled at the procedure MDA of 690 ft, the aircraft would have cleared the trees on its track by approximately 130 ft, and would have cleared the trees on the adjacent highest ground by about 90 ft (using an average tree height of 60 ft).
