**INCIDENT**

<b>Aircraft Type and Registration:</b>	AS332L2 Super Puma, G-REDN	
<b>No &amp; Type of Engines:</b>	2 Turbomeca Makila 1A2 turboshaft engines	
<b>Year of Manufacture:</b>	2004	
<b>Date &amp; Time (UTC):</b>	14 December 2007 at 1000 hrs	
<b>Location:</b>	Aberdeen Airport, Scotland	
<b>Type of Flight:</b>	Commercial Air Transport (Passenger)	
<b>Persons on Board:</b>	Crew - 2	Passengers - None
<b>Injuries:</b>	Crew - None	Passengers - N/A
<b>Nature of Damage:</b>	None	
<b>Commander's Licence:</b>	Airline Transport Pilot's Licence	
<b>Commander's Age:</b>	39 years	
<b>Commander's Flying Experience:</b>	7,400 hours (of which 5,400 were on type) Last 90 days - 125 hours Last 28 days - 34 hours	
<b>Information Source:</b>	Aircraft Accident Report Form submitted by both pilots and operator's own incident report

**Synopsis**

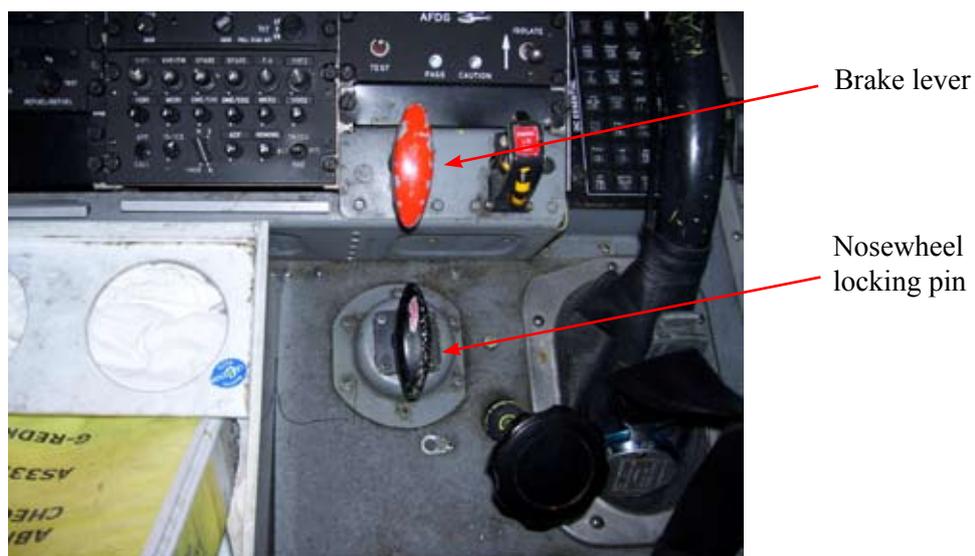
Figure 2

The nosewheel locking pin lever is painted black and is located between the pilots' seats, just aft of the brake lever, which is painted red. Both levers are aligned fore and aft when in the 'OFF' position (Figure 2).

It is recognised that the levers may be confused due to their proximity, which has led to attempts to differentiate between them by colour. Identification of the mistake through the use of the checklist was unsuccessful probably as the result of the change in PF role at that point. It is unclear exactly when the checklist was actioned and it is possible a check of the locking pin position was overlooked. Fatigue may have been a contributory factor due to the early start of this and the previous duty periods, although they were of a relatively short duration.

- changes to the checklist relating to the nosewheel locking pin
- reinforcing amongst crews the need for discipline when using checklists
- improved training on the use of the nosewheel locking pin and in particular the actions to be taken should it be found to be inadvertently locked during taxi
- introduction of procedures for ground crew to check the locking pin flag position prior to taxi
- proposed improvements to the positioning and ground handling of aircraft on the company apron to provide better clearance between them
- improvements to the handling of data after an incident or accident

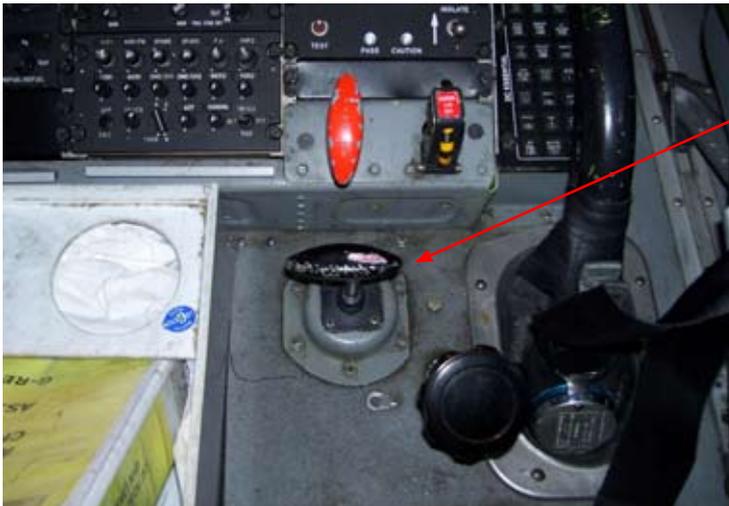
Figure 3 (left)

The nosewheel locking pin is engaged by raising the lever and rotating it to the right (Figure 3), the pin then dropping under spring pressure and entering into a fixed hole on the nosewheel leg when the nosewheel is centred. This also causes a flag (see Figure 4) to drop below the body of the aircraft in front of the wheel indicating the pin has been applied. The flag will drop as soon as the lever is rotated, even if the pin has not engaged into the fixed hole in the nosewheel leg.

Nosewheel locking pin - engaged

Had the nosewheel locking pin been set to the locked position with the nosewheel offset to the right when the aircraft was parked on Spot 5 the pin would have been unable to engage. The helicopter would have been able

to continue a turn to the right when it recommenced its taxi. When the aircraft then turned to the left, however, the pin would have engaged as the nosewheel passed through the central position, preventing the helicopter continuing the turn. The forces exerted on the aircraft by the application of left yaw pedal whilst the helicopter was unable to turn would have created a rolling moment, exasperated by the increase in collective pitch application. This is probably the reason the helicopter rolled to the right when it was sufficiently light on its wheels.

It seems that the most likely cause of the nosewheel lock having been set is that the lever was placed in the engaged position instead of the parking brake after parking on Spot 5. The helicopter would probably have remained stationary without the parking brake being set due to the apron being flat and chocks being put in place quickly after it parked.

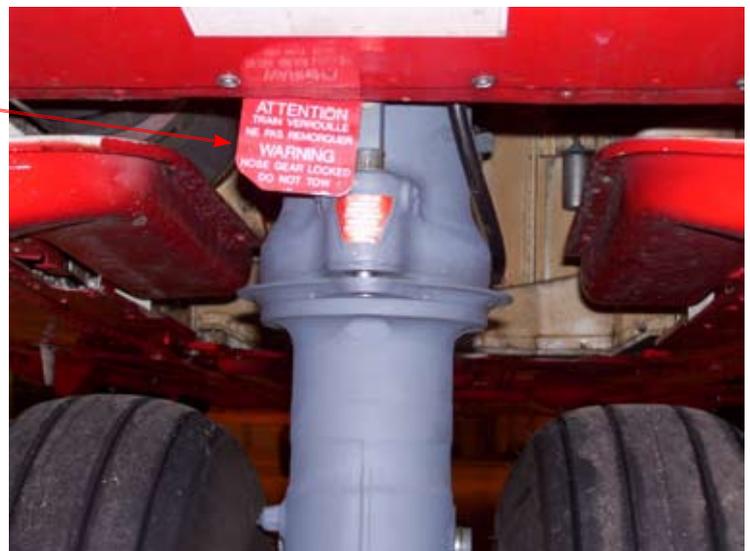
Figure 4 (right)

Warning flag
