Aircraft Type and Registration:	MW5D Sorcerer, G-MZEI	
No & Type of Engines:	1 Rotax 503 piston engine	
Year of Manufacture:	1997	
Date & Time (UTC):	2 September 2004 at 1648 hrs	
Location:	Belle Vue Farm, Great Torrington, Devon	
Type of Flight:	Private	
Persons on Board:	Crew - 1	Passengers - None
Injuries:	Crew - 1 (Serious)	Passengers - N/A
Nature of Damage:	Aircraft destroyed	
Commander's Licence:	Private Pilot's Licence	
Commander's Age:	63 years	
Commander's Flying Experience:	420 hours (of which 10 were on microlights) Last 90 days - 5 hours Last 28 days - 3 hours	
Information Source:	AAIB Field Investigation

Synopsis

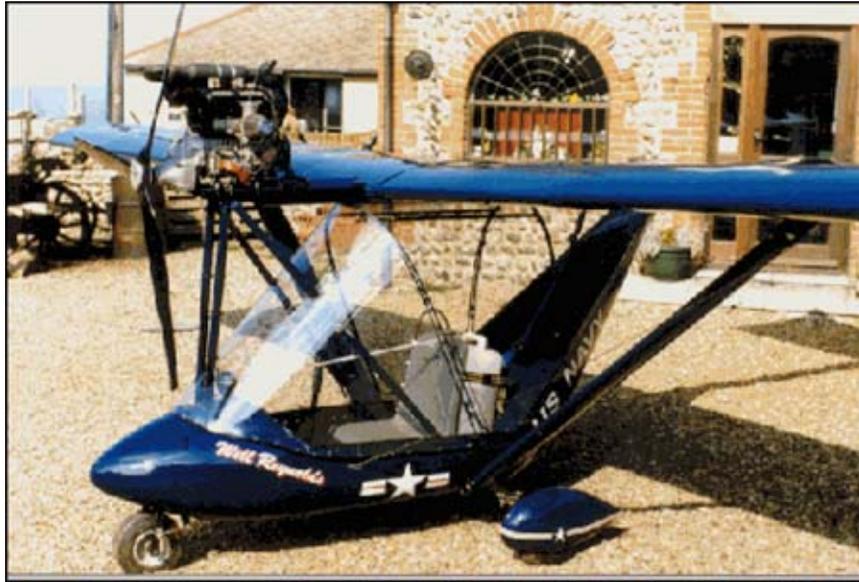
A photograph of G-MZEI shown above. The main structural member of this type of aircraft is a longitudinal alloy boom running from the tail, through the wing centre section and then beyond the leading edge. The fuselage is located below the wing such that the boom runs along the cockpit roof. The engine is mounted on the front of the boom and so is positioned above and forward of the pilot. This arrangement had served to protect the pilot to an extent, as the main force of the impact had been borne by the engine and mounting structure. However, additional bracing was provided in the form of struts located between the engine mount and the cockpit sides, and the compressive failure of one of these during the impact had resulted in a broken end penetrating the pilot's right thigh, causing a serious injury.

There was no evidence of a pre-impact structural failure, or of any pre-impact failure or disconnection of the flying controls. However, the tailplane trim system was the focus of some attention. The aircraft featured an 'all flying' tail, which is usually more powerful than the tailplane and elevator combination that was a feature of the X'Air aircraft on which the pilot had conducted some training. This had necessitated the fitting of an anti-balance tab on the trailing edge of the left side, which also functioned as the trim tab. The trim adjustment wheel in the cockpit had been fabricated from the hollow cap of a plastic 'Jerrycan' container and was mounted on a pair of brackets with a threaded insert in its centre. Rotation of the wheel caused a longitudinally orientated threaded shaft to move either fore or aft, depending on the direction of rotation. The rear end of the shaft was connected to the trim cable, which moved the tab against the tension of a spring mounted between the tab operating horn and the underside of the tailplane. The design was such that normal operation

The trim operating cable had remained intact, although the boom along which it was clipped had broken at its join with the fuselage. Some stretch had inevitably occurred during the accident and subsequent recovery, but after allowing for this, the as-found position was considered to be excessively trailing edge up (ie aircraft nose down). This corresponded with the as-found position of the trim adjuster, which was set with 24 mm of exposed thread ahead of the wheel and only 7 mm to the rear. Rotating the adjuster until the threaded shaft was in its mid position produced a tab position that was only slightly nose down. It thus appeared that the trim had been set to a markedly nose-down position prior to the accident flight. However, it was noted that a casual glance at the adjuster, which was located under the pilot's right elbow, gave the impression of an approximate mid position, due to the length of threaded shaft that was "hidden" under the rim of the hollow Jerrycan cap.
