**AAIB Bulletin No:** 3/95      **Ref:** EW/C94/7/5      **Category:** 1.1

**Aircraft Type and Registration:** Airbus A300-B4, OO-ING

**Date & Time (UTC):** 23 July 1994 at 0115 hrs

**Location:** Stand 23, London Gatwick Airport

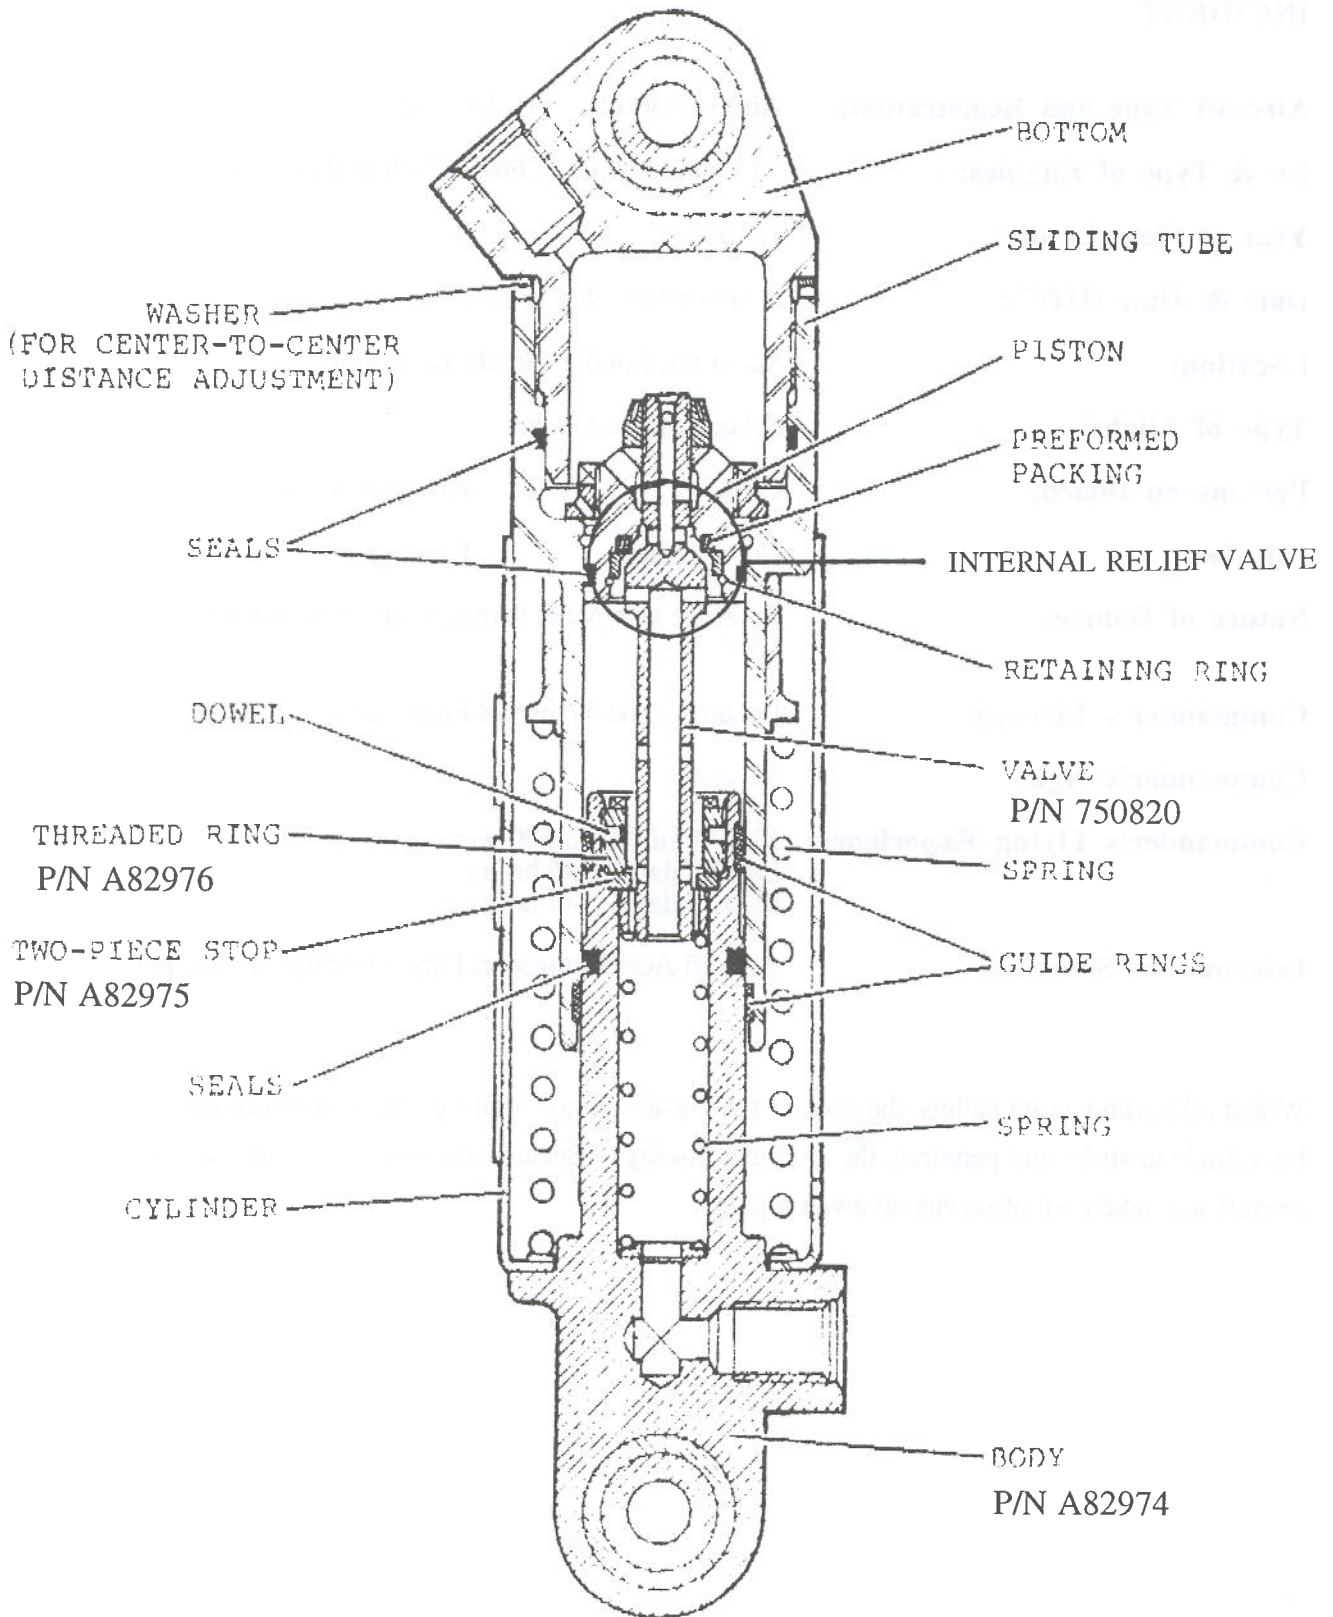
Figure 3

Because of the damage to the aircraft it was not possible, initially, to test the aircraft's braking system as a complete system. When the front of the right-hand main landing gear truck was raised clear of the ground it was found that the numbers 3 and 4 wheels could not be rotated by hand. Static tests revealed an apparent fault with the right-hand footmotor, part number 746078-102, which had been fitted to the aircraft ten days prior to the accident. During the removal of the right-hand footmotor it was noted that the top retaining bolt, the first of the two retaining bolts to be removed, was extremely tight within its locating holes and that as the top of the footmotor was moved away from its top fitting point it expanded in length. When refitted it had to be compressed to allow the second of the two retaining bolts to be fitted. A pencil line was drawn on the footmotor body to mark its compressed position when fitted in the aircraft. The difference between the compressed fitted length and the relaxed length of the footmotor was found to be approximately 0.65 mm.

The footmotor was removed from the aircraft and hydraulic pressure was applied to its output port. With the footmotor in its relaxed position there was fluid flow through the unit. With the footmotor compressed to the pencil line, the position of the footmotor when fitted within the aircraft, there was no fluid flow through the unit. This indicated that, when the unit was fitted to the aircraft, any pressure in the hydraulic line between the BDDV and the footmotor would be trapped and would not be allowed to bleed back to the footmotor reservoir when the right brake pedal was in the relaxed (brake OFF) position. The pipeline from the footmotor to the BDDV was routed under the cockpit and cabin floor through the main avionics bay and cargo bays to the main landing gear bay where the BDDV was located. It is felt that the thermal expansion of the hydraulic fluid within this pipe was, under certain operating conditions, enough to raise the pressure within the line to that required to operate the BDDV. This would allow Yellow system pressure to activate the Alternate brake system and produce a hard feel to the right brake pedal over a relatively short distance of travel. With the Yellow system depressurised and aircraft braking taking place using the Green system then the braking action would be asymmetric between the right and left brakes due to the right brake pedal travel being restricted.

A number of components from the aircraft's Yellow braking system, including the right-hand footmotor, were examined and tested by the component manufacturer. When the right-hand footmotor was bench tested it was found that the dead travel, that is the amount of compression required to close the Internal Relief Valve (Figure 3), was 0.5 mm which was within the unit's specification. This supported the view that, when installed, the compression of 0.65 mm would have been sufficient to close the Internal Relief Valve.

Overall measurement of the footmotor was 171.5 mm whereas the specified length was 170 mm +0.05 mm to +0.1 mm. Strip examination of the unit revealed that the Threaded Ring, part number A82976 was not correctly installed in that it had not been tightened sufficiently into the body, part number A82974. Further disassembly revealed witness marks on the two halves of the Two-piece Stop, part number A82975, which strongly suggested that on assembly at overhaul one half of the Stop had been allowed to be partially lying on top of the other half. The unit was then reassembled correctly using all the original parts and found to functioned satisfactorily.

- 95-4** It is recommended that the DGAC reviews, and revises where necessary, the overhaul and quality assurance procedures of the overhaul agency to ensure that, in future, it releases only components which are fully serviceable.
