BULLETIN CORRECTION**INCIDENT**

Aircraft Type and Registration:	Boeing 737-73V, G-EZKA	
No & Type of Engines:	2 CFM56-7B20 turbofan engines	
Year of Manufacture:	2003	
Date & Time (UTC):	28 December 2005 at 1840 hrs	
Location:	6 miles west of Newcastle, Northumbria	
Type of Flight:	Public Transport (Passenger)	
Persons on Board:	Crew - 5	Passengers - 128
Injuries:	Crew - None	Passengers - None
Nature of Damage:	None	
Commander's Licence:	Airline Transport Pilot's Licence	
Commander's Age:	47 years	
Commander's Flying Experience:	11,121 hours (of which 4,380 were on type) Last 90 days - 206 hours Last 28 days - 78 hours	
Information Source:	Aircraft Accident Report Form submitted by the pilot and subsequent enquires by the AAIB

AAIB Bulletin No 4/2006, page 49 refers

An incorrect figure (**Figure 1** - Location of APU air inlet on Boeing 737-700) was inadvertently printed in the above report in the April bulletin. The complete report is reproduced below:

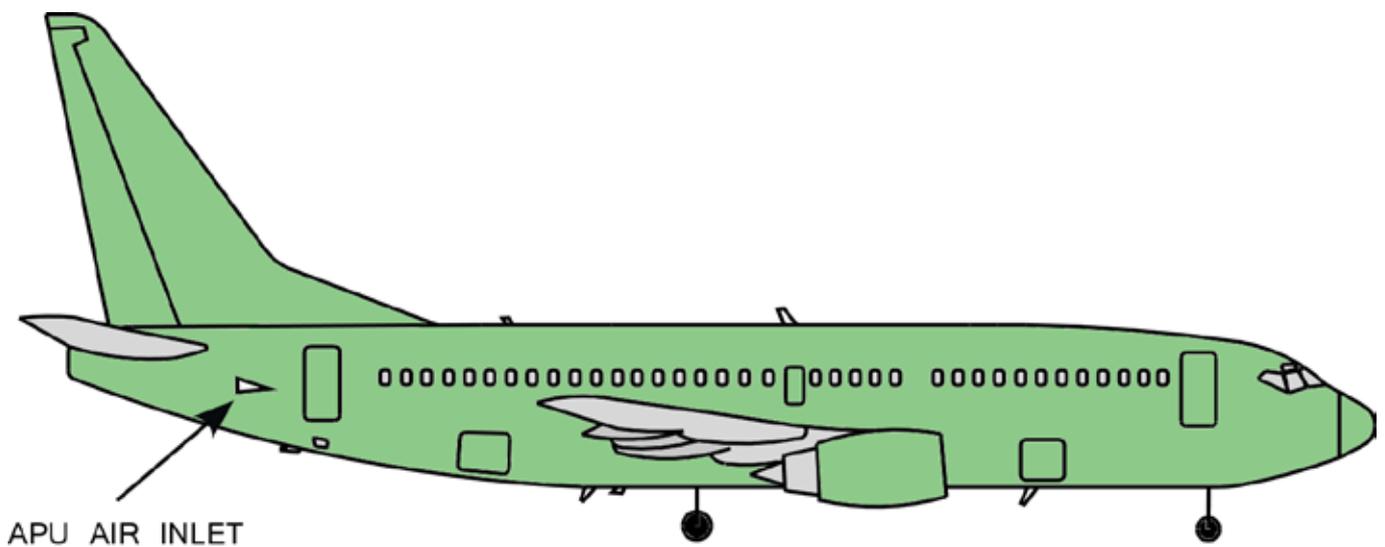
Figure 1

A review of the CAA's Mandatory Occurrence Report database revealed at least three previous occurrences of contaminated bleed air during the takeoff on Boeing 737 aircraft. In all three cases the cause was reported as excess de-icing fluid finding its way into the APU air inlet (Figure 1) during takeoff and climb.

The most likely cause of the fumes and smoke that entered the cockpit and cabin was excess de-icing fluid finding its way into the APU air inlet (Figure 1) during the climb out. The de-icing fluid would then enter the hot sections of the APU, causing it to produce smoke and fumes which would then pass through to the air conditioning and into the aircraft. Performance limitations for this

Location of APU air inlet on Boeing 737-700

The operator has undertaken to remind those who de-ice the aircraft about the need to take care when de-icing in the vicinity of the APU inlet on Boeing 737 aircraft.
