## ACCIDENT

<b>Aircraft Type and Registration:</b>	Pegasus Quantum 15, G-BZJF	
<b>No &amp; Type of Engines:</b>	1 Rotax 582-40 piston engine	
<b>Year of Manufacture:</b>	2000	
<b>Date &amp; Time (UTC):</b>	26 August 2007 at 1920 hrs	
<b>Location:</b>	Knotting Wood, near A6 Northamptonshire	
<b>Type of Flight:</b>	Private	
<b>Persons on Board:</b>	Crew - 1	Passengers - 1
<b>Injuries:</b>	Crew - 1 (Fatal)	Passengers - 1 (Fatal)
<b>Nature of Damage:</b>	Aircraft destroyed	
<b>Commander's Licence:</b>	National Private Pilot's Licence	
<b>Commander's Age:</b>	38 Years	
<b>Commander's Flying Experience:</b>	37 hours (all of which were on type) Last 90 days - 8 hours Last 28 days - 2 hours	
<b>Information Source:</b>	AAIB Field Investigation

The microlight aircraft suffered an in-flight break-up, causing fatal injuries to the two occupants. Examination of the wreckage revealed damage consistent with the aircraft having entered a tumble; a rapid, uncontrolled pitch rotation usually resulting in structural failure. Insufficient evidence was available to allow the cause of the tumble to be determined, although mechanical failure could be ruled out as a contributory factor.

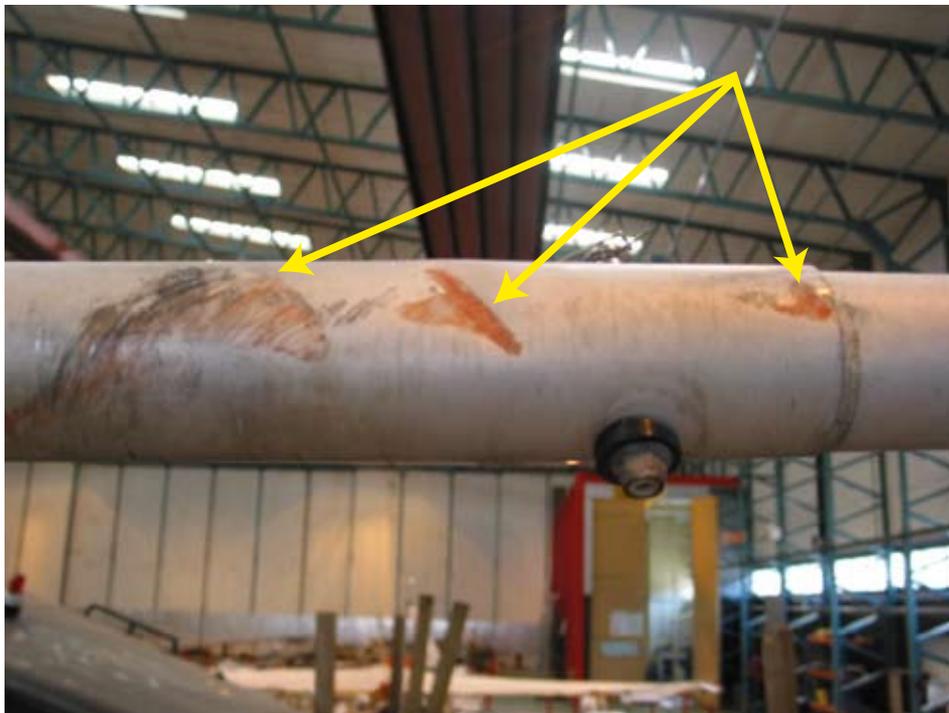
**Figure 2**

The front strut had failed, with the upper and lower portions remaining attached to the wing and the trike, respectively. The pilot had sustained a wound to the front of his head, consistent with having struck the fractured end of the upper portion of the strut. The monopole had failed at the locking clamp location, leaving an approximately 150 cm long section of it attached to the wing; the rest of the monopole was still attached to the trike. Multiple paint transfer marks, indentations on the rear of the wing keel tube and cuts in the fabric of the fin were indicative of the propeller blades having struck the rear of the wing whilst the propeller was turning (Figure 2).

Propeller strike marks on wing keel tube

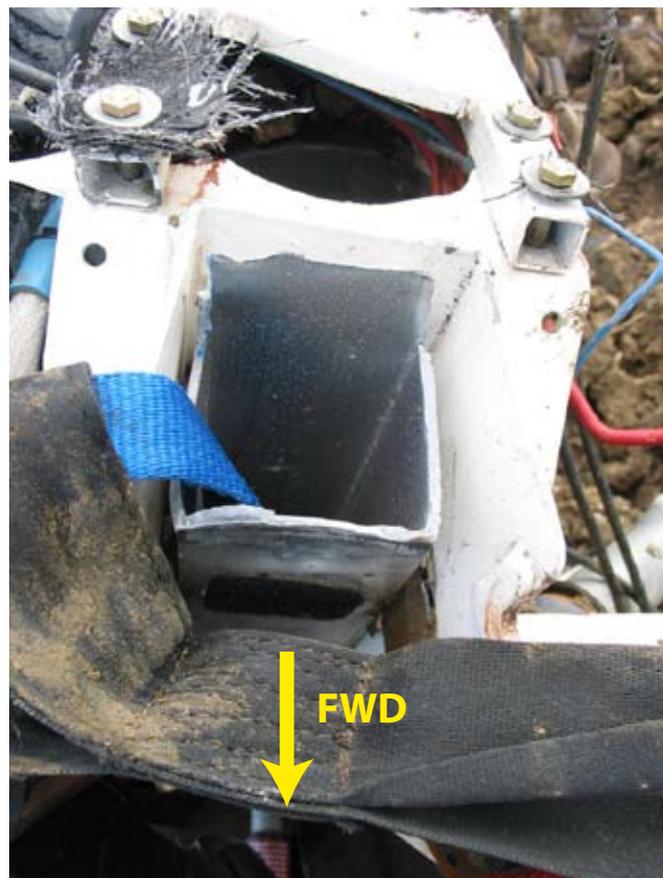
**Figure 3**  
Monopole failure

From the deformation of the material in the area of the failure (Figure 3), it was evident that the monopole had been exposed to large bending loads in the fore and aft directions prior to failure. The stitching in the upper loop of the safety strap had subsequently failed in overload, causing the wing and trike to separate in the air.

The fractures of the monopole, front strut, basebar and right 'A' frame upright were examined. The failures were found to be consistent with rapid overloading of the structure. No pre-existing defects, such as fatigue, were found that could have contributed to the failure of these components.
