Aircraft Type and Registration: Falco F8L home build, G-MRCI

Date & Time (UTC): 1 April 1993 at 1220 hrs

Location: Newcastle Airport

Nature of Damage: Left hand flap broken off at inner pivot point

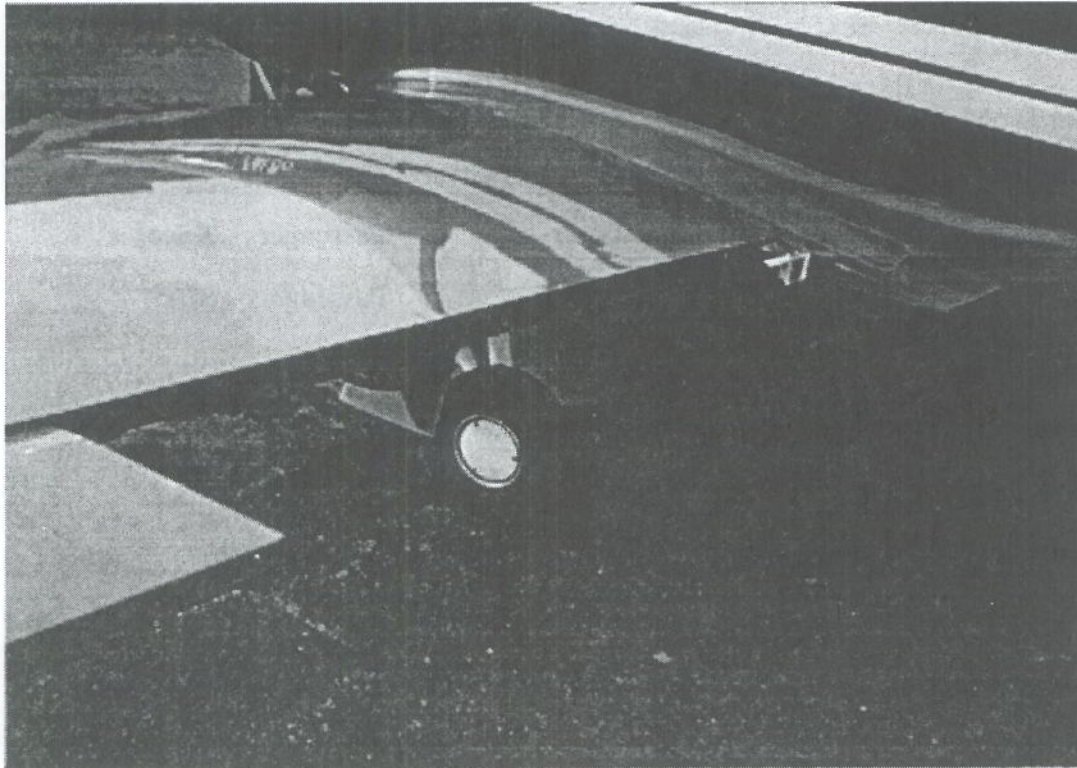
The left flap had pulled out of the pivot bolt hinge on the outer end near the aileron, and had broken at the inner wing root end. The mounting bracket was still attached to the operating rod/hinge along with approximately three inch square of broken splintered wood. A thorough check revealed excessive play in the right flap linkage and hinge.

This particular aircraft had the flaps set approximately 3° above the neutral position when selected fully up, and it had been normal practice to re-adjust the flaps to the neutral, level with the wing trailing edge, in normal flight. In this position the flaps were not held against a positive stop, but were retained in position by the actuating linkage. This was the position of the flaps during the V_{NE} test and the pilot is of the opinion that the lack of positive retention, plus the play in the linkage, caused the flap to vibrate/flutter.
