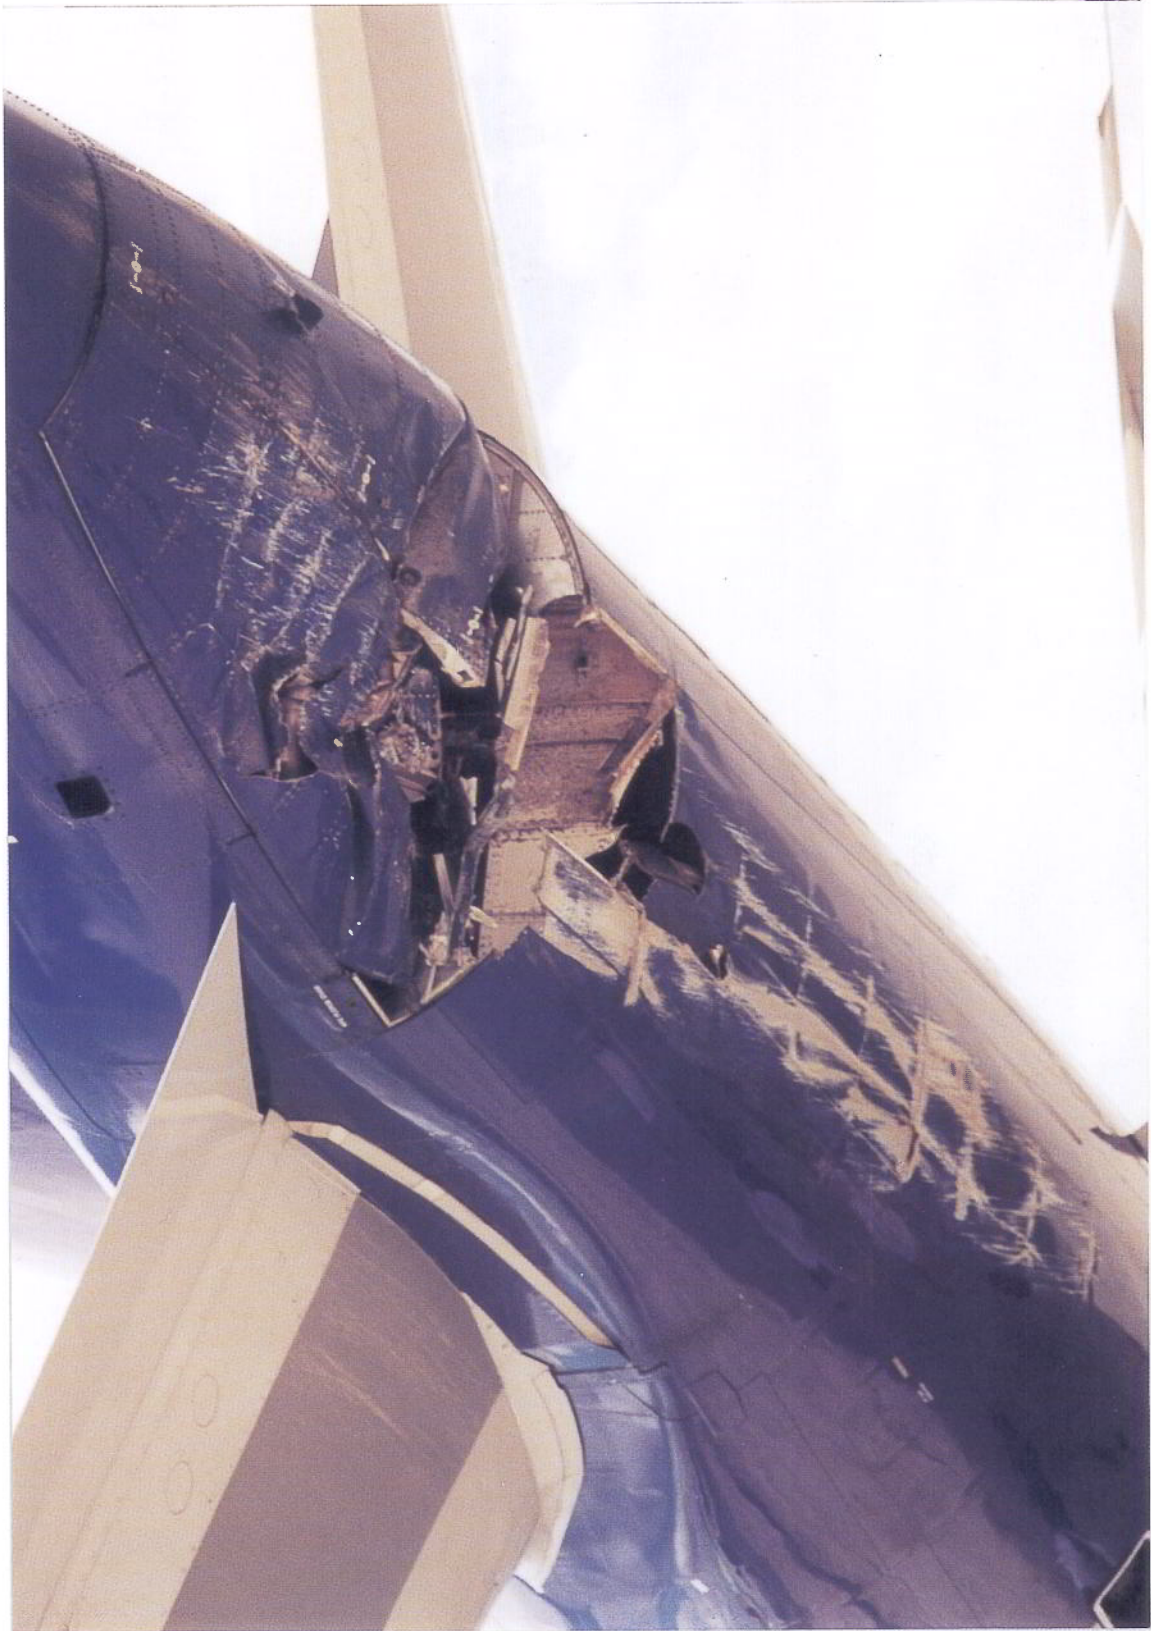
Figure 3 **View of damage to rear fuselage**
