AAIB Bulletin No: 10/99

Ref: EW/C99/1/3

Aircraft Type and Registration: Boeing 767-323 ER, N373AA

Location: London Heathrow Airport

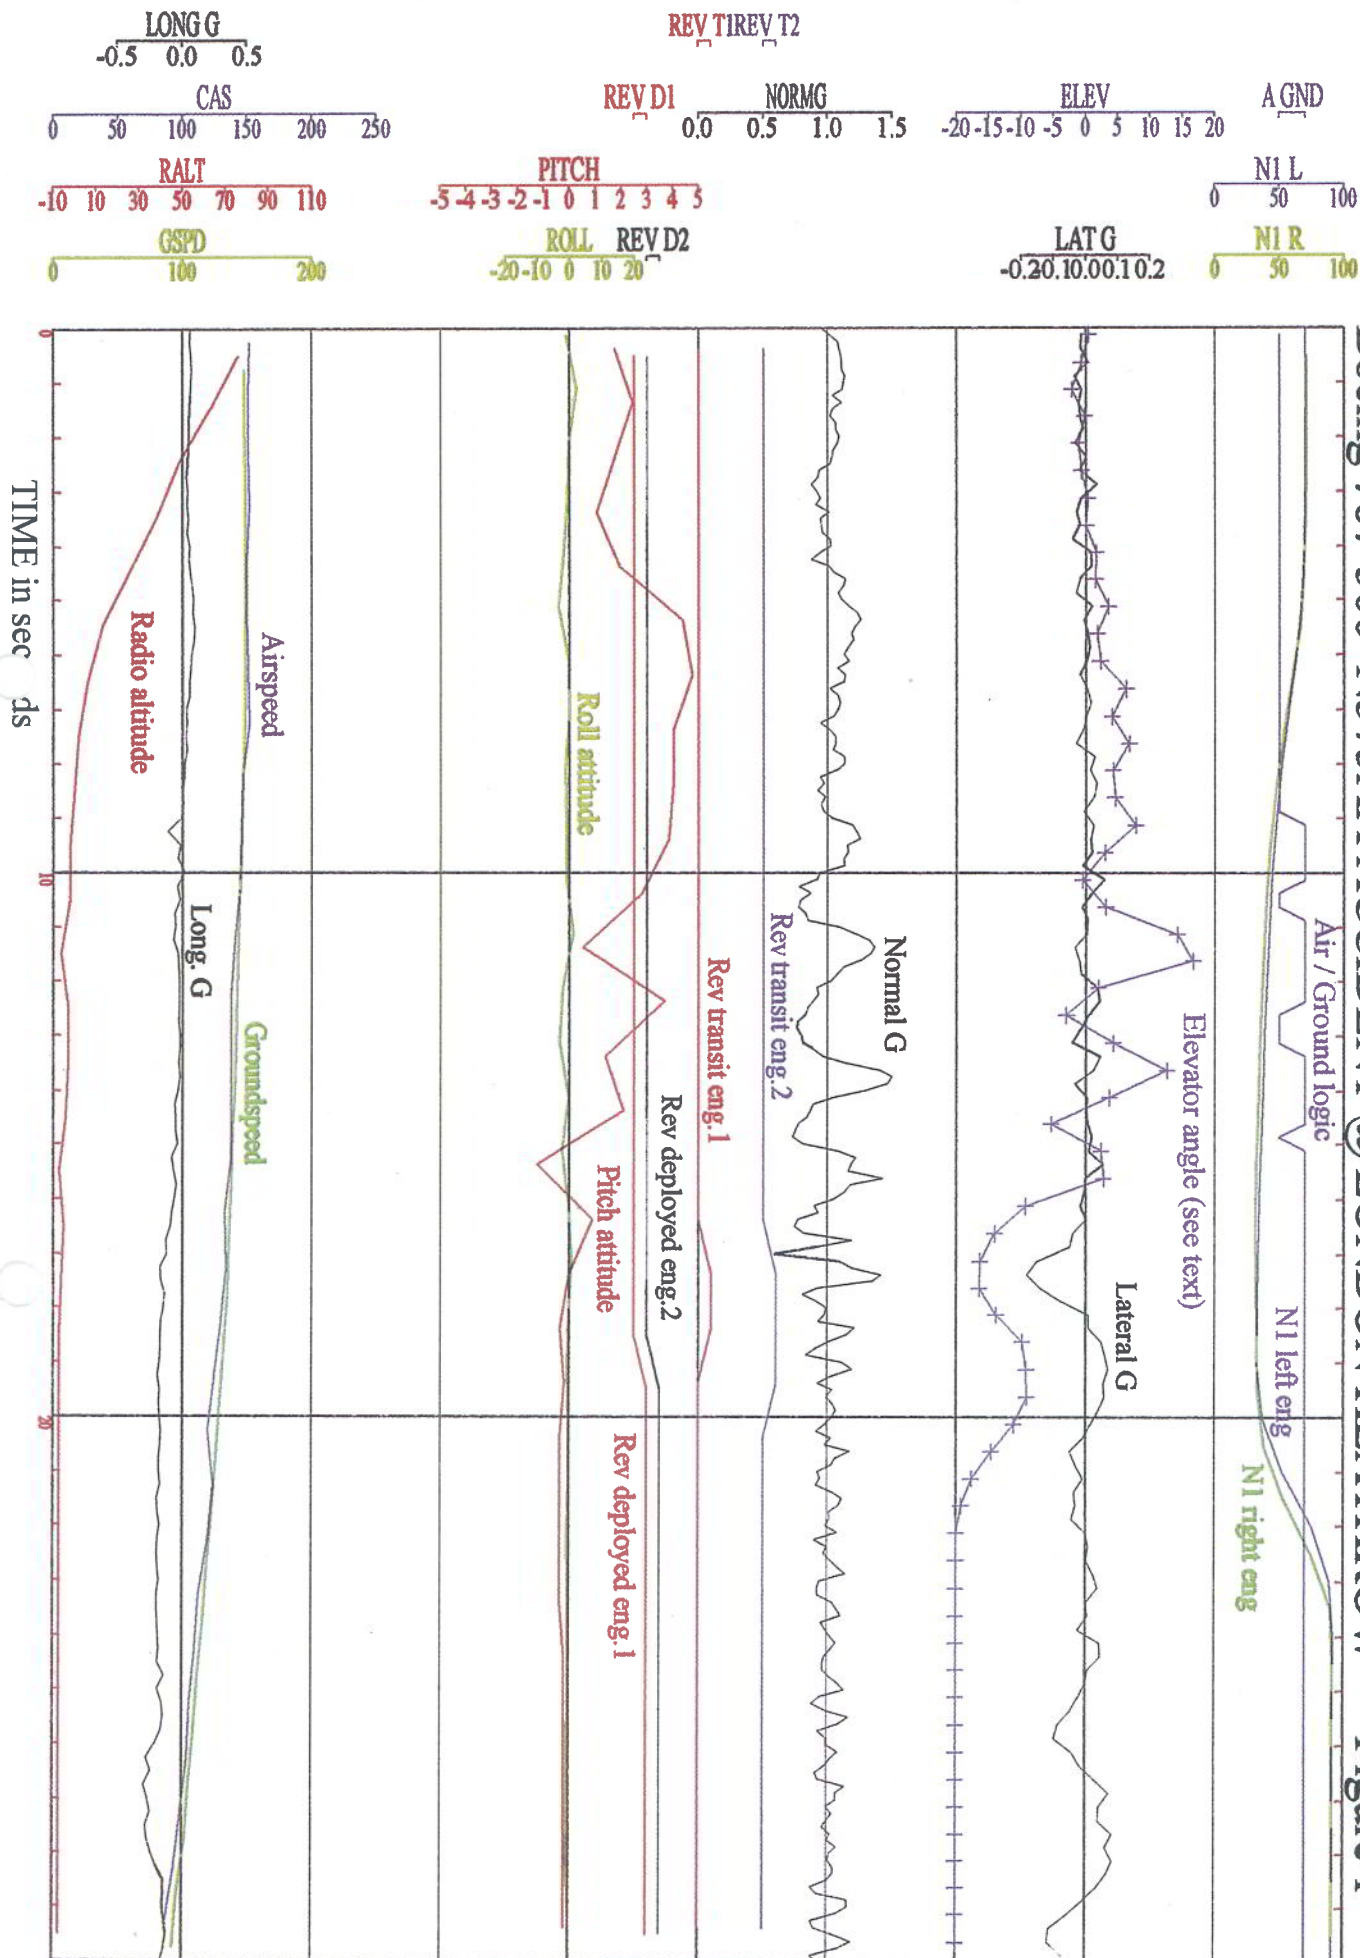
Boeing 767-300 N373AA ACCIDENT @ LONDON HEATHROW Figure 1

Figure 1 is a graphical time history of relevant DFDR parameters during the final approach and landing. The approach was accurately and smoothly flown. Then, after a normal flare, the aircraft touched down smoothly on the main landing gear at an airspeed of 146 kt and with a positive pitch attitude of 4°. N373AA subsequently bounced three times resulting in 4 touchdowns over a total period of 6 seconds; during this time both thrust levers, which had been retarded at a constant rate between the flare and initial touchdown, remained at idle. Additionally, over the same period, the roll attitude of the aircraft varied between 3° left and 1° right. With no movement in the thrust levers and no major changes in roll attitude during these 'bounces', it was necessary to concentrate on the changes in longitudinal control inputs and pitch attitude changes together with normal acceleration recordings.

The vertical velocity at the Centre of Gravity, derived from recorded accelerations and attitudes as the main landing gear alternately compressed and rebounded during landing, indicated a maximum recorded normal acceleration of 1.5g; this was not excessive but, if coupled with high pitch rates and vertical velocities of the nose gear, could result in high stresses on the airframe.

There were high pitch rates generated during the 'bounces'. However, the recorded time histories of pitch attitude and elevator angle could not be used to analyse accurately the dynamics of the aircraft attitude during this period. Firstly, the DFDR did not sample pitch attitude and elevator angle sufficiently frequently and secondly, control column position was not recorded. Additionally, the recorded elevator angle was not a direct record of the actual elevator angle; on Boeing 757 and 767 aircraft, control position data is filtered within the Engine Instrument Crew Alert System (EICAS). Analysis by the aircraft manufacturer, during the investigation of similar accidents, has shown that the effect of the filter can cause the recorded elevator angle samples to differ from the actual elevator angle by up to 20°. Therefore, it was not possible to accurately interpret the relationship between the longitudinal control inputs and the aircraft pitch attitudes.

Nevertheless, it was possible to assess the pitch attitudes of the aircraft at the point of changeover from air to ground logic and to interpret the rate of change of pitch just prior to these points. On the initial touchdown, the pitch attitude had been relatively constant for two seconds at plus 3.5°. The second touchdown was at plus 1.5° with the pitch decreasing. The third touchdown was at plus 0.5° again with the pitch decreasing. The final landing was at minus 1.0° again with the pitch decreasing. The pitch attitudes were fluctuating as the aircraft was bouncing. The most extreme nose down pitch attitude occurred on the final touchdown. Audio recording from the cockpit area microphone channel
