SUMBURGH AIRPORT
Showing path followed by HS 748 G-BEKF on 31 July 1979

FLIGHT DATA RECORDER PLOT
HS 748 G-BEKF at Sumburgh, 31st July 1979
Flap angle 15° throughout time period shown

CALCULATED ACCIDENT RUN & STOPPING DISTANCES COMPARED WITH FDR AIRSPEED READ-OUT

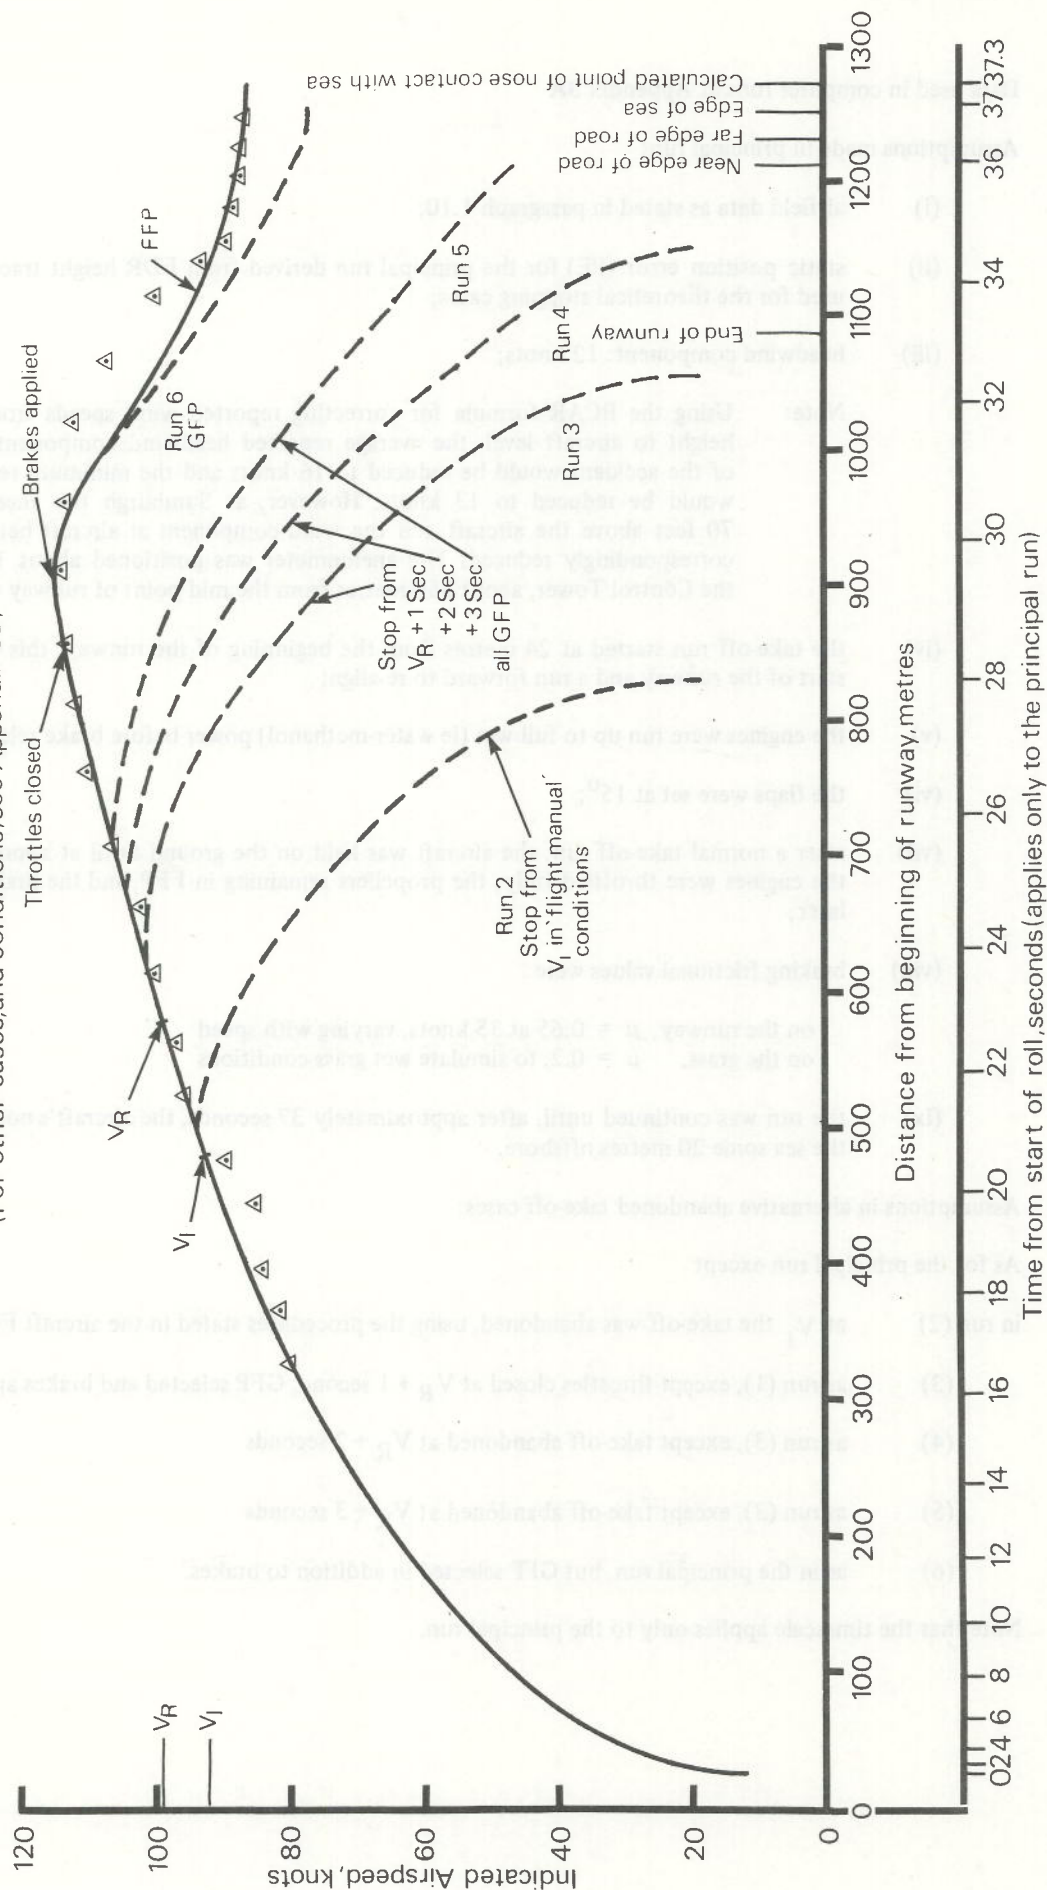
HS 748 G-BEKF at Sumburgh, 31st July 1979

15° Flap, water-methanol on
12 Knot headwind at aircraft level

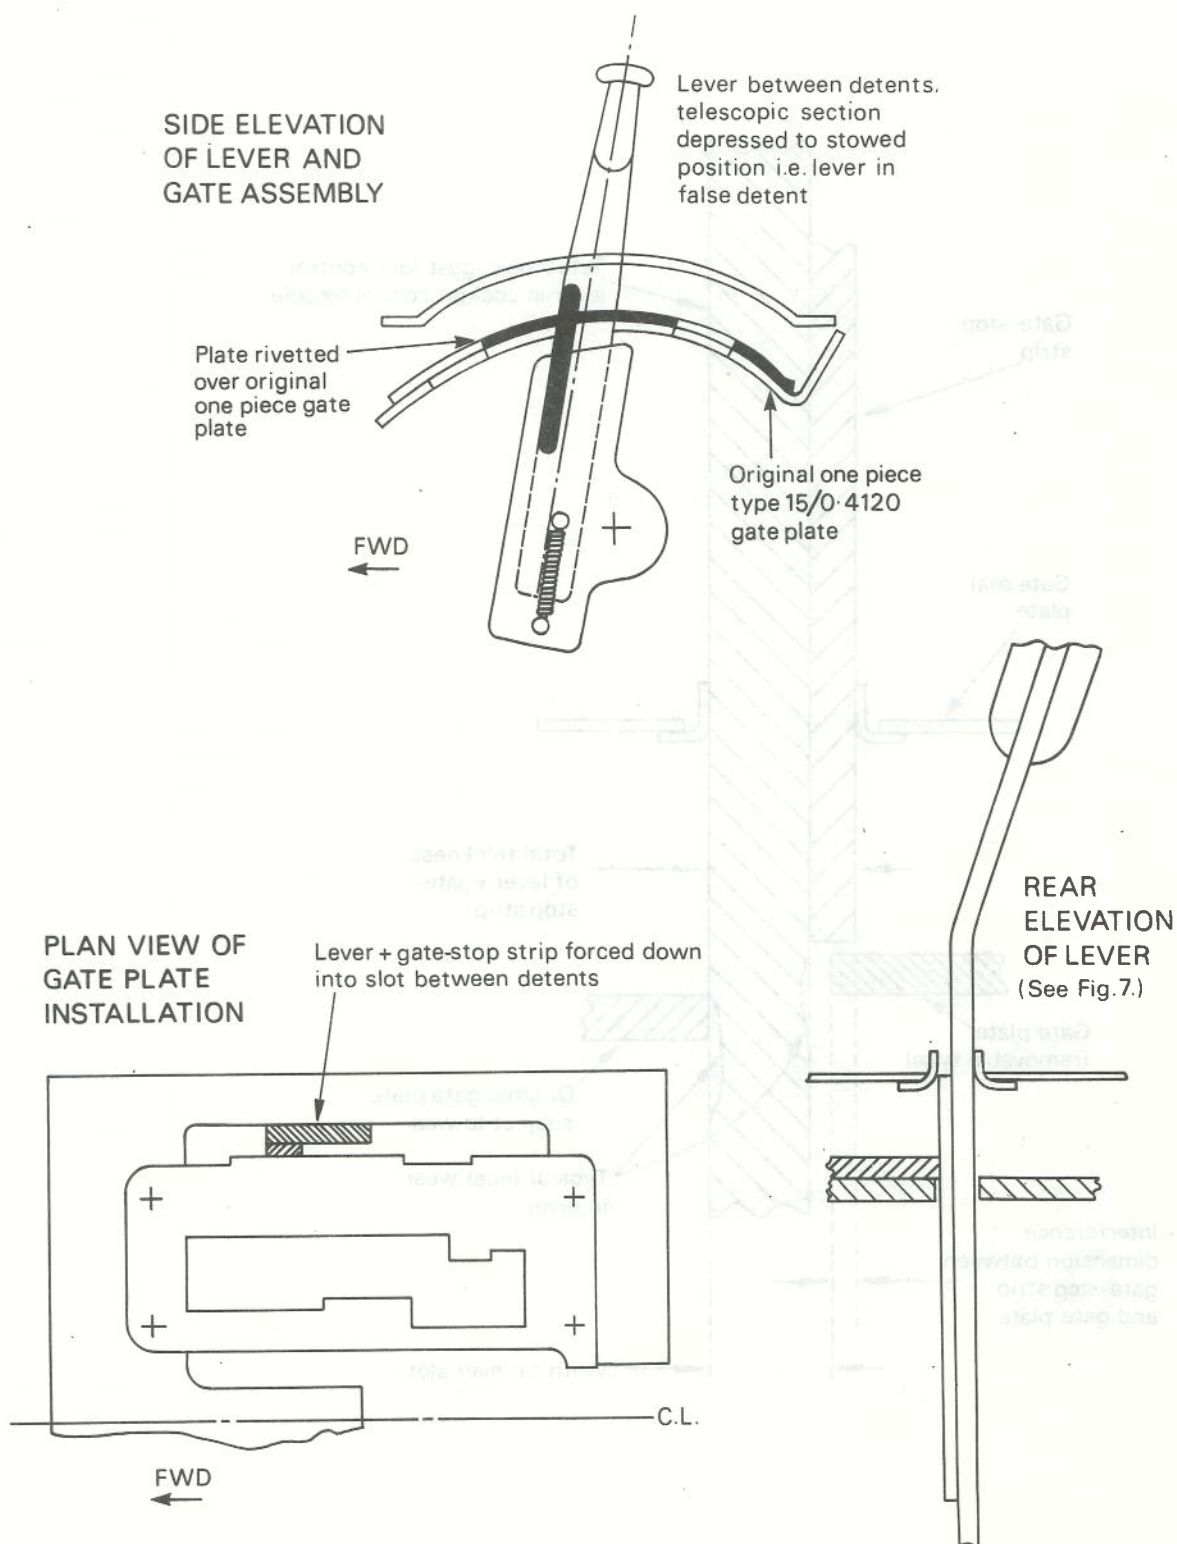
SITUATION OF GUST-LOCK LEVER AND GATE
 PLATE IN CONTROL CONSOLE AS DEMONSTRATED ON G-BEKF

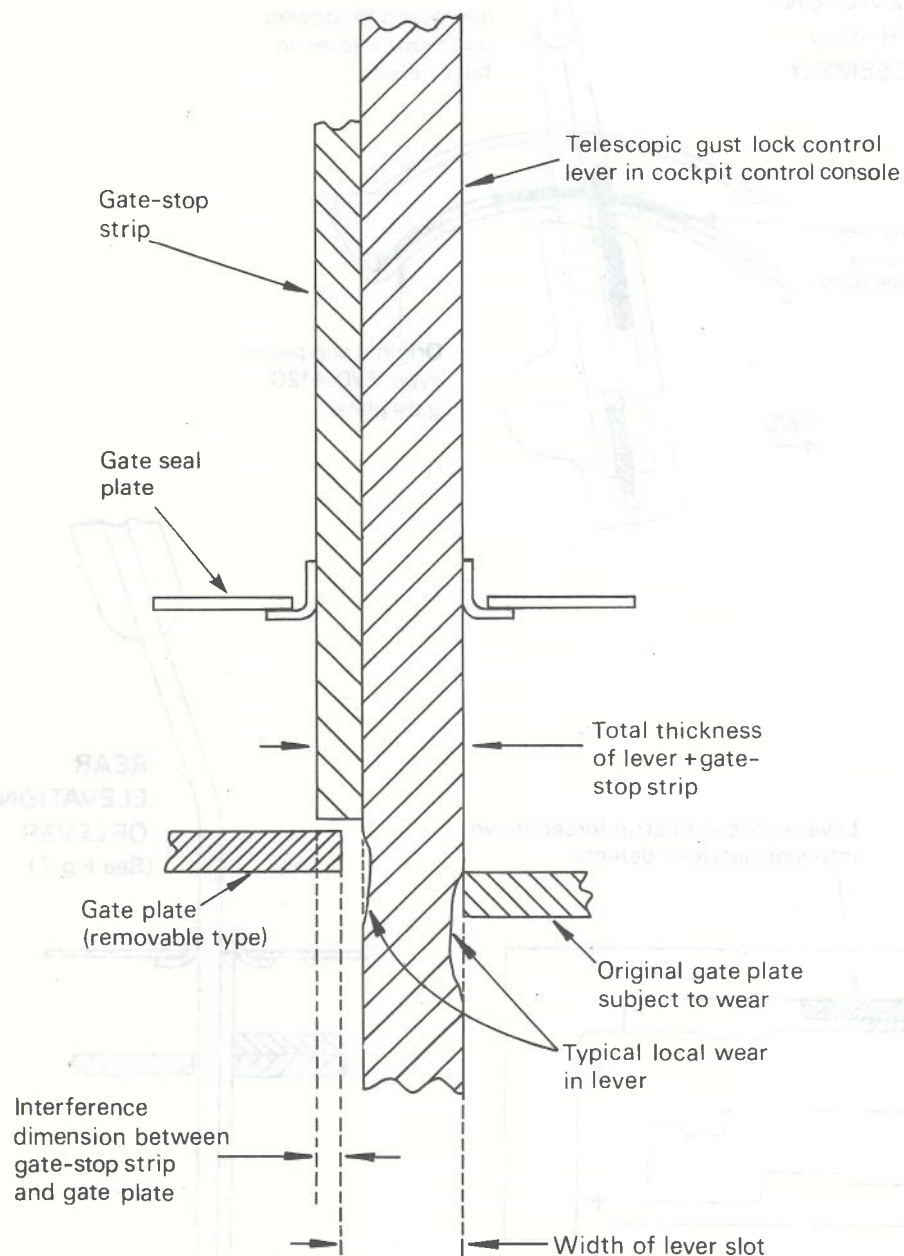
FIGURE 6

SECTION THROUGH TYPICAL GUST-LOCK LEVER
AND GATE-STOP STRIP, SHOWING INTERFERENCE WITH
GATE PLATE (LOOKING FORWARD)

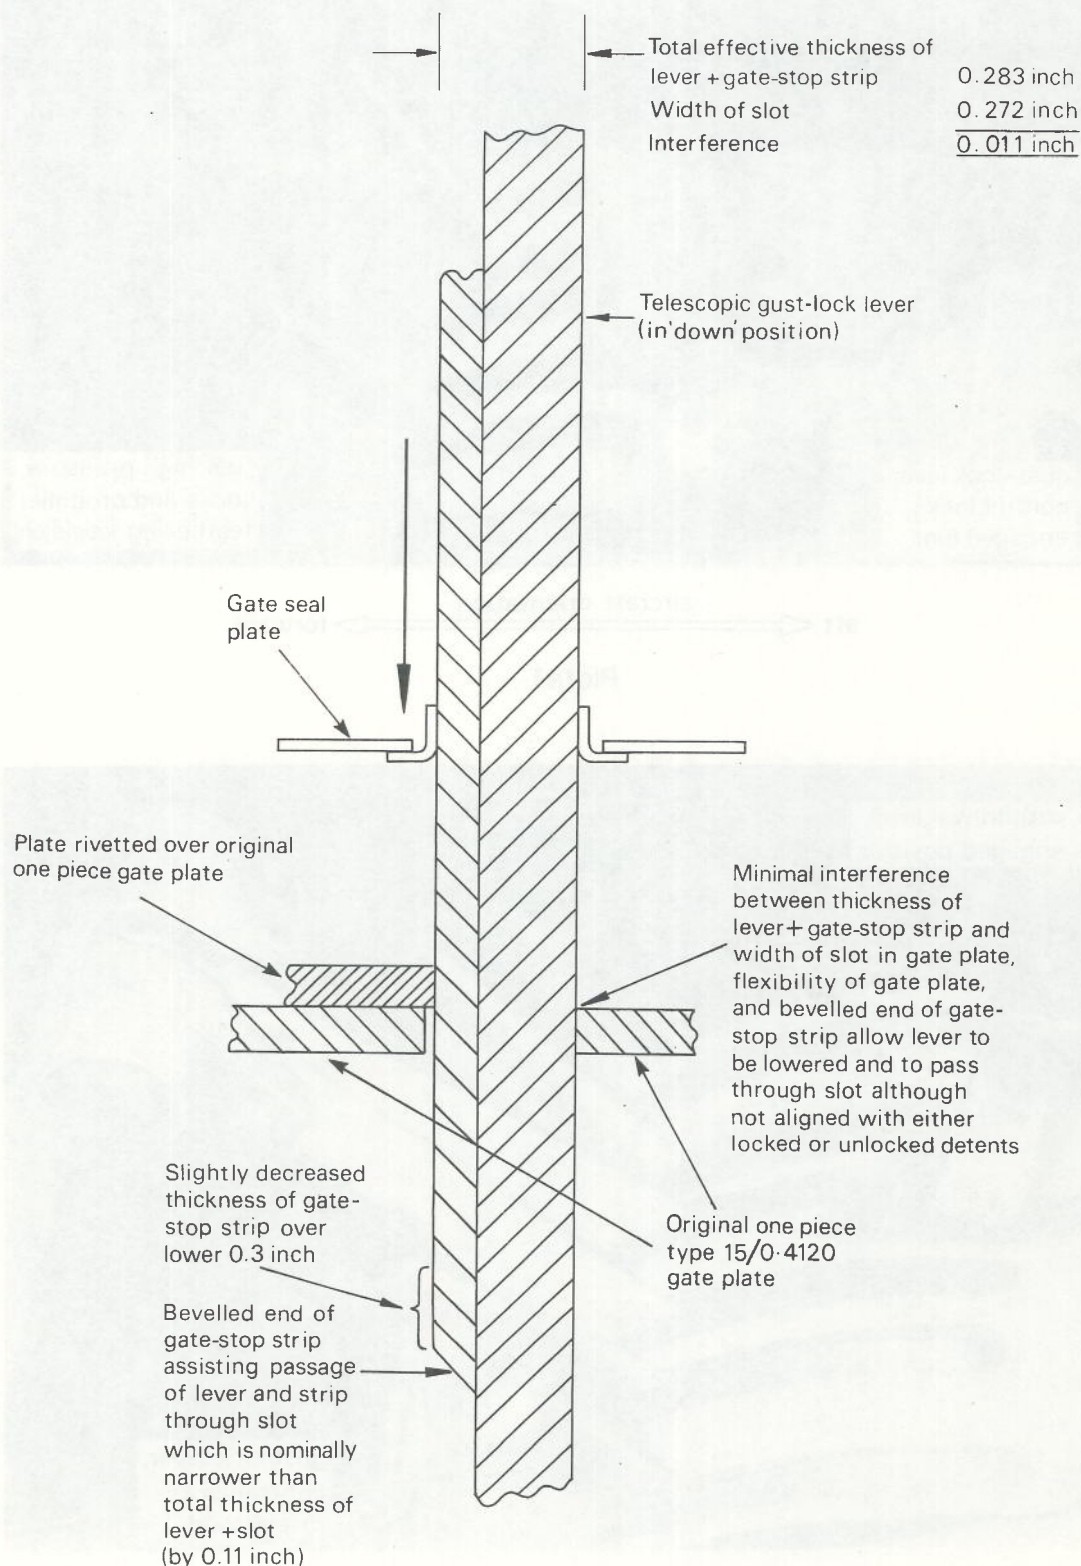
FIGURE 7

DIAGRAM OF SECTION THROUGH GUST-LOCK LEVER, GATE PLATE AND GATE-STOP STRIP, SHOWING SITUATION DEMONSTRATED ON G-BEKF, WITH LEVER LOWERED BETWEEN DETENTS TO A POSITION RESEMBLING 'LOCKS DISENGAGED' POSITION

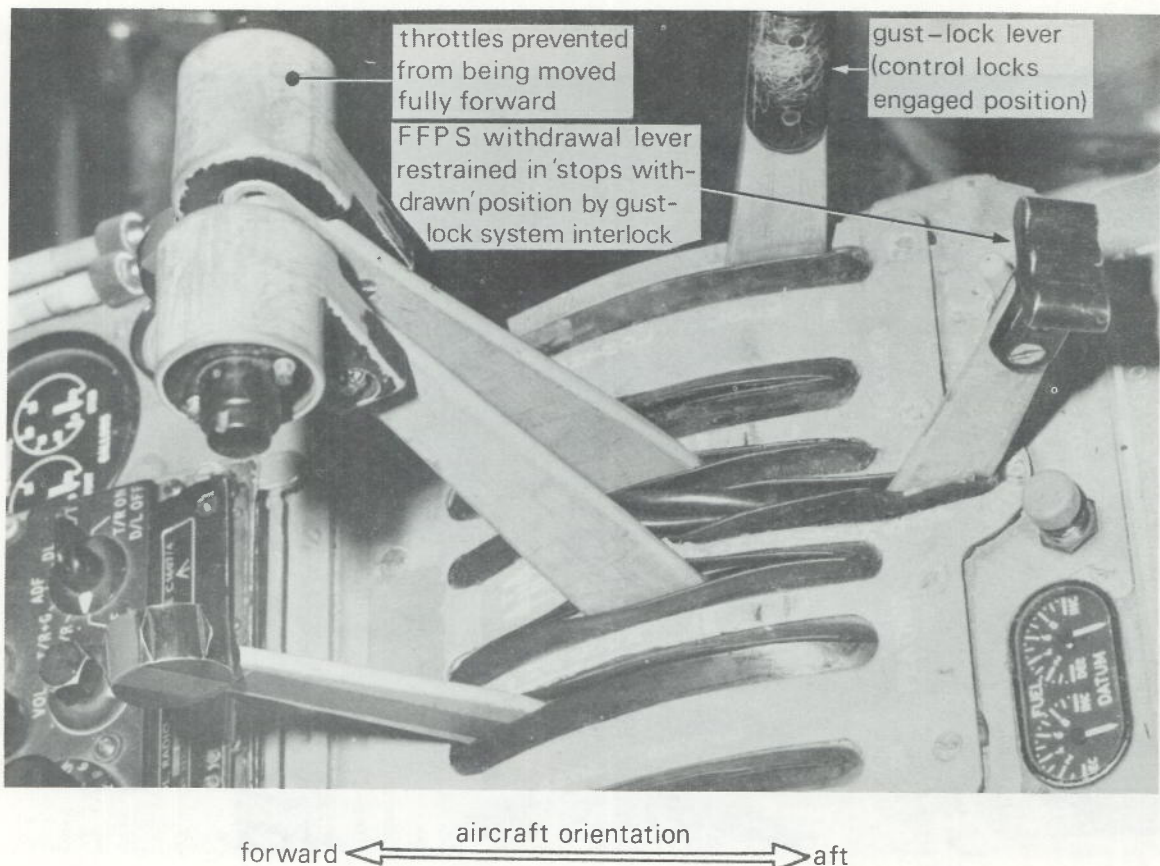
Plate 4 : throttle position when baulked by the interlock

Cockpit controls-centre pedestal
Gust-lock lever approximately 30% back from 'off'detent, in false detent position.
Throttles closed

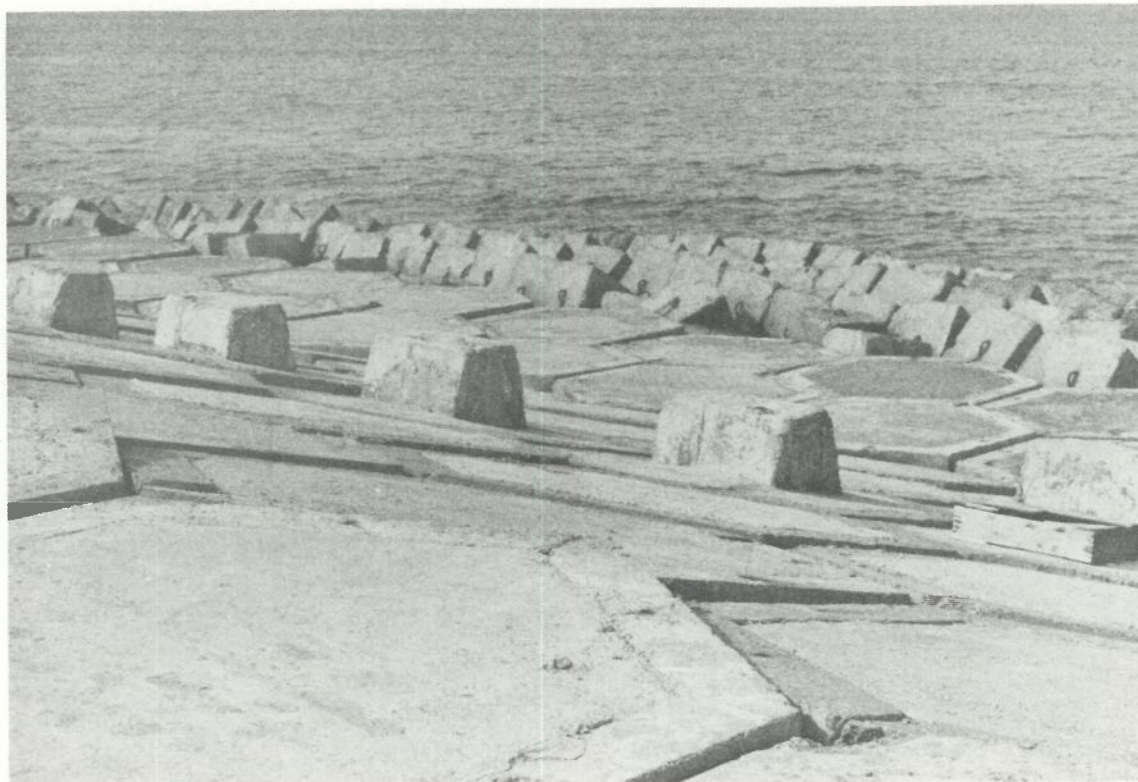
Plate 7 : the sea defences, viewed from the perimeter road

Topography at eastern end of overrun area
