**SECTION OF ENGINE SHOWING LOW PRESSURE STATOR VANE LOCATION**

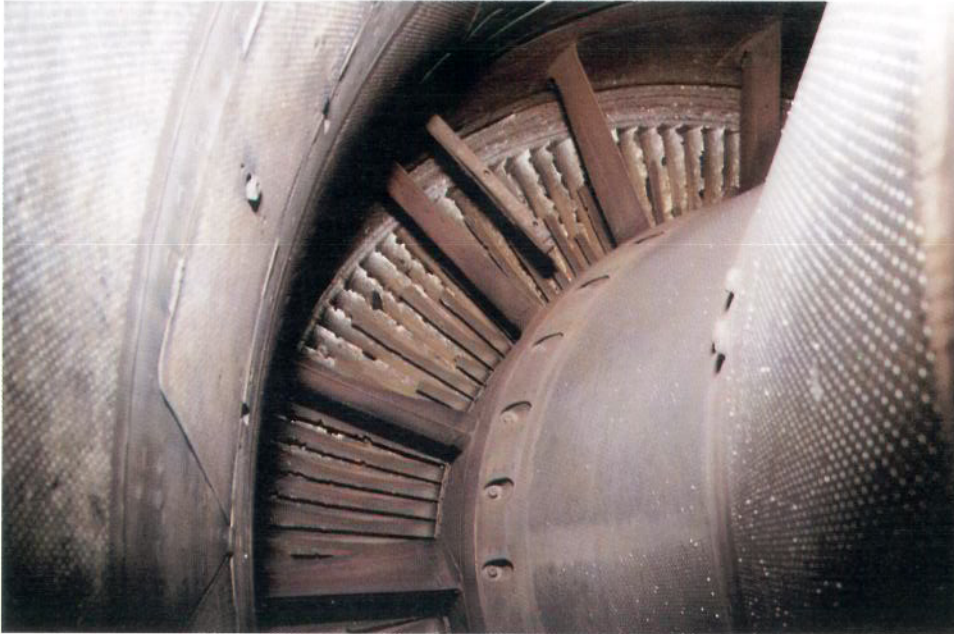
**PHOTOGRAPH SHOWING DAMAGE TO  
L.P. TURBINE COMPONENTS.**

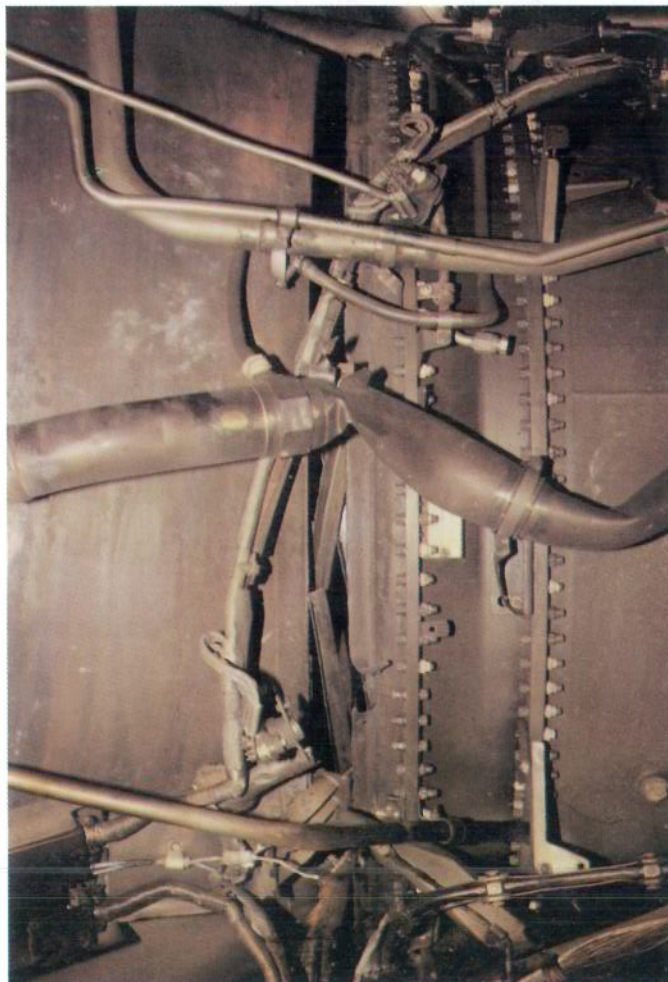
**PHOTOGRAPH SHOWING CIRCUMFERENTIAL  
FRACTURE OF TURBINE CASE**
