SERIOUS INCIDENT

Aircraft Type and Registration:	Embraer ERJ 190-200 LR (Embraer 195), G-FBEH
No & Type of Engines:	2 General Electric Co CF34-10E7 turbofan engines
Year of Manufacture:	2007
Date & Time (UTC):	1 August 2008 at 1220 hrs
Location:	40 nm NW of Wallesey, en route from Manchester to Belfast City
Type of Flight:	Commercial Air Transport (Passenger)
Persons on Board:	Crew - 5 Passengers - 90
Injuries:	Crew - 1 (Minor) Passengers - 4 (Minor)
Nature of Damage:	No 1 air cycle machine failure
Commander's Licence:	Airline Transport Pilot's Licence
Commander's Age:	48 years
Commander's Flying Experience:	6,500 hours (of which 410 were on type) Last 90 days - 147 hours Last 28 days - 65 hours
Information Source:	AAIB Field Investigation

Synopsis

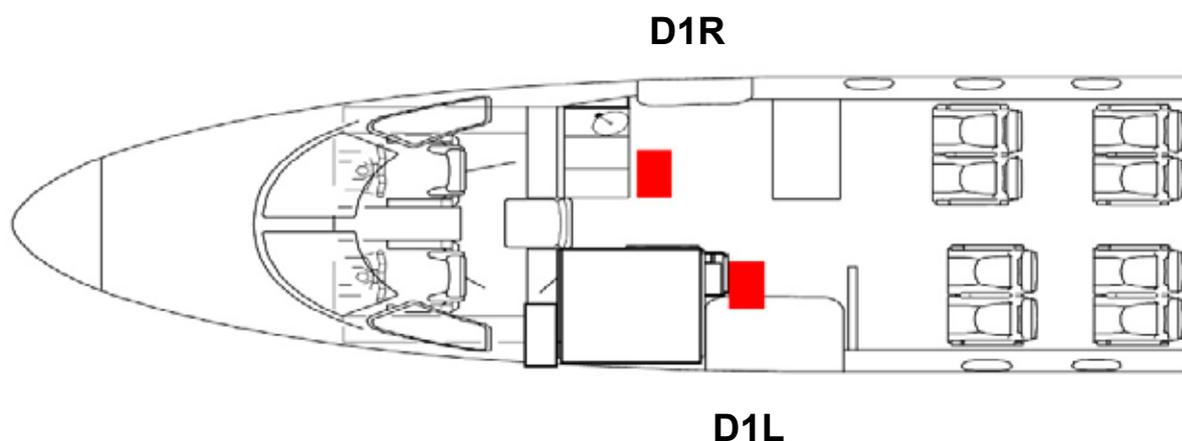
Figure 1

approximately midway up the cabin, over the wings. On hearing the order to evacuate, the cabin crew opened their allocated doors, the escape slides inflating automatically. The SCCM initially prevented passengers using Door 1 Left (D1L) as the slide had not fully inflated by the time the first passenger arrived there. Once it was fully inflated, the SCCM had to push himself past the flow of passengers to reach Door 1 Right (D1R) to open it. He commented that had he opened this door first, given the layout of the cabin, he would not have been able to push past passengers to get to D1L (Figure 1).

Forward cabin layout, showing forward exits (Doors 1 Left and Right)

None of the passengers evacuated the aircraft via D1R. This, it is considered, was influenced by the staggered layout of the front two emergency exits. In addition, there was only one crew member situated in this part of the cabin to direct and assist passengers during the evacuation and he was standing next to D1L. Passengers would have therefore had to find and use D1R at their own initiative.

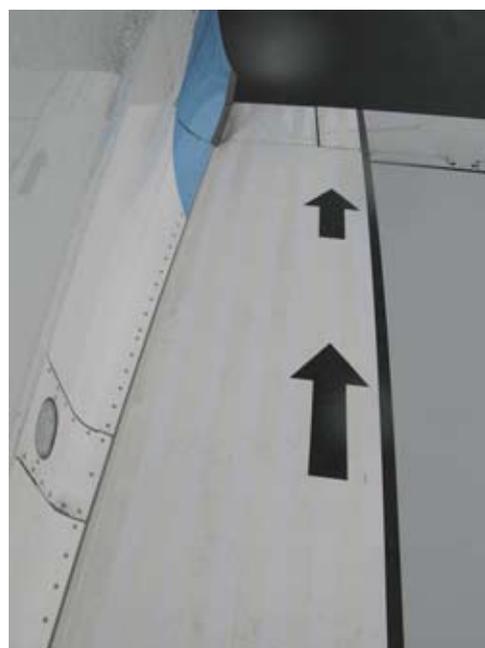
Figure 3

Passengers evacuating via the left overwing exit reported that once out on the wing, there was confusion as to how they should get off the wing down to the ground. A 61 cm-wide walkway was demarcated at the wing root in black paint, with arrows pointing towards the trailing edge (Figure 3). This was not noticed by some passengers; one passenger thought that the markings denoted an engineers' walkway, rather than an escape route. The overriding comment from passengers who evacuated onto the wing was that it was not obvious to them that they were meant to climb off the wing via the trailing edge. Although the wing flaps were lowered in accordance with the emergency evacuation checklist, there remained a considerable drop to the ground of about 1.7 metres.

Overwing exit evacuation route markings (left wing shown, view towards wing trailing edge)

It is apparent from this incident that the issue of ambiguous overwing escape route markings that resulted in AAIB Safety Recommendation 2002-42 still exists. It is therefore appropriate that this matter is re-examined. As responsibility for aircraft certification now lies with the EASA, the previous Safety Recommendation is therefore re-issued as follows:

Following this incident the operator revised its briefing to passengers seated next to the overwing exits to make them aware that the arrows on the wing indicate direction of evacuation, ie aft over trailing edge of the wing.

It is recommended that the European Aviation Safety Agency review the design, contrast and conspicuity of wing surface markings associated with emergency exits on Public Transport aircraft, with the aim of ensuring that the route to be taken from wing to ground is marked unambiguously.

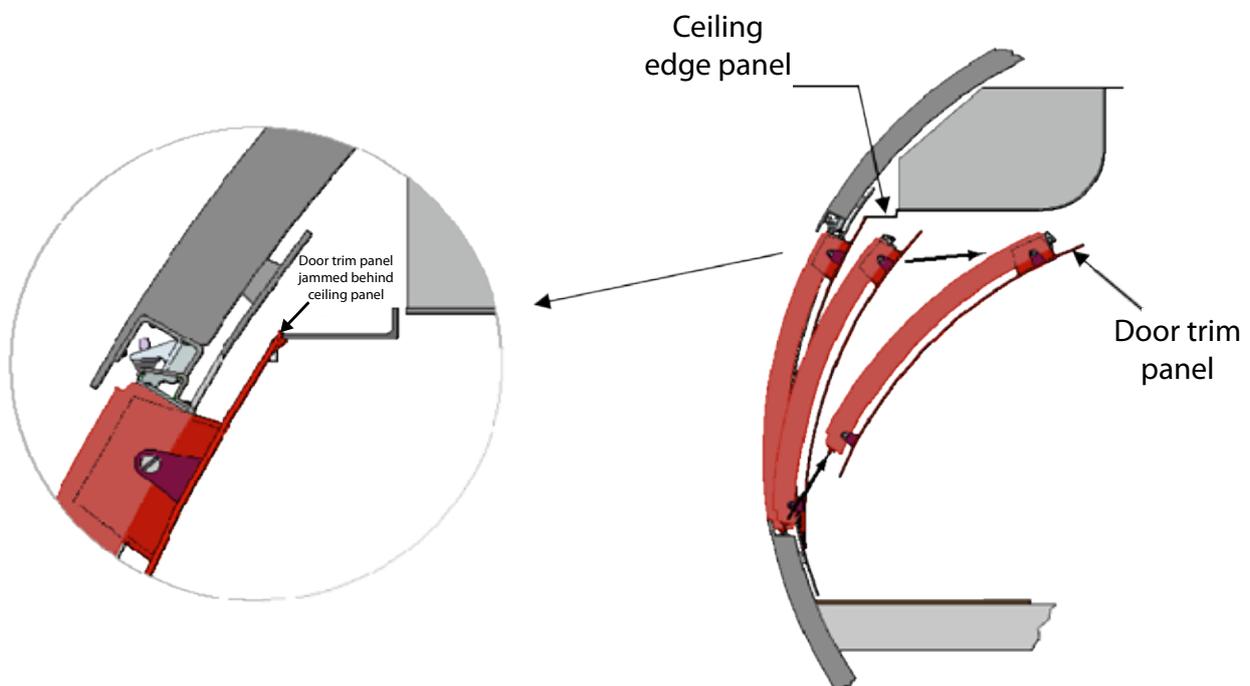
Figure 5

The overwing exit door is retained at its lower edge by spigots which engage in recesses in the bottom edge of the door aperture. Its top edge incorporates a locking mechanism operated by a handle at the top of the door, covered by a removable panel secured by Velcro strips. Pulling the operating handle disengages the lock at the top of the door and allows the door to pivot inwards about its lower edge. The spigots remain engaged until the door has pivoted inwards sufficiently for its top edge to clear the aperture, after which it is lifted clear of the aperture using a fixed handle near its base to support its weight. The door must then be thrown out of the aperture so that it does not cause an obstruction in the cabin to evacuating passengers. A compressible rubber bumper block limits the vertical displacement of the door during the initial phase of opening.

Overwing emergency exit opening, showing location of jam

Although the edge of the ceiling panel was cut back around the top edge of the overwing exit door, the resulting clearance between the door trim and ceiling edge panel was insufficient. Measurements of the right overwing exit showed that over most of its length the clearance was just sufficient to accommodate insertion of a credit card, but near the forward corner of the door, where the door trim had jammed, the clearance was only 0.003 inch.

Prior to this investigation, no clearance was specified at any location on or around the overwing exit door. After being alerted of this incident by the AAIB, the aircraft manufacturer issued Service Bulletin (SB) 190-25-0092. This required an inspection of the clearance between the overwing exit door trim and the ceiling edge panel, and replacement of the latter if the clearance was less than 2 mm. Additionally, a check was introduced during aircraft production to verify a minimum clearance of 2 mm between the door trim panel and the ceiling edge panel.

The AAIB checks demonstrated that, whilst improving the situation, the 2 mm minimum clearance specified in SB 190-25-0092 was insufficient to prevent the door liner from fouling the ceiling edge panel if the door was lifted firmly as it was unlocked, or if the door was jerked open, as might occur in an emergency. The 2 mm clearance requirement is not entirely effective in eliminating the possibility of a jam. The following Safety Recommendation is therefore made:

It is recommended that Embraer modify the overwing emergency exits on Embraer 195 aircraft, to eliminate the possibility of the exit door jamming due to interference between the door trim panel and the ceiling edge panel.

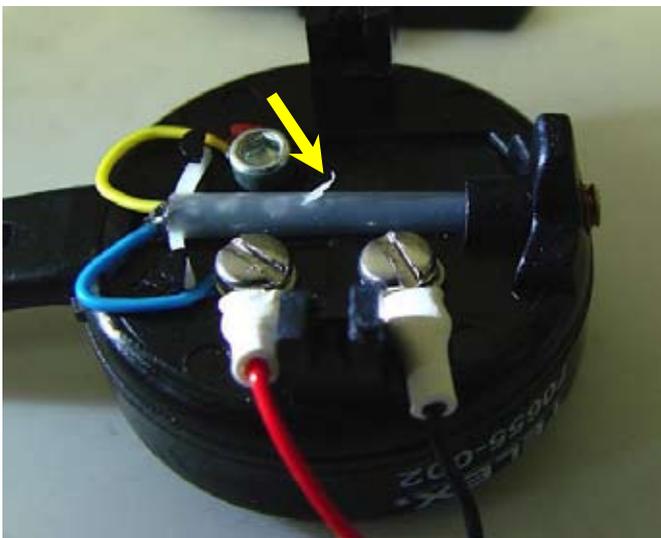
Figure 6

Disassembly of the captain's mask from the other aircraft identified a spurious whisker projecting from the plastic housing of the cut-out switch, the free end of which contacted the underside of the flow sensor pivot. The

whisker acted as a ratchet, tending to inhibit movement of the sensor vane in the direction required to reactivate the microphone, whilst leaving its motion in the direction required to cut out the microphone unaffected. Consequently, the mechanism tended to stick in the cut-out position, leaving the microphone open circuit. The whisker or spurious material appeared to be a ‘curl’ of the switch casing material (Figure 6), probably created either in the production of the switch itself, or during its assembly into the mask.

Whisker of plastic material on cut-out switch

In the light of these findings, the mask manufacturer undertook a detailed review of its design and manufacturing processes. This resulted in an improved physical location of the magnet at its attachment to the flow sensor vane, the use of adhesive to prevent movement of the switch body once its position has been adjusted to provide the required change-point, and the addition of quality checks to ensure that switch casings supplied to the company are free of burrs.
