AAIB Bulletin No: 6/94

Aircraft Type and Registration: Piper PA-34-200T Seneca II, G-BOSD

Location: Bristol (Lulsgate) Airport, Avon

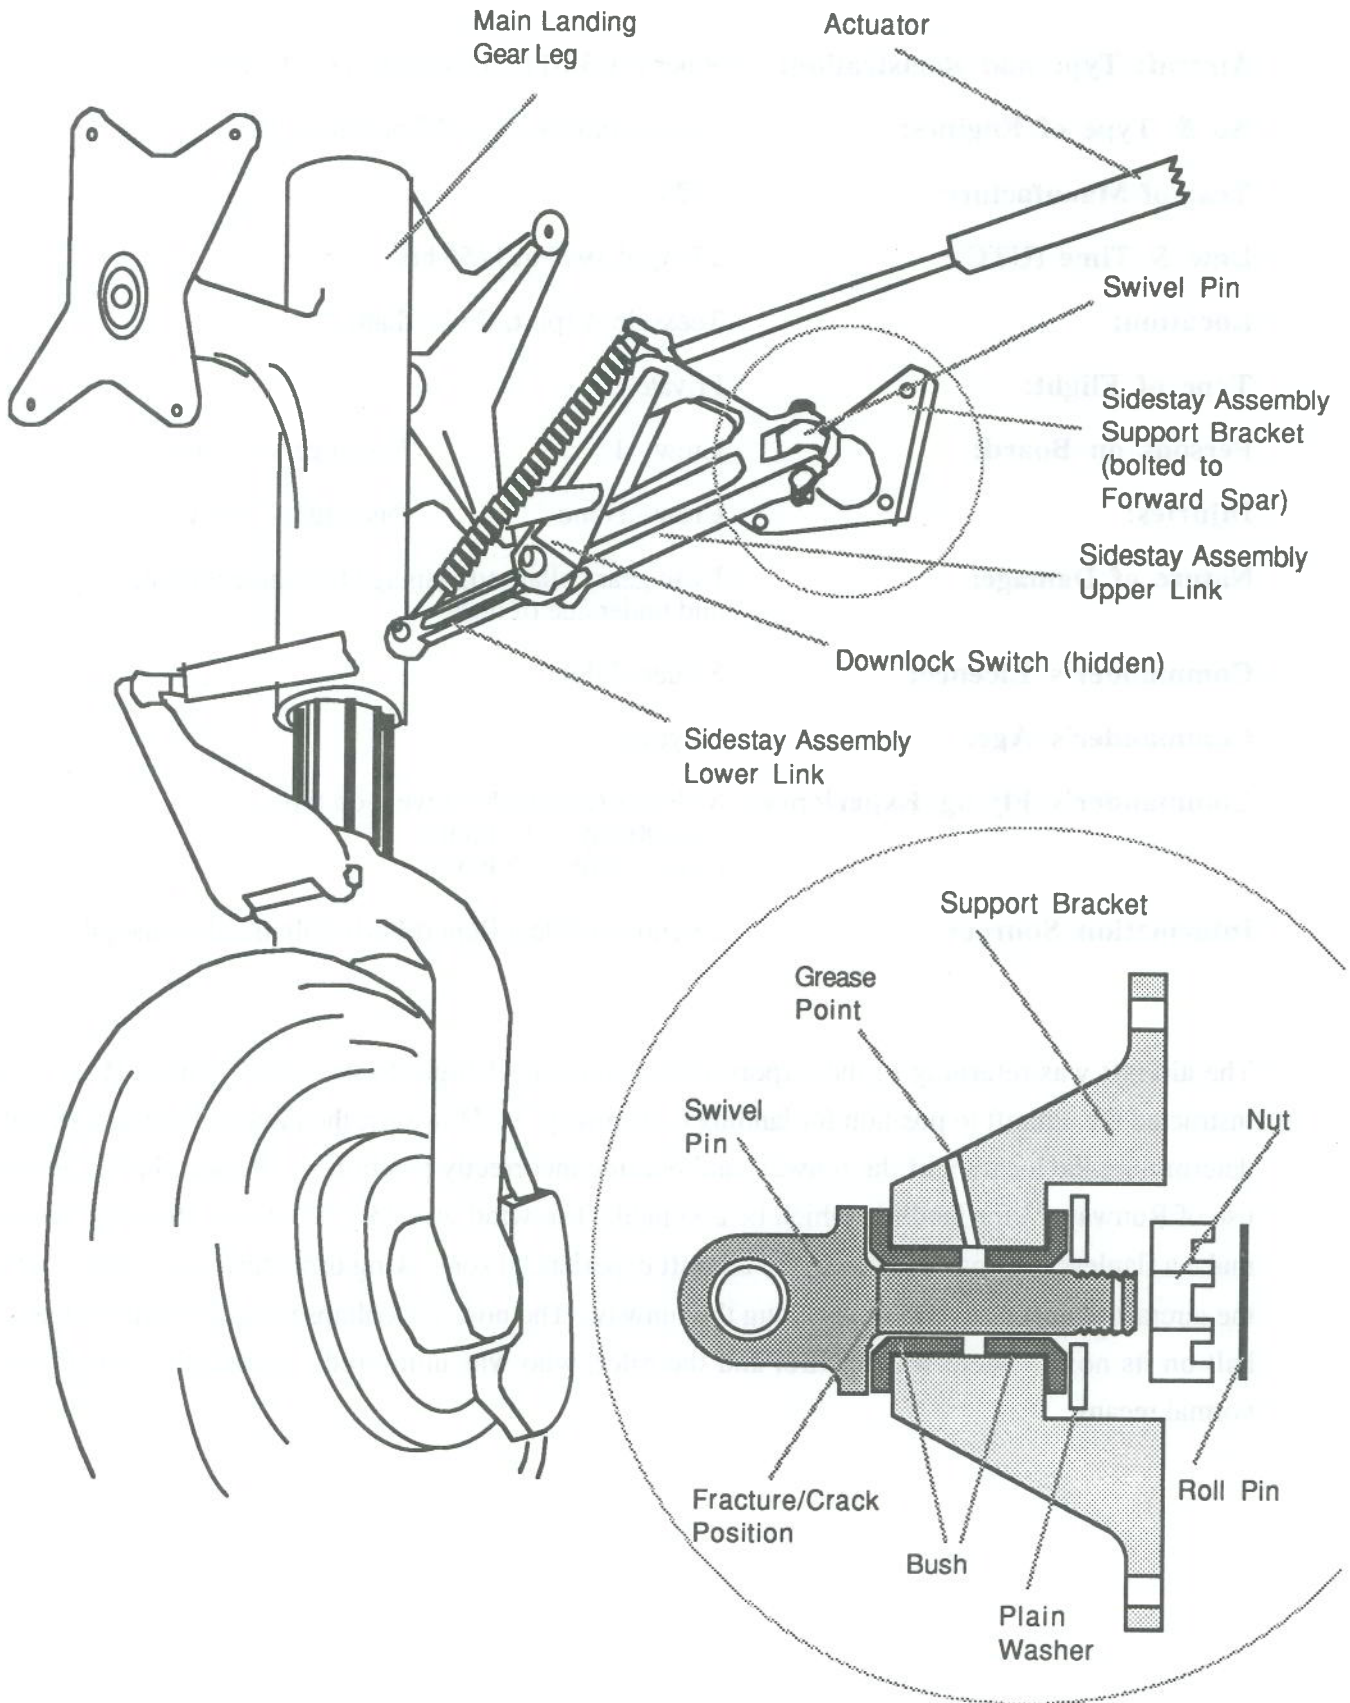
G-BOSD MAIN LANDING GEAR

Examination showed that the left landing gear had folded because of failure of the swivel pin (referred to as a 'stud' in the Piper Illustrated Parts Catalogue), Part No 95299-02. Referring to the diagram it can be seen that this component attaches the landing gear sidestay to the airframe structure and its failure would thus inevitably lead to gear collapse.

Metallurgical examination revealed that the fracture of the pin occurred due to a high-stress/low-cycle fatigue mechanism in reverse bending. This is an identical mechanism to that involved in three previous PA-34 landing gear collapses occurring in the UK (see paragraph below entitled 'Previous Instances of Failure'). It was also found that the failed pin had partially seized in its bushing and that, although fresh grease was evident in the lubrication passage between the two halves of the bush, it had

not penetrated through to the majority of the contact surfaces. Examination of the same components from the right landing gear showed that the swivel pin, whilst not exhibiting such evidence of seizure, was nevertheless cracked at the same location (see diagram).

Both left and right swivel pins from G-BOSD were the smaller of two types made by Piper, being of $\frac{9}{16}$ in diameter compared with $\frac{5}{8}$ in diameter fitted as standard to later serial numbered aircraft. The larger pin can be physically accommodated in the same size bore in the support bracket because a thinner, one piece bush is used (Part No 67026-12). However, the same support brackets cannot be directly interchanged because the one-piece bush has a chamfer under the flange which would require machining of the lip of the bore in the support bracket to accommodate it. The $\frac{5}{8}$ diameter pin is now the only standard available from Piper and thus modification from the older standard should involve purchase of a matching support bracket as well as the new bush and shim washers.

'It has been recommended that the CAA require a periodic check of the swivel pin and assess the need for mandatory replacement of the fitting type with one of more robust design.'
