**AAIB Bulletin No:** 12/93      **Ref:** EW/C92/12/5      **Category:** 1.1

**Aircraft Type and Registration:** Airbus Industrie A320-211, D-AIPK

**Nature of Damage:** Substantial heating damage to the No 2 air turbine starter and the wiring to the Engine Control Unit (ECU)

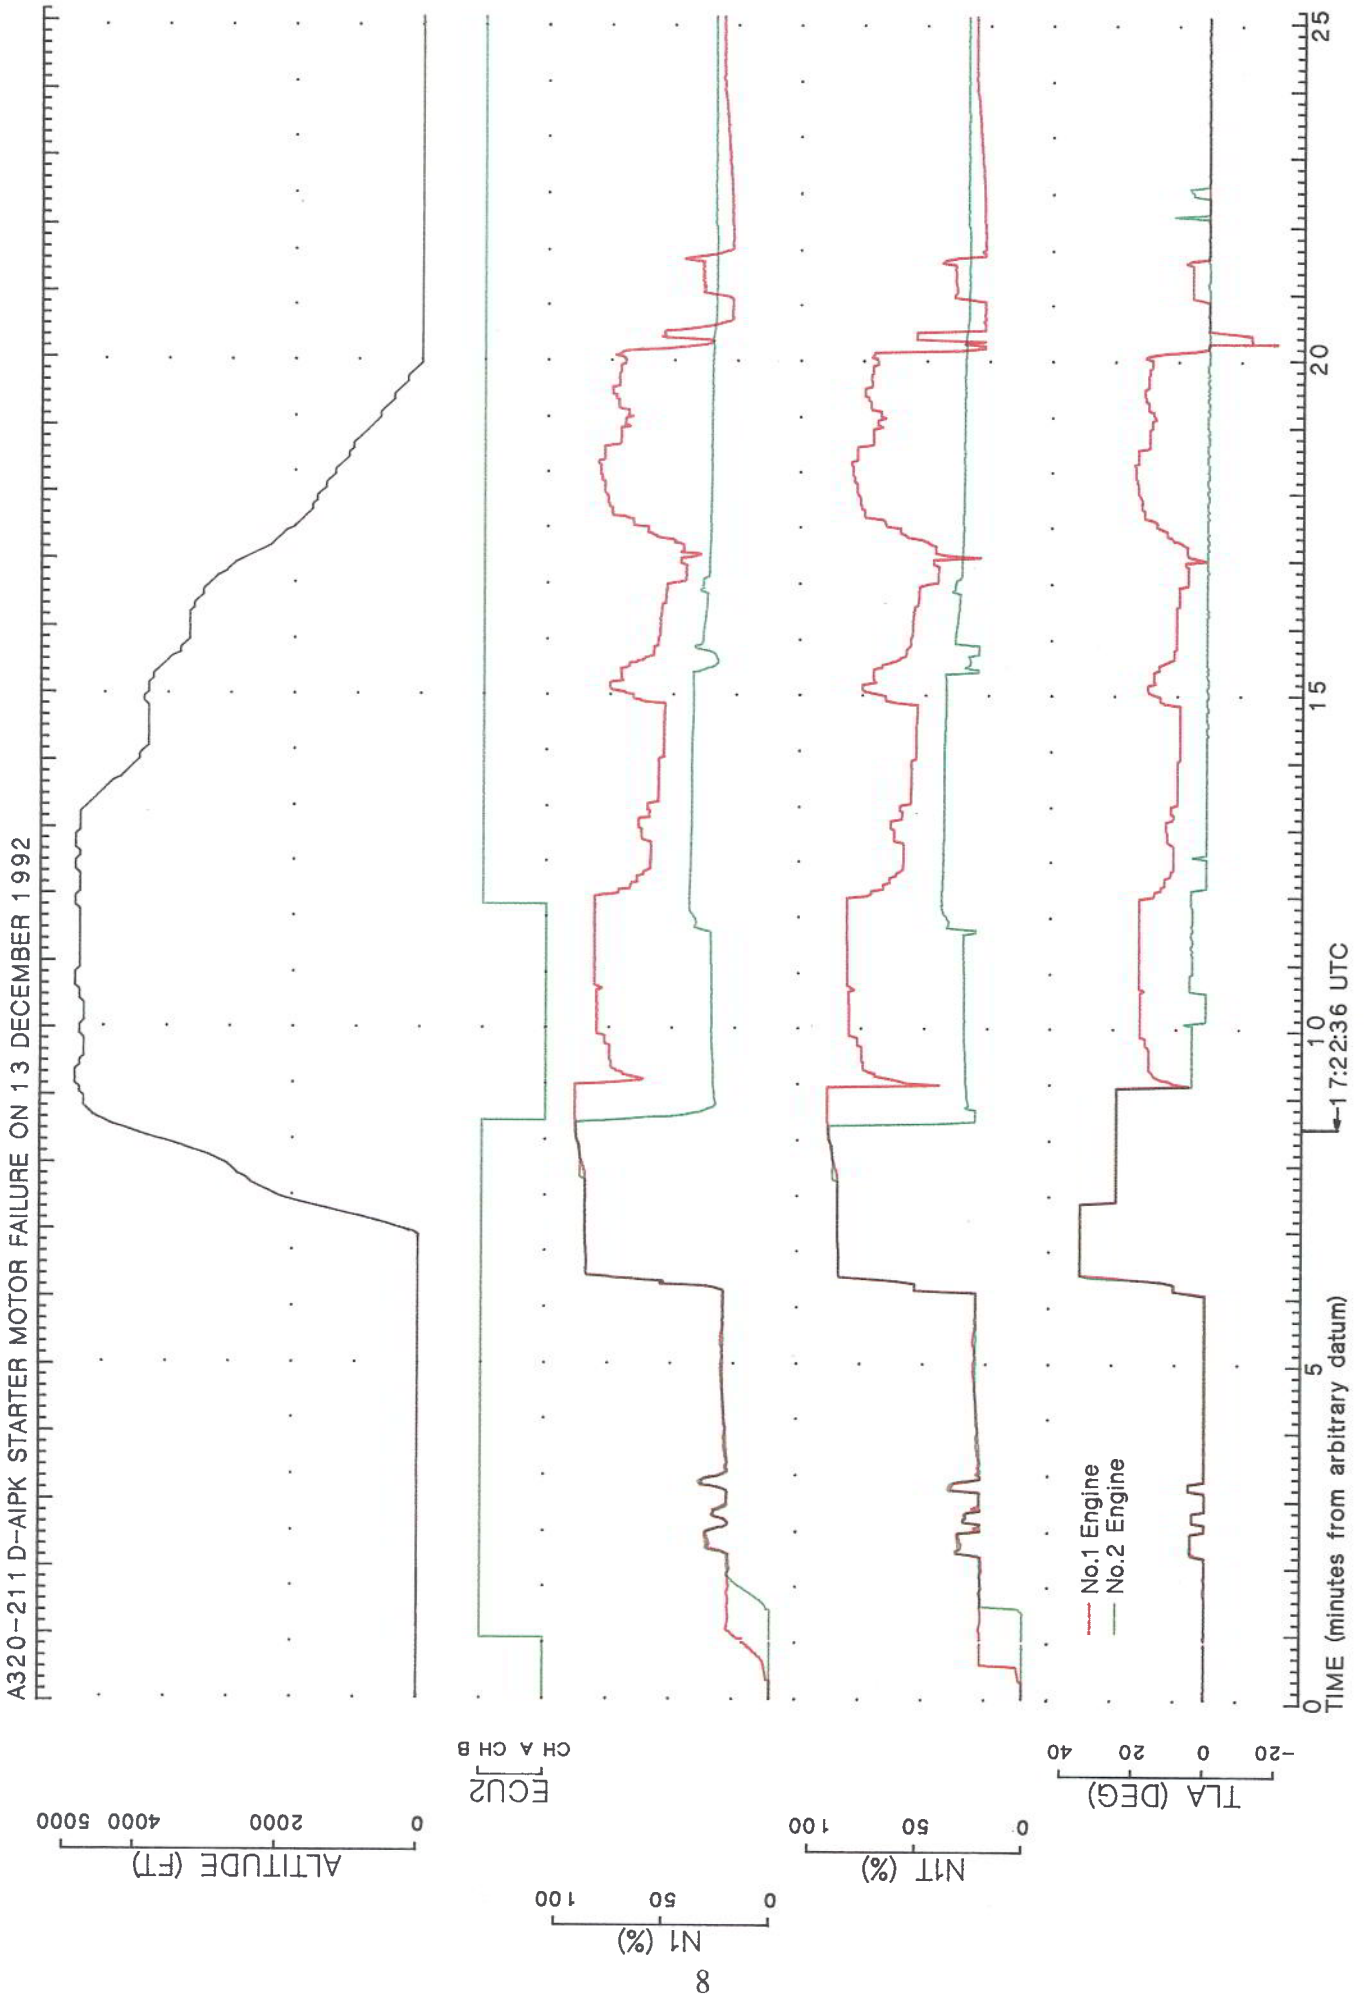
A subset of the DFDR data is presented in Figure 1 covering the period from the successful start of both engines, through the take off, landing and finally taxi. The timescale is in minutes referenced to an artificial datum. UTC, as obtained from the aircraft system is also indicated.

At 1722:36, as the aircraft was passing through an altitude of 4,500 feet, the No 2 engine reduced power over a 15 second period from an N1 value of 91% to a value of 27%. The value recorded for the No 2 throttle lever angle did not change during this event. Prior to the event the No 2 engine's ECU had been using its internal channel B, within 3 seconds of the event the ECU had changed to channel A.

After the event, steady values of No 2 engine N1 matched the commanded N1 values to within 1%, with the exception of a 5 second period, shown at 15 minutes 40 seconds in Figure 1, when a commanded N1 reduction to 22% (N1T) was answered by a rise in engine N1 to 37%.

At 3 minutes 10 seconds after the event the No 2 engine's ECU reverted to using channel B. Coincident with this change of channel was the loss on the DFDR of the No 2 engine's N2 signal. At 1734 hrs the aircraft landed successfully using reverse thrust on the No 1 engine during the landing run. Following a taxi to the stand both engines were shut down at 1741 hrs.

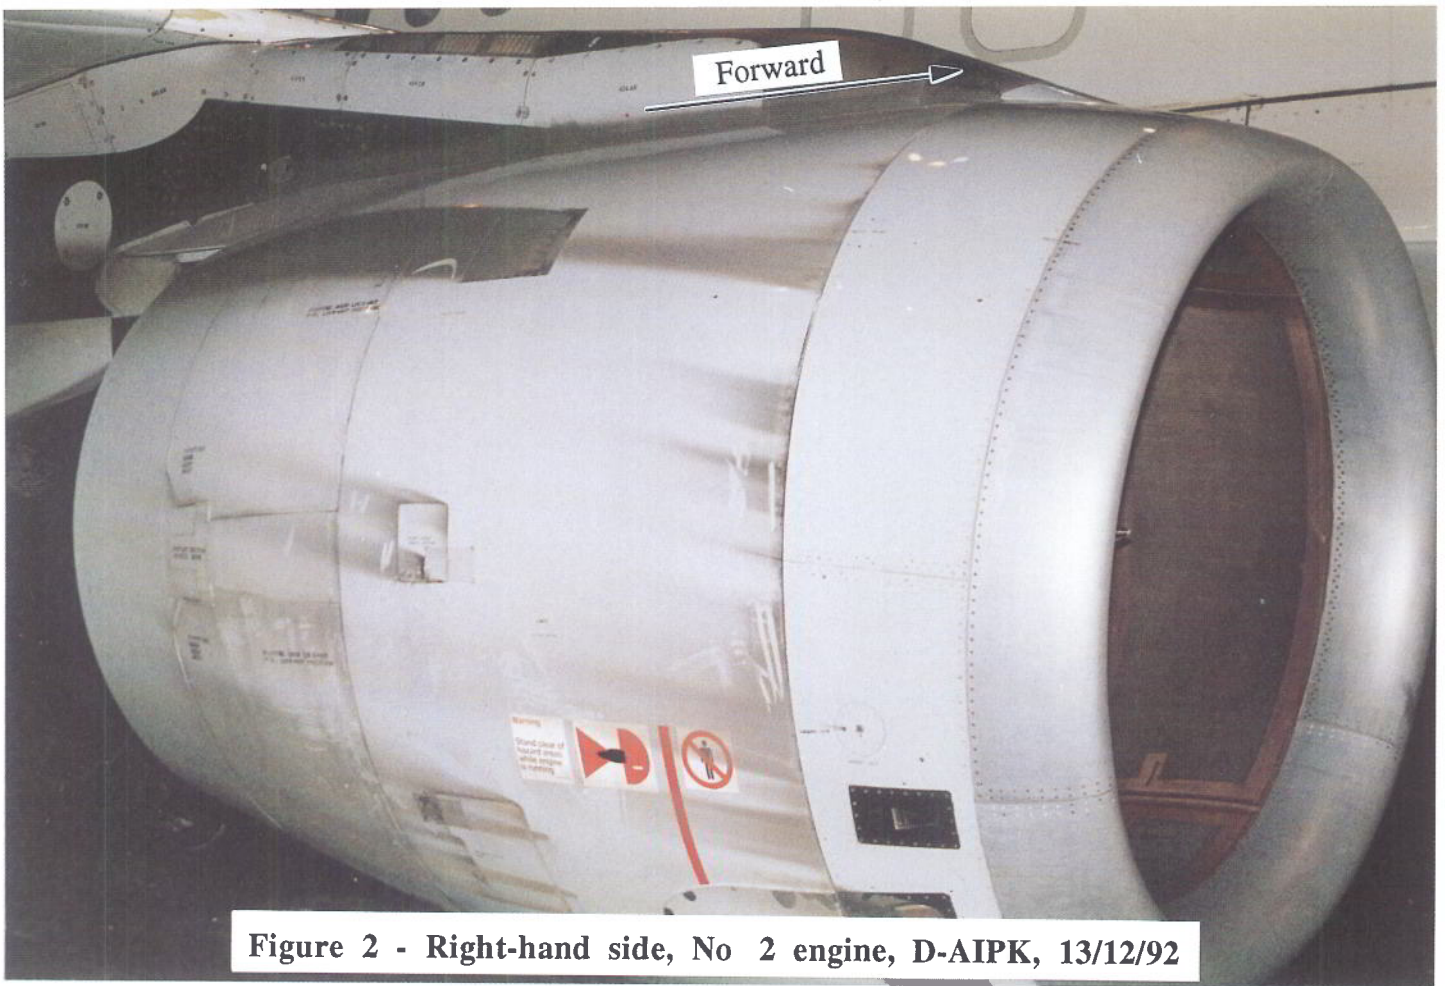
**Figure 2 - Right-hand side, No 2 engine, D-AIPK, 13/12/92**

Figure 2 shows the cowlings on the right-hand side of the No 2 engine after D-AIPK's return to Heathrow. From the heavy streaking emerging from every aperture aft of the fan case front face, it was apparent that there had been extensive combustion within the engine compartment in flight. Figure 3 is a closer photograph of the lower portion of this engine compartment with the cowling door open, showing the starter air duct, the position of the air turbine starter, the ECU and the electrical harnesses connected to the ECU. In this design, all the ECU's electrical signalling connections are mounted on this lower face of the ECU box. Not visible in these photographs is the extensive heat damage to the inside face of the cowling door close to the air turbine starter and the ECU electrical harnesses.

The air turbine starter (s/n 25176) from the No 2 engine, by contrast, showed evidence of massive overheating and the loss of all lubricating oil. This had resulted in the release of the steel turbine wheel from its bearings and this wheel had then advanced into its air inlet plenum, demolishing the stator assembly, which is made of aluminium alloy. The overheating had occurred due to the loss of one complete pawl from the pawl-and-ratchet clutch and this pawl, found in two main pieces, had jammed the clutch mechanism. Thus, following the closure of the start valve at 50% N2, the starter's epicyclic train and turbine wheel had continued to be back-driven by the engine gearbox, generating large amounts of heat, until the failure of the turbine bearings and the release of the turbine wheel. The timing of the ECAM messages and the streaking on the nacelle demonstrate that this occurred while the aircraft was in flight.

**93-62** It is recommended that the CAA liaise with the DGAC in order to confer mandatory status on the Service Bulletin, CFM SB 80-003, which provides for rework of the air turbine starter on CFM56-5 engines. (Issued 23 November 1993)

**93-63** It is recommended that the CAA liaise with the DGAC and review, for the CFM56-5 engine design, the protection from fire and overheat afforded to the Engine Control Unit (ECU) and the associated wiring harnesses. (Issued 23 November 1993)

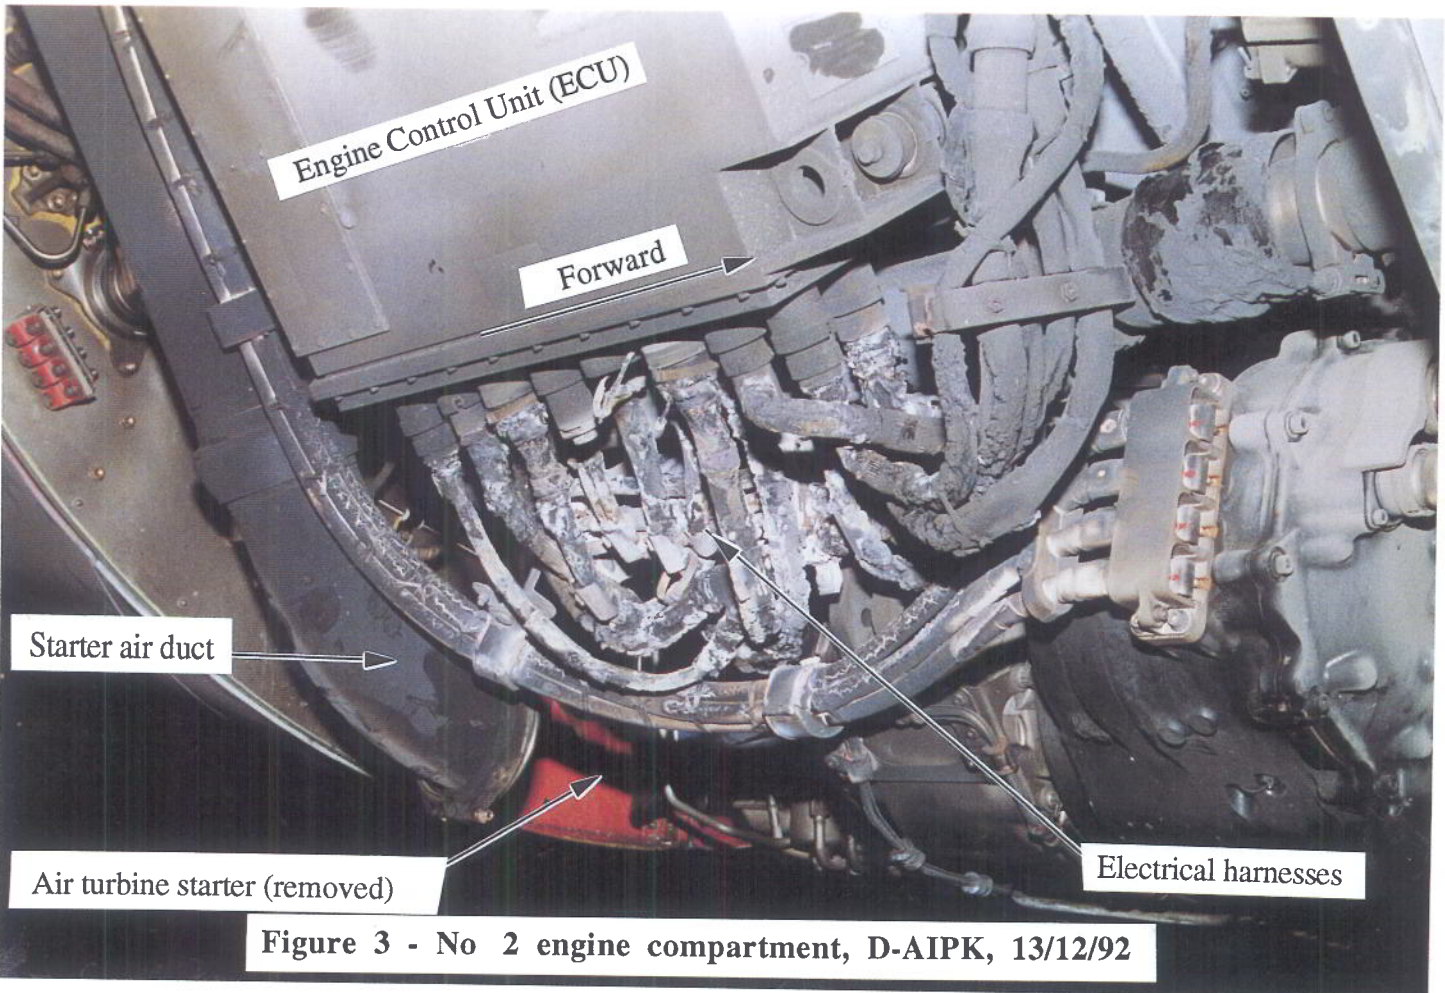
**Figure 3 - No 2 engine compartment, D-AIPK, 13/12/92**

It was immediately apparent that the source of the heating in the No 2 engine compartment had been the air turbine starter, which is attached to the aft face of the engine accessory gearbox and which, during engine starting, drives this gearbox and thus the engine's HP shaft. The system design is that the start valve stays open until the HP shaft reaches 50% N2, at which point the air start valve closes and the air turbine starter disengages. This air turbine starter (s/n 25176) had suffered massive overheating and so, as an initial step, the operation of the start valve was examined; it is the start valve which admits air from the aircraft's pneumatic system to operate the air turbine starter, which is purely mechanical and has no electrical connections. The system was functioned with the APU running and the start valve was found to operate normally; when removed, the valve body and mechanism were found to be undamaged.

The thrust reverser portion of the engine wiring harness was examined by the manufacturer of the engine nacelle. This showed that heat damage to the harness in proximity to the ECU had resulted in a number of electrical 'shorts'; the wire manufacturer assessed that this pyrolysis of the insulation would require localised temperatures of at least 750°F (399°C).
