INCIDENT

Aircraft Type and Registration:	Boeing 757-236, G-BIKN	
No & Type of Engines:	2 Rolls-Royce RB211-535C-37 turbofan engines	
Year of Manufacture:	1984	
Date & Time (UTC):	23 January 1993 at about 1130 hrs	
Location:	Near London Heathrow Airport	
Type of Flight:	Public Transport	
Persons on Board:	Crew - 12	Passengers - 86
Injuries:	Crew - None	Passengers - None
Nature of Damage:	None	
Commander's Licence:	Airline Transport Pilot's Licence	
Commander's Age:	45 years	
Commander's Flying Experience:	9,500 hours (of which 2,726 hours were on type) Last 90 days - 77 hours Last 28 days - 26 hours	
Information Source:	AAIB Field Investigation

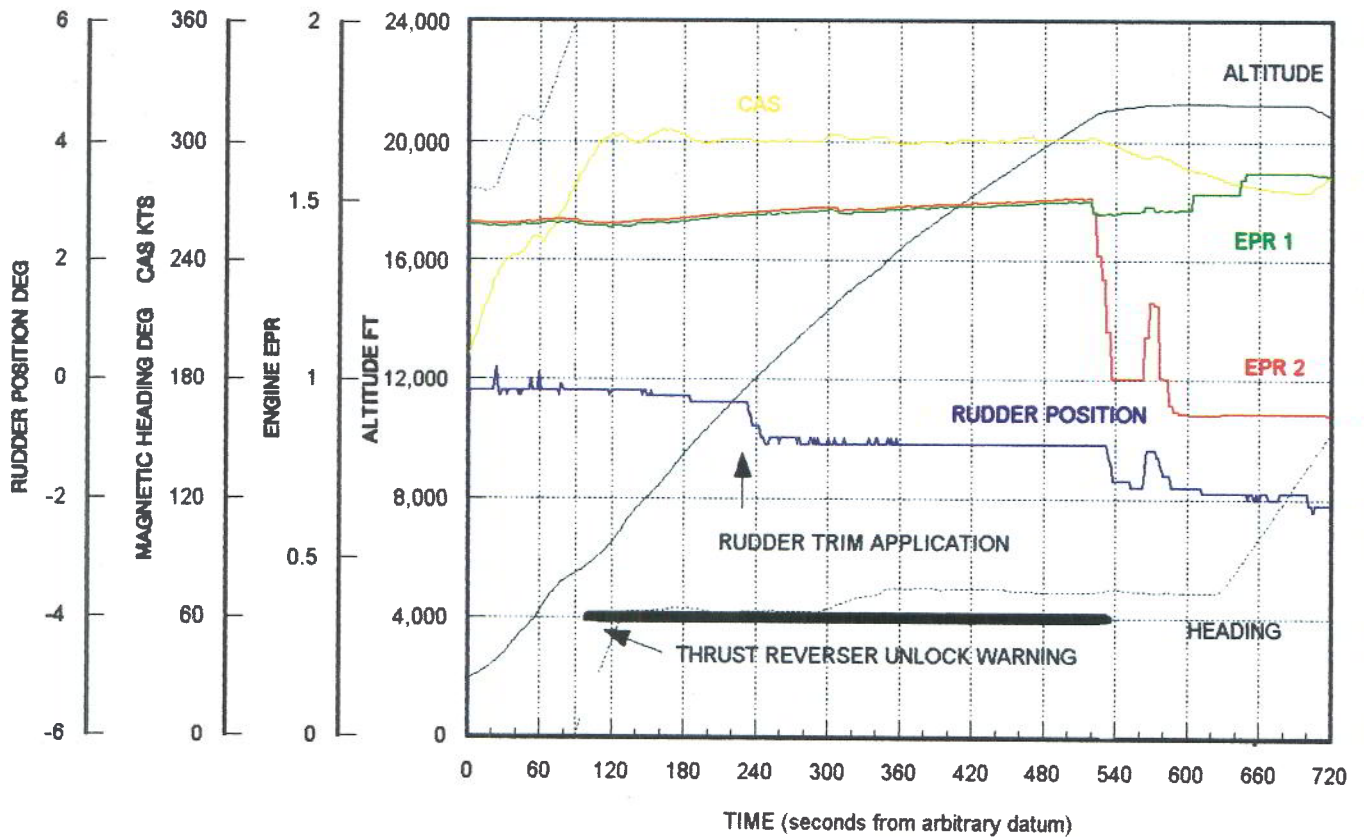
FIGURE 1

Figure 1 shows a plot of some of the recorded parameters from the QAR for the relevant period. The aircraft was climbing through an altitude of 5,700 feet, with the No 2 autopilot engaged, when the Thrust Reverse Unlock indication on No 2 engine activated, there was no apparent crew intervention at this time. The recorded engine power settings remained unchanged; there was no indication of thrust asymmetry, and no movement of recorded rudder position. The calculated rudder trim was 2.7 div. left, from the recorded rudder position of -0.4° at an airspeed of 280 kt CAS.

At an altitude of 20,900 feet, No 2 engine was throttled back initially to the flight idle position, and the Thrust Reverse Unlock indication ceased. The power was increased slightly on No 2 engine to an engine pressure ratio of 1.27 without the warning recurring. The power was decreased again after 12 seconds and the engine was then shut down. Examination of the data until after the landing and shutdown revealed no further Thrust Reverse Unlock indication.

G-BIKN SELECTED PARAMETERS FROM FLIGHT RECORDER DATA DURING INCIDENT

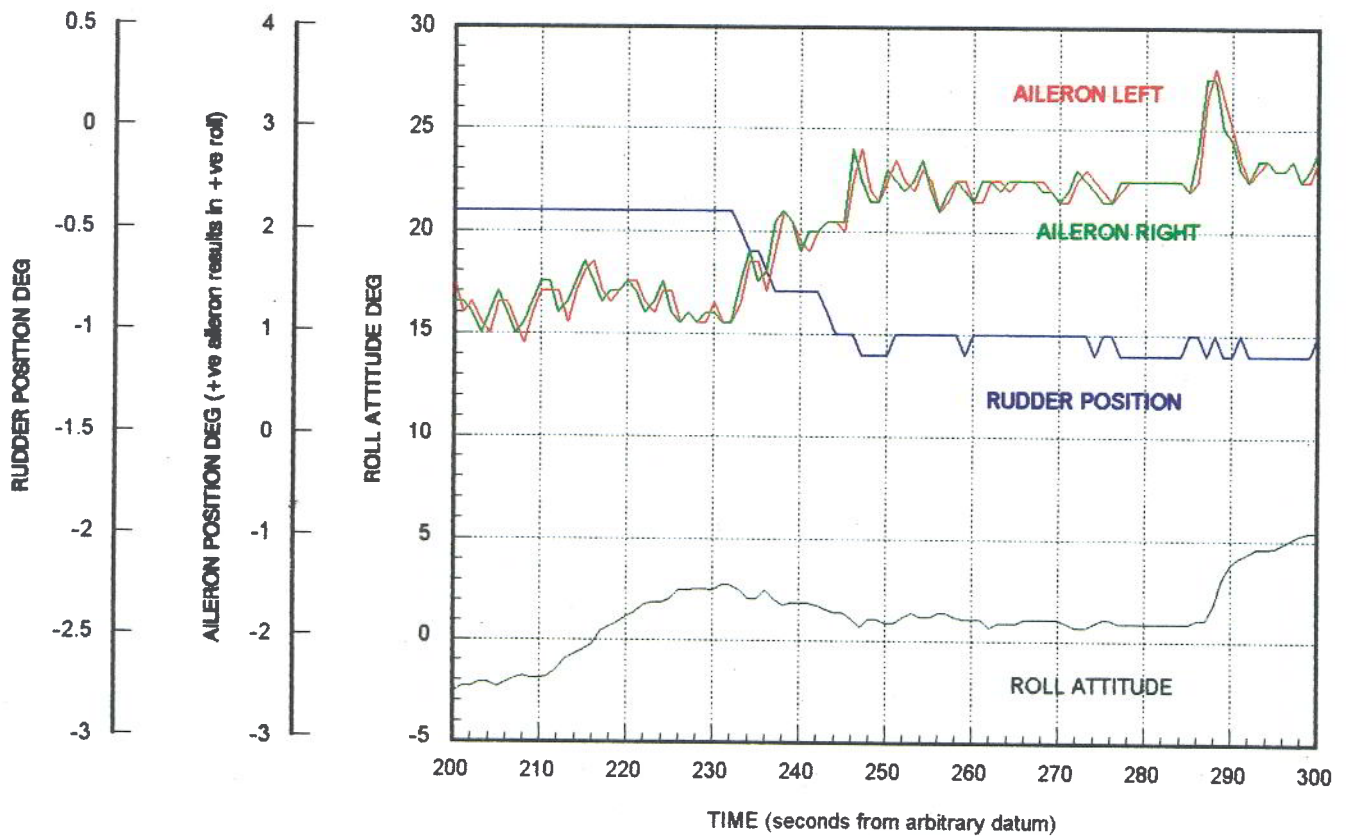
FIGURE 2

As the aircraft climbed through an altitude of 12,000 feet there was a movement of rudder position from -0.4° to -1.1° over a period of about 12 seconds, which corresponded to a left rudder trim of 5.7 div. at an airspeed of 300 kt CAS. There was also a corresponding movement of aileron to balance the rudder input and maintain aircraft heading. There was no change in the engine power setting. This control movement is shown in more detail in Figure 2, and was not directly associated with the Thrust Reverse Unlock indication.

The data from five previous sectors was analysed and this showed that the rudder position varied between -0.3° and -0.6° , and so the use of -1.1° on the incident flight was unusual. The manufacturer's analysis showed that the 5 div. of left rudder trim was more than was necessary to maintain heading and was being compensated by the use of right aileron. During the climb as the composite rudder control surface distorts due to temperature effects, and possible airframe icing, a change in rudder trim can occur. There is a Service Bulletin, No 757-27-67 (CAA-AD 007-04-88), which details the installation of a rudder thermal compensator. This was fitted to this aircraft.

G-BIKN EXPANDED FDR PLOT SHOWING APPLICATION OF RUDDER TRIM

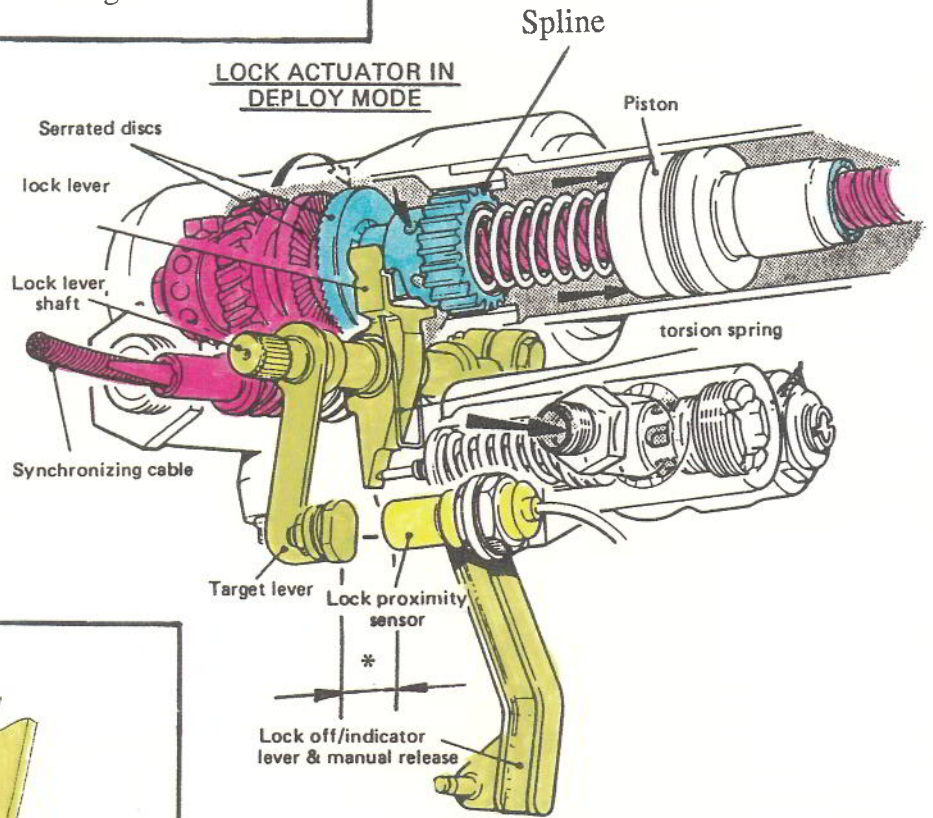
At the AAIB's request, arrangements were made to transport the lock actuator to the aircraft manufacturer's facility in Seattle where, following a meeting attended by representatives of the airline, engine and cowl manufacturers and the AAIB to discuss various aspects of the thrust reverser and warning system, it was examined in detail. After a partial strip examination, which revealed the unit to be in good mechanical condition, the unit was reassembled and sent to its manufacturer for a full 'production acceptance test'. This demonstrated that the unit was serviceable, in good condition and with all internal leakage rates within limits. The external leak rate from the ram seal was outside limits but had no effect on the operation of the actuator. It was, however, established that the gap between the proximity sensor and its target, with the internal lock fully engaged, was inconsistent (an observation made by maintenance personnel generally) and could be set anywhere between a zero gap and .028 inches, due to clearances within the actuator between the lock lever and non-rotating serrated lock disc, ref. Figure 4. A light torsion spring is installed to bias the lock lever with the intention of removing the effects of backlash, the allowable limits of which are given as 0.050 inches. The gap rigging limits specified in the maintenance manual are $0.010 \pm .003$ inches.

*
Required sensor/target gap
when closed and locked:-

$$0.010'' \pm .003''$$

Gap measured on actuator:-
Max= 0.028'' Min 0.000''

93-42 The CAA should review, in conjunction with the FAA and associated manufacturers, the design of the lock/unlock indication system on Boeing 757 aircraft in relation to the present Maintenance Manual proximity sensor rigging instructions in view of their evident inability to prevent associated false warnings. (Issued 21 July 1993).
