ACCIDENT

Aircraft Type and Registration:	Pulsar, G-BUDI	
No & Type of Engines:	1 Rotax 582 piston engine	
Year of Manufacture:	1994	
Date & Time (UTC):	13 October 2006 at 1328 hrs	
Location:	Popham Airfield	
Type of Flight:	Private	
Persons on Board:	Crew - 1	Passengers - None
Injuries:	Crew - None	Passengers - N/A
Nature of Damage:	Damage to propeller, nose landing gear and engine mountings	
Commander's Licence:	Private Pilot's Licence	
Commander's Age:	60 years	
Commander's Flying Experience:	228 hours (of which 111 were on type) Last 90 days - 3 hours Last 28 days - 3 hours	
Information Source:	Aircraft Accident Report Form submitted by the pilot and metallurgical examination of the failed component

Synopsis

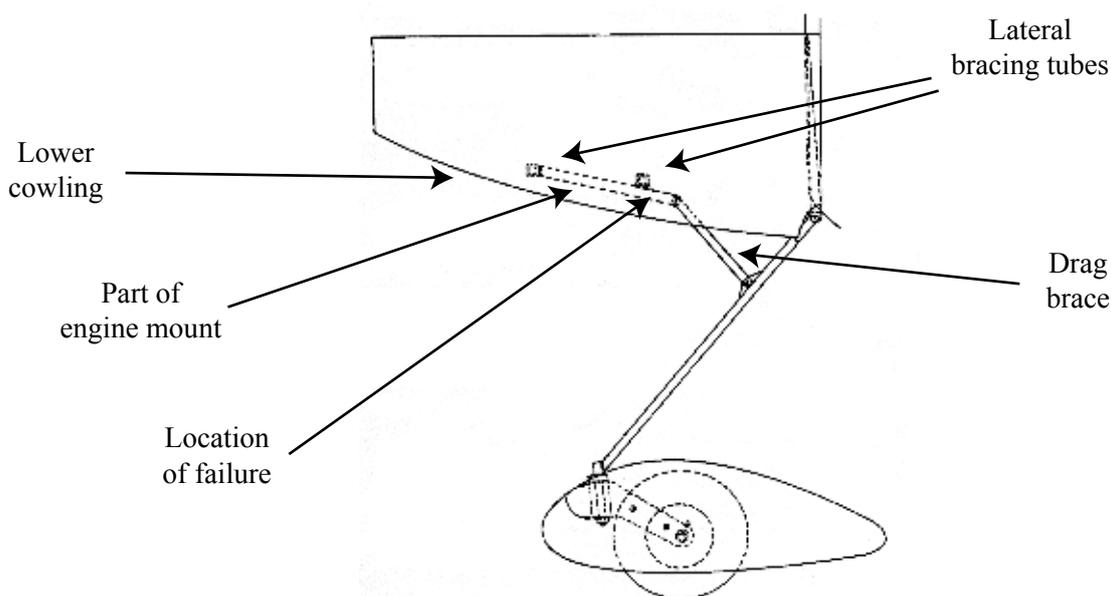
Figure 1

The nose landing gear strut on this type of aircraft consists of a thick-walled square tube, with a castoring nose wheel assembly attached to the lower end (see Figure 1). Near the top of the strut a drag brace is attached, which runs forward to the central longitudinal member of the engine mount assembly. This longitudinal member is welded to lateral bracing tubes. Some aircraft, including G-BUDI, have a damper incorporated with the drag brace.

Nose landing gear and engine mount assembly

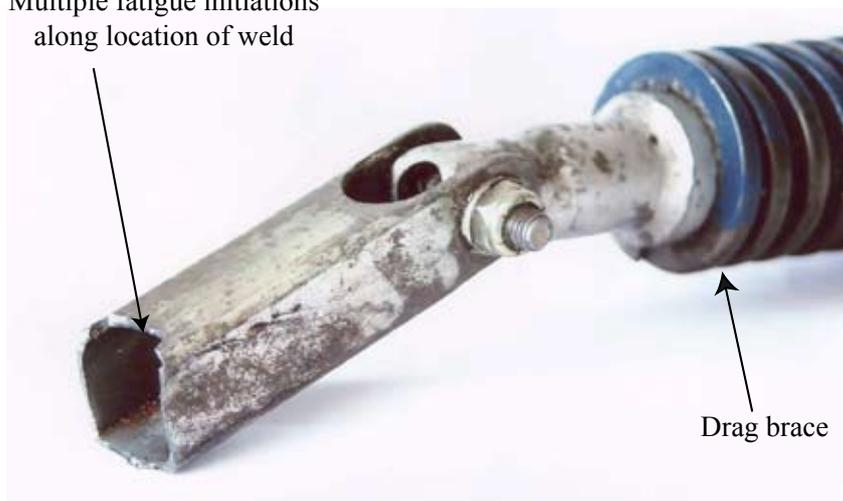
Figure 2

The longitudinal engine mount tube had failed at the location of the weld attaching it to the rear lateral

bracing tube. The engine mount, together with the drag brace, was returned to the AAIB for metallurgical examination (see Figure 2).

Multiple fatigue initiations along location of weld

Failed engine mount tubing for G-BUDI

The PFA intend to issue a bulletin to Pulsar owners calling for a reinforcement of the nose leg support stub. This will be mandatory for the issue or renewal of a Permit-to-Fly.

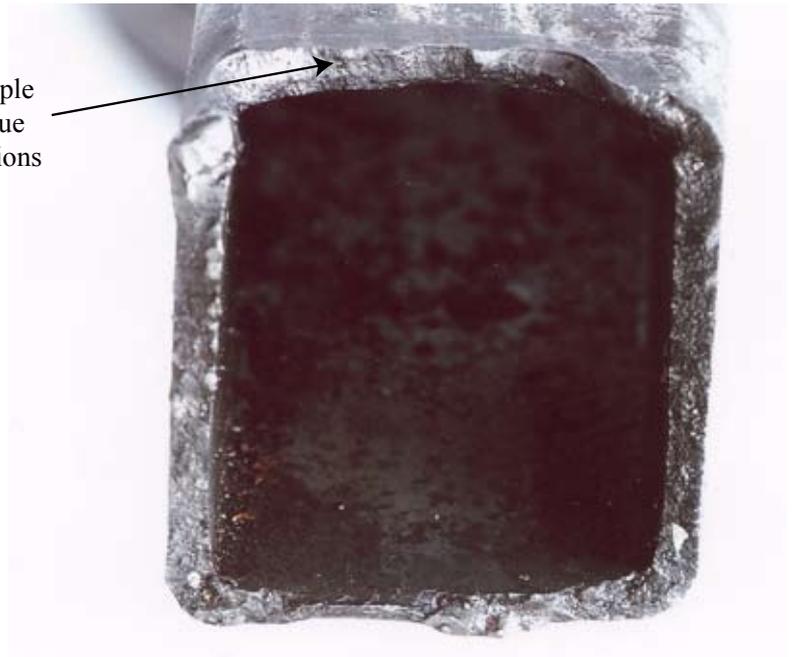
Figure 3

Magnetic tests on the tubing showed that it had been manufactured from ferro-magnetic steel. The failure had developed from multiple fatigue initiations across the majority of the tube face. The face had been extensively mechanically damaged during and after separation (see Figure 3) but it was evident that multiple, relatively low-cycle, fatigue initiations had occurred along the top edge where the weld had been located. It was concluded that the separation resulted from fatigue damage induced by cyclic bending due to normal operating loads on the landing gear.

Multiple
fatigue
initiations

End-on view of fracture face from G-BUDI
