**INCIDENT**

<b>Aircraft Type and Registration:</b>	Dassault Falcon 20-F5, N757CX	
<b>No &amp; Type of Engines:</b>	2 Honeywell TFE-731-SER turbofan engines	
<b>Year of Manufacture:</b>	1980	
<b>Date &amp; Time (UTC):</b>	9 May 2007 at 2205 hrs	
<b>Location:</b>	Descent and approach to London (Stansted) Airport	
<b>Type of Flight:</b>	Private	
<b>Persons on Board:</b>	Crew - 2	Passengers - 5
<b>Injuries:</b>	Crew - None	Passengers - None
<b>Nature of Damage:</b>	None	
<b>Commander's Licence:</b>	Airline Transport Pilot's Licence	
<b>Commander's Age:</b>	45 years	
<b>Commander's Flying Experience:</b>	7,622 hours (of which 2,053 were on type) Last 90 days - 109 hours Last 28 days - 34 hours	
<b>Information Source:</b>	AAIB Field Investigation

**Synopsis**

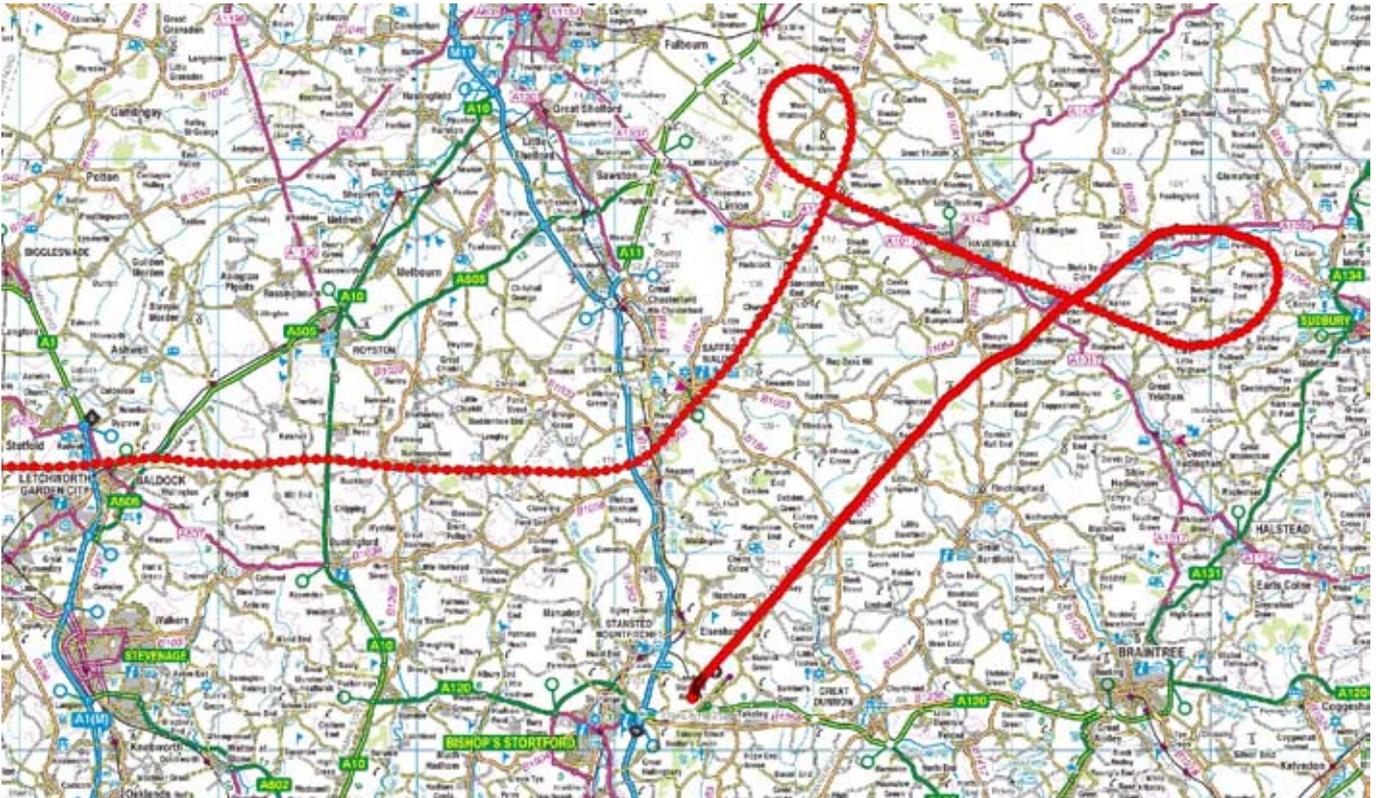
Radar track of N757CX inbound to London Stansted

The recorded data started at 21:50:00 with N757CX overhead Royal Leamington Spa on a south-westerly track whilst descending through Flight level 204. A left turn was then made, as the aircraft passed over Brackley, onto an easterly track. Figure 1 depicts the aircraft on this easterly track overhead Letchworth (21:58:53) at Flight Level 117 (still descending) and ends with the landing and subsequent taxiing at London Stansted (22:26:14). The figure shows several 270° turns to the left, followed by minor heading corrections to the right as the aircraft was positioned to intercept the localiser on the ILS approach to Runway 23.

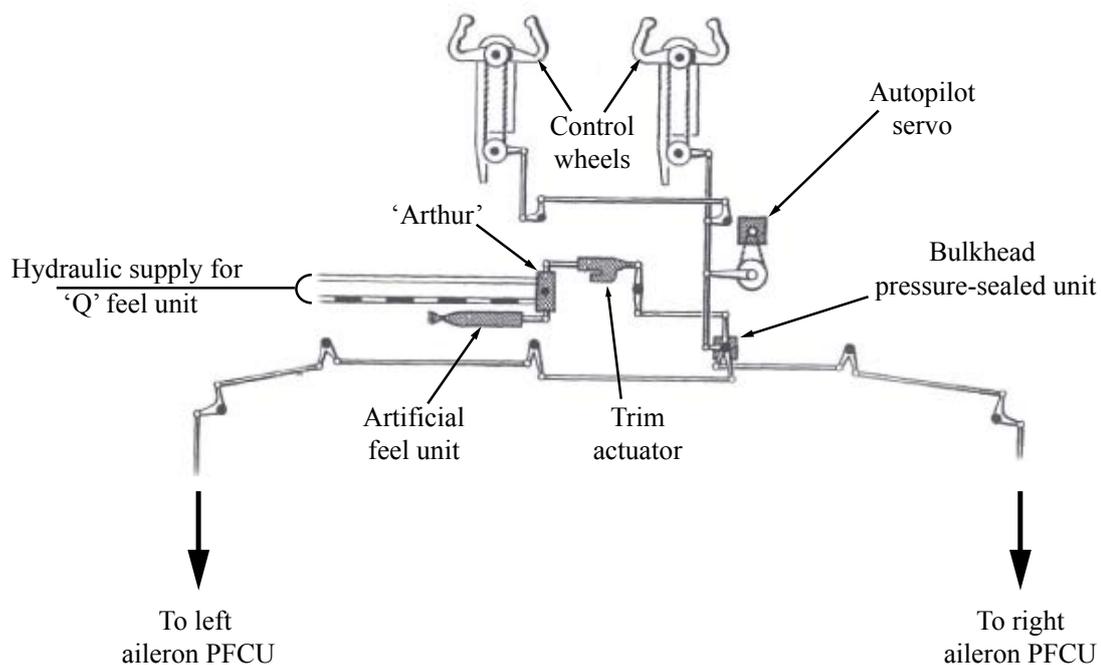
**Figure 2**

The Falcon 20 aircraft has dual hydraulic systems with manual reversion of the primary flight controls available in the event of a double hydraulic failure (see Figure 2). From the base of the control columns, rods and bellcranks

Schematic of Falcon 20 aileron mechanical control system

are used to transmit yoke inputs to the hydraulic servos in the wings. The autopilot actuators for roll and pitch control are situated on the right side of the forward vestibule, above the main floor level, from whence the roll control rod goes down to below floor level. A pressure-sealed bulkhead unit then allows rods to travel outside the pressure hull to the left and right wings. However, a further rod remains in the pressurised area to connect to the electric roll trim actuator, the hydraulic 'Q' feel unit (called 'Arthur' by the manufacturer) and an artificial feel unit, which is a simple spring strut and serves the purpose of centring the control. Thus it can be seen that the aileron trim actuator body moves with pilot or autopilot inputs and that, when trim commands are made, the actuator effectively extends or retracts against the artificial feel unit spring, deflecting the ailerons. It should be noted, therefore, that if movement of the electric trim actuator body, which moves with control inputs, is restricted, then that restriction will be felt by the pilots or the autopilot.
