ACCIDENT

Aircraft Type and Registration:	Taylor JT1 Monoplane, G-CEKB	
No & Type of Engines:	1 Volkswagen VW 1834 piston engine	
Year of Manufacture:	2006	
Date & Time (UTC):	27 June 2009 at 1043 hrs	
Location:	Great Oakley Airfield, near Harwich, Essex	
Type of Flight:	Private	
Persons on Board:	Crew - 1	Passengers - None
Injuries:	Crew - 1 (Fatal)	Passengers - N/A
Nature of Damage:	Aircraft destroyed	
Commander's Licence:	Private Pilot's Licence	
Commander's Age:	69 years	
Commander's Flying Experience:	1,160 hours (of which 857 were on type) Last 90 days - 12 hours Last 28 days - 2 hours	
Information Source:	AAIB Field Investigation

Synopsis

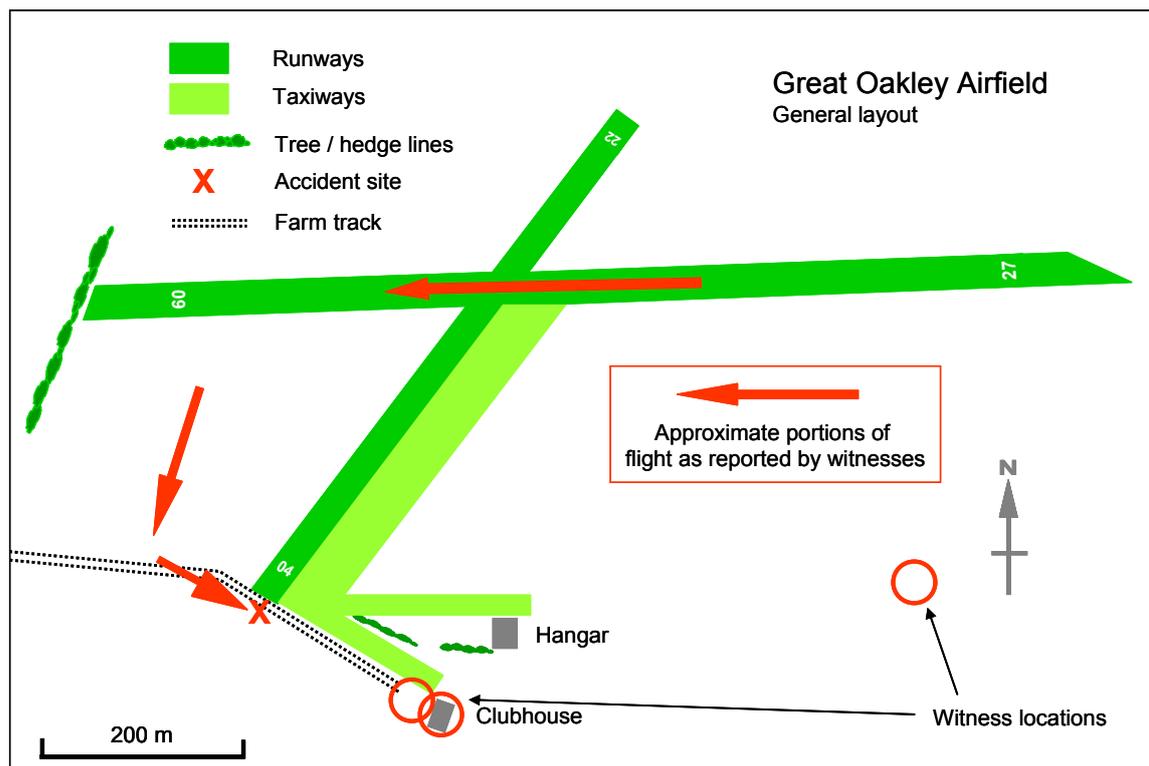
Figure 1

General layout of Great Oakley Airfield.
Portions of the flight seen by witnesses are shown

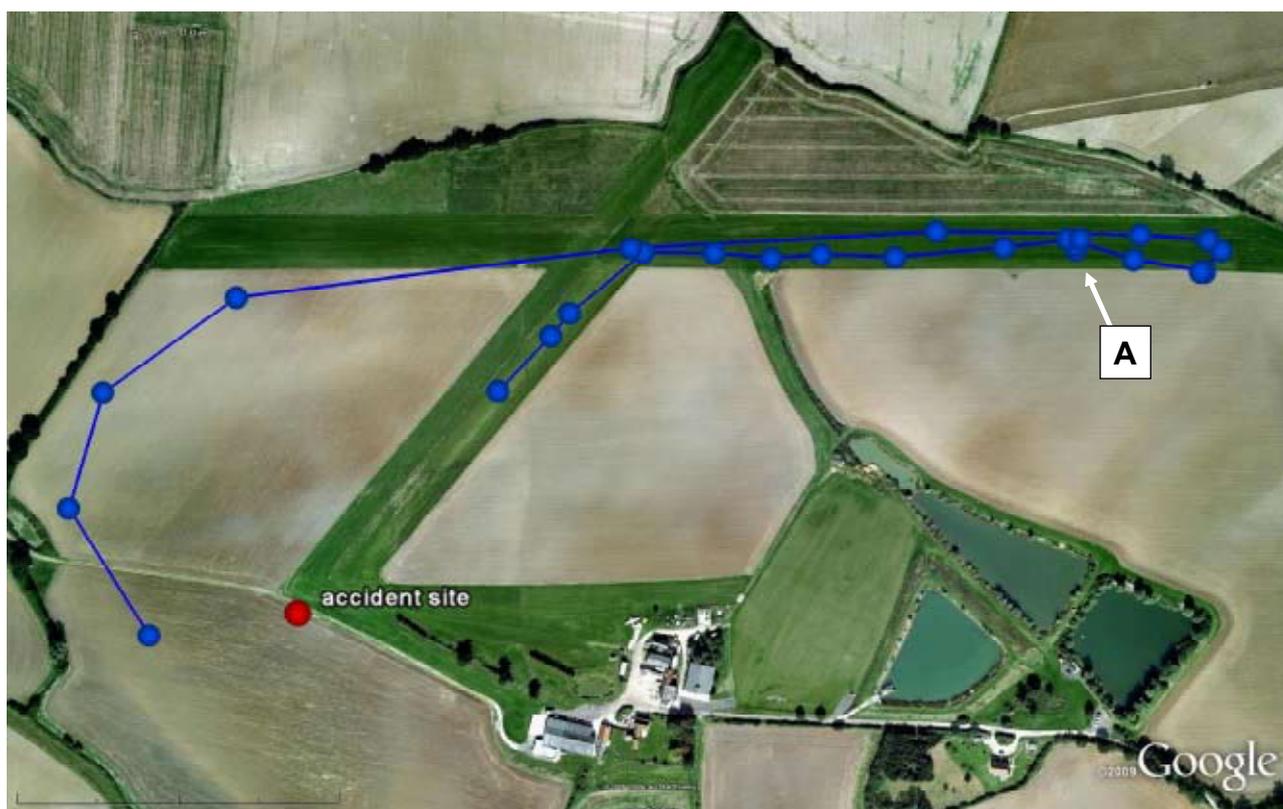
Figure 2

The track of the accident flight is shown at Figure 2. The recording starts at 10:37:20 hrs as the aircraft was taxiing prior to takeoff and ends at 10:42:43 hrs, near the accident site. The track shows that the aircraft entered Runway 09 and taxied part-way along it, before stopping for approximately one minute, presumably while the pilot carried out his before takeoff checks (position A of Figure 2). The aircraft then continued taxiing to the takeoff point. The average groundspeed between each GPS track point is presented in Figure 3.

GPS track of the accident flight.

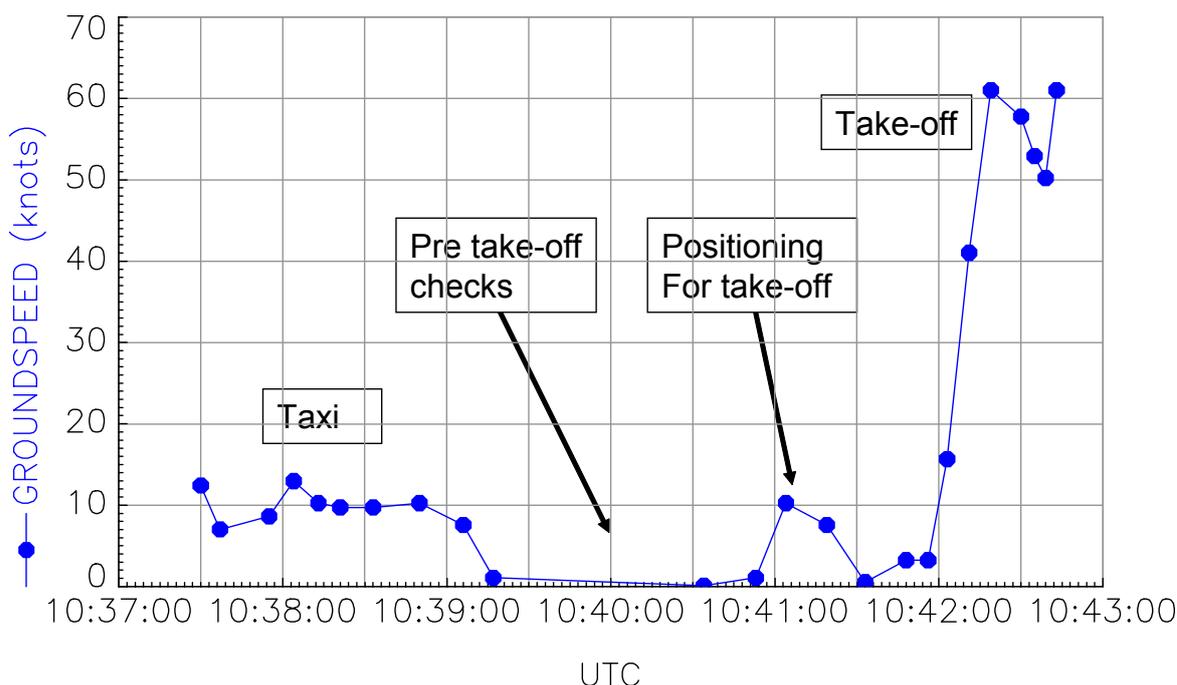
Figure 3

Accident flight calculated groundspeeds

The GPS groundspeed indicated apparently normal takeoff acceleration until the aircraft would have been approximately over the midpoint of the runway. However, the speed did not continue to increase but reduced instead as the aircraft turned crosswind.
