**SERIOUS INCIDENT**

<b>Aircraft Type and Registration:</b>	1) DHC-8-402, Dash 8, G-JECL 2) Boeing 737-5H6, G-PJPJ
<b>No &amp; Type of Engines:</b>	1) 2 Pratt & Whitney Canada PW150A turboprop engines 2) 2 CFM56-3C1 turbofan engines
<b>Year of Manufacture:</b>	1) 2005 2) 1994
<b>Date &amp; Time (UTC):</b>	30 October 2009 at 1900 hrs
<b>Location:</b>	Exeter Airport, Devon
<b>Type of Flight:</b>	1) Commercial Air Transport (Passenger) 2) Commercial Air Transport (Passenger)
<b>Persons on Board:</b>	1) Crew - 4                      Passengers - 58 2) Crew - 2                      Passengers - 0
<b>Injuries:</b>	1) Crew - None                  Passengers - None 2) Crew - None                  Passengers - None
<b>Nature of Damage:</b>	1) None 2) None
<b>Commander's Licence:</b>	1) Airline Transport Pilot's Licence 2) Airline Transport Pilot's Licence
<b>Commander's Age:</b>	1) 30 years 2) n/k years
<b>Commander's Flying Experience:</b>	1) 6,259 hours (of which 639 were on type) Last 90 days - 143 hours Last 28 days - 50 hours  2) n/k hours (of which n/k were on type) Last 90 days - n/k hours Last 28 days - n/k hours

<b>Information Source:</b>	AAIB Field Investigation

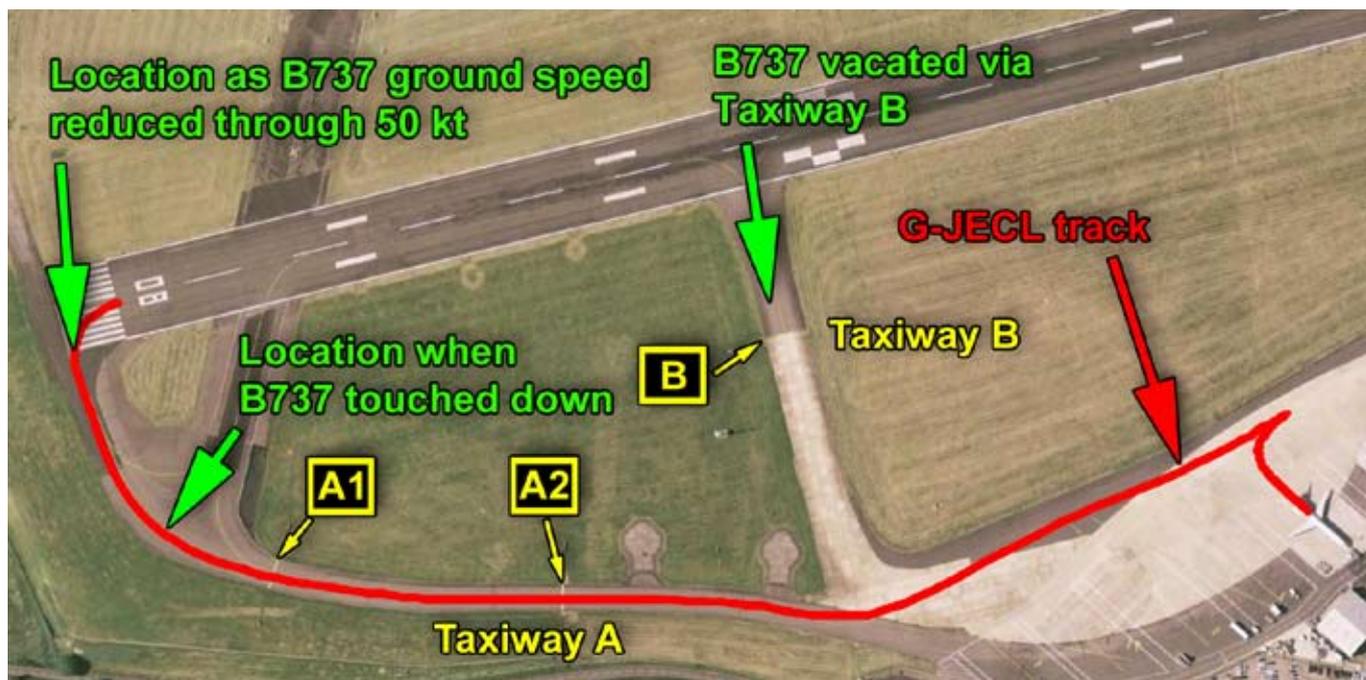
**Figure 1**

The relevant radio communications are given in the history of the flight. The relative aircraft positions during the incident are shown in Figure 1. G-JECL proceeded along Taxiway Alpha without stopping at Holding Point Alpha One and while taxiing along Taxiway Alpha, the crew would have not had the landing B737 in their view. The B737 touched down shortly after G-JECL passed Holding Point Alpha One. As the B737 decelerated through a ground speed of

G-JECL track and G-PJPJ positional information  
(Google Earth™ mapping service/Infoterra Ltd & Bluesky)

50 kt, G-JECL started turning onto the runway. The B737 vacated the runway via Taxiway Bravo.
