Schweizer 269C-1, G-ODNH

AAIB Bulletin No: 8/2004	Ref: EW/C2003/05/02	Category: 2.3
Aircraft Type and Registration:	Schweizer 269C-1, G-ODNH	
No & Type of Engines:	1 Lycoming HO-360-C1A piston engine	
Year of Manufacture:	2000	
Date & Time (UTC):	7 May 2003 at 0930 hrs	
Location:	Pateley Bridge, Yorkshire	
Type of Flight:	Training	
Persons on Board:	Crew - 2	Passengers - None
Injuries:	Crew - None	Passengers - N/A
Nature of Damage:	Damaged horizontal stabiliser and elongation of bolt holes in tail-boom skin locating tail rotor gearbox mounting. Failure of attachments between tail-boom and rear fuselage structure. Fractured tail-rotor drive fork hinge bolt	
Commander's Licence:	Not known	
Commander's Age:	54 years	
Commander's Flying Experience:	3,100 hours (of which 530 were on type)	
	Last 90 days - 83 hours	
	Last 28 days - 25 hours	
Information Source:	AAIB Field Investigation

Synopsis

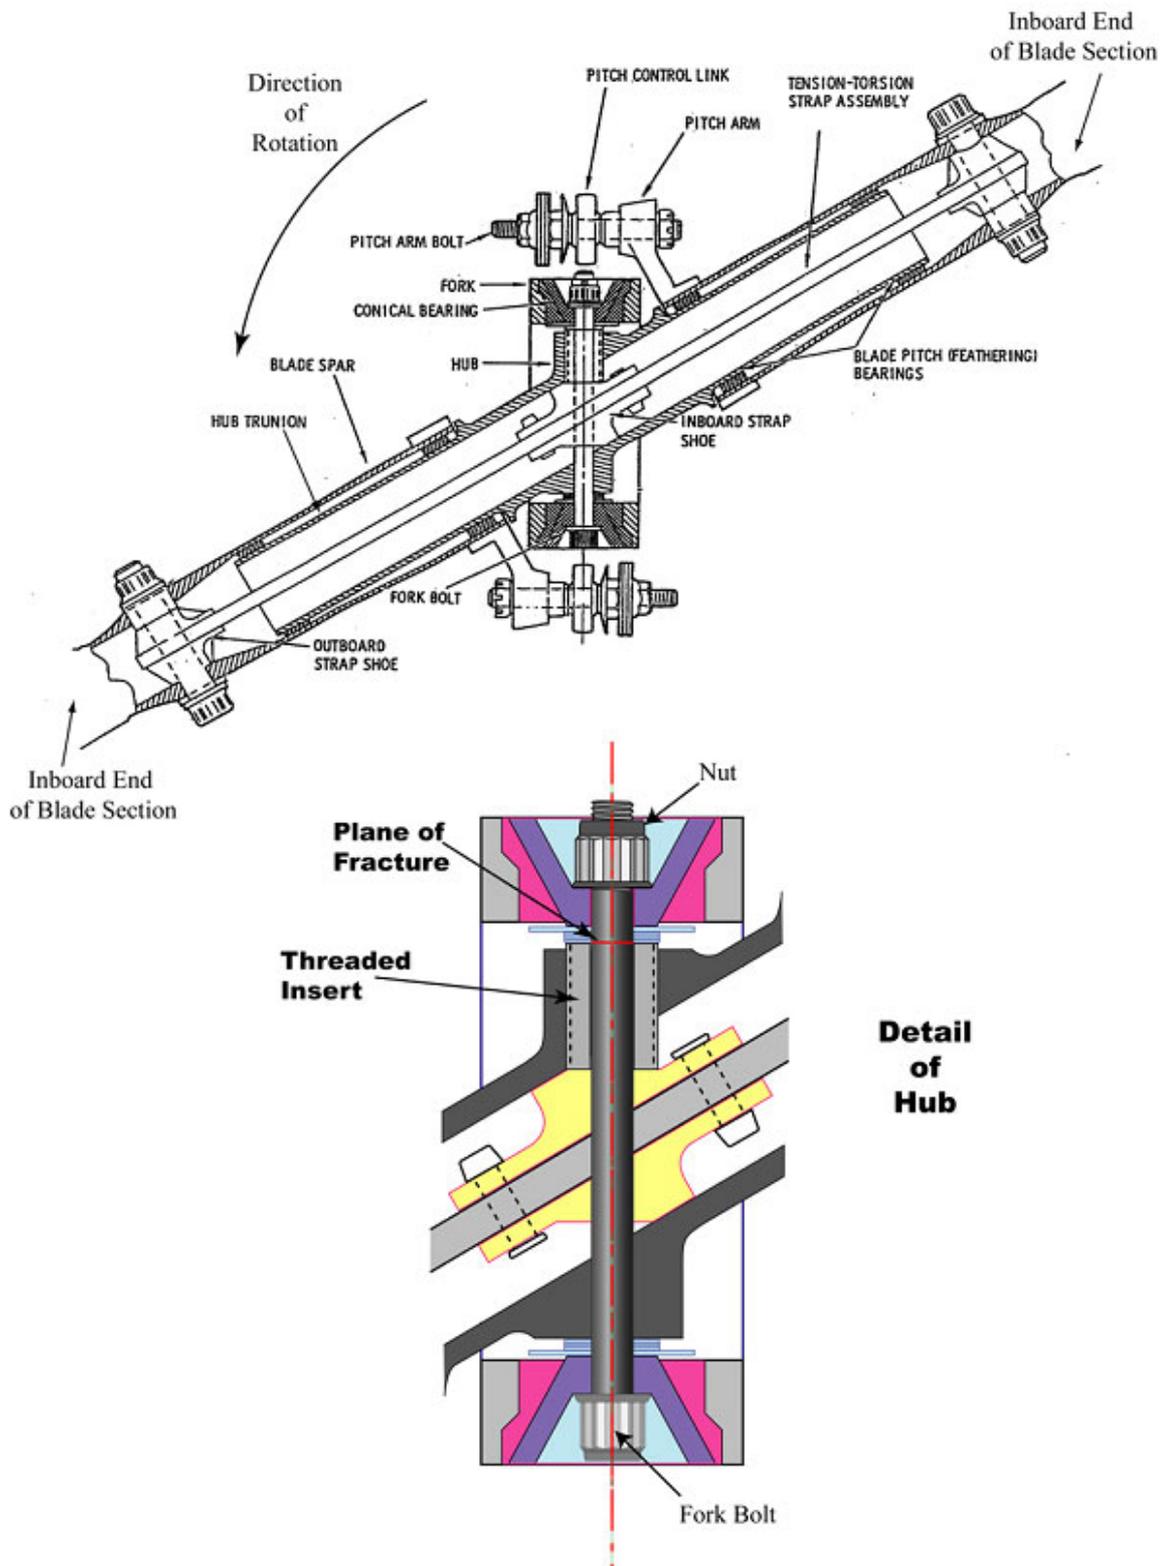
The tail rotor consists of two blades mounted on a hub assembly (see Figure 1) which is in turn mounted in a rotating fork. The fork incorporates two conical bearings and a bolt passes through the hub and both bearings. Teetering motion of the rotor is enabled by the presence of the bearings. The bolt, in addition to passing through the bearings and the basic hub trunnion, passes through a shoe, within the hub, which locates the straps holding the two blades against centrifugal force. It also passes through an insert threaded into the hub. Shim washers of various thicknesses bear against the protruding inner races of the conical bearings and enable the pre-load to be adjusted. Two washers of larger diameter, acting as dust shields, are positioned on either side of the hub.

Figure 1 Layout and Details of Tail Rotor Hub Components

The bolt is secured and tensioned by a nut which, when the assembly is correctly installed, ensures that the inner races, (ie the smaller diameter elements of the hub bearings) the nut, bolt, hub, shoe, threaded insert, shim washers and the dust shields all oscillate in unison relative to the fork as the rotor rotates during forward flight.

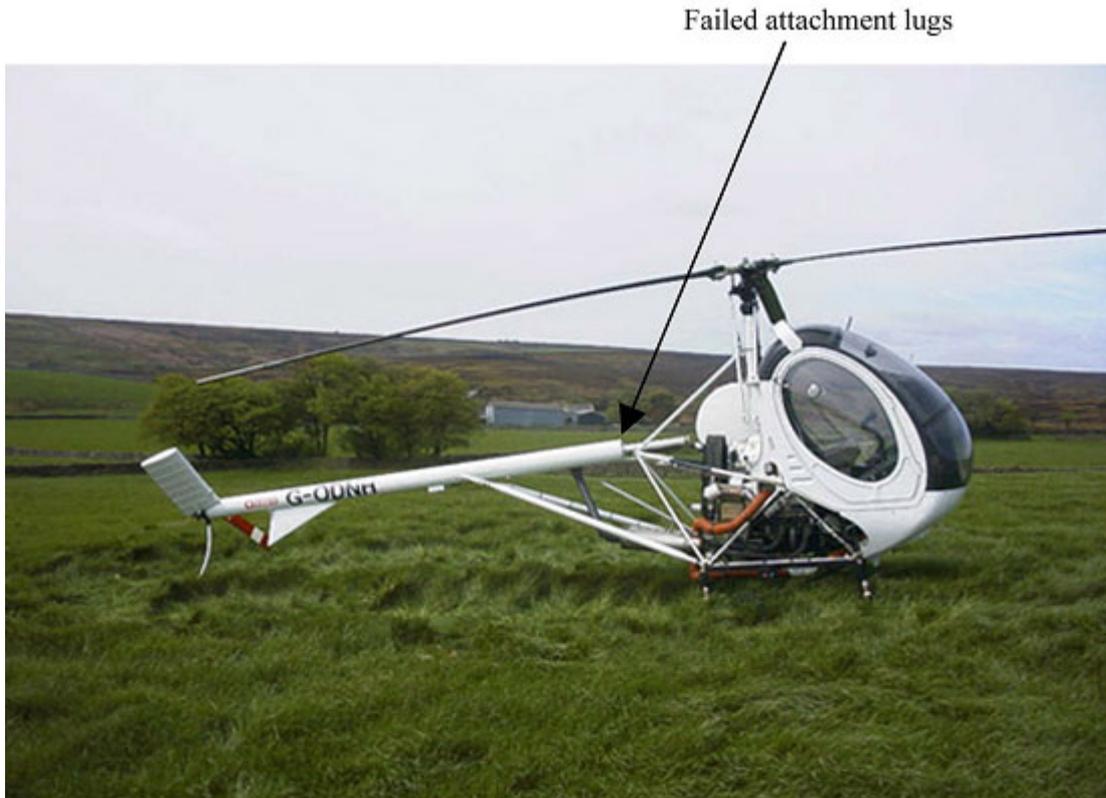
The forward end of the extruded tubular aluminium alloy tail-boom terminates in a casting incorporating two lugs through which bolts pass securing the unit to tubular structural members behind the occupied section. An additional pair of larger diameter tubes brace the boom further aft to the structure below and behind the occupied section (see Figure 2).

Figure 2 – General view showing location of tail boom attachment lug failure

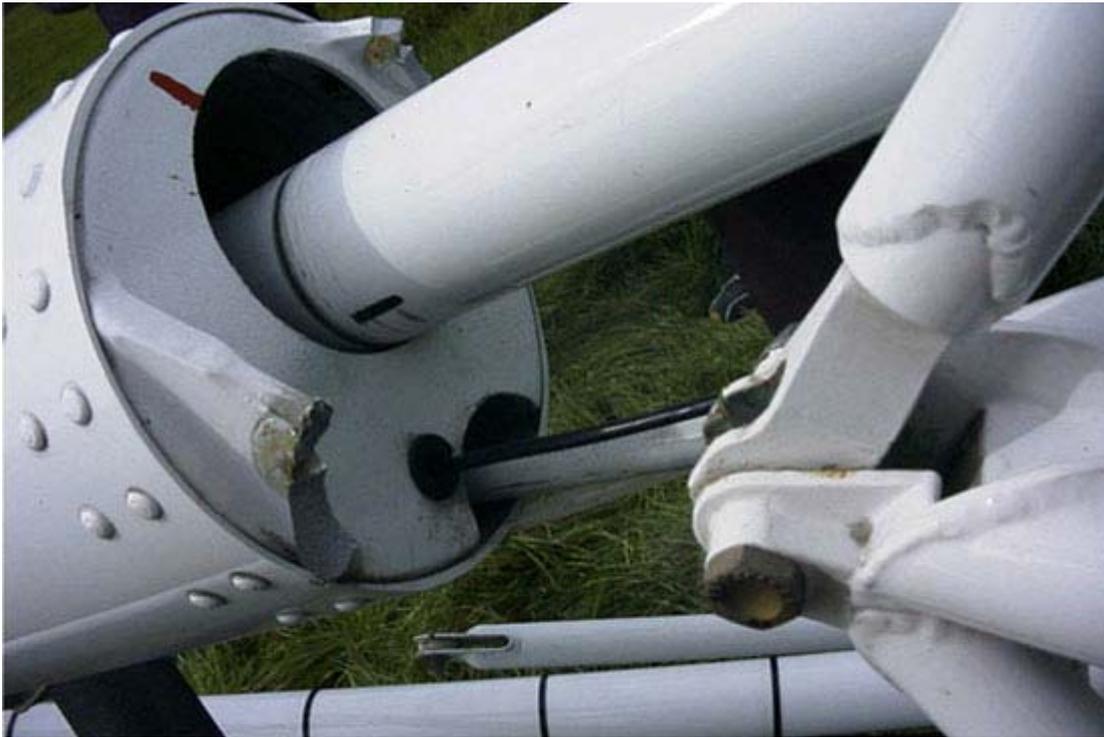
Examination of the fracture faces of the failed tail boom attachment lugs (see Figure 3) revealed no evidence of fatigue and suggested that overload had occurred.

Figure 3- Detail of tail boom attachment failure

The simple overload failures of the tail-boom attachment lugs indicate that they were not the consequence of the high vibration level brought about by the unbalanced rotation of the tail rotor during the descent. The pilot's report, the lack of reported ground markings and the absence of evidence of a heavy landing on the skids and other parts of the aircraft all suggest that failure did not occur as a result of ground impact. Neither the timing nor the mechanism of their failure are clear.

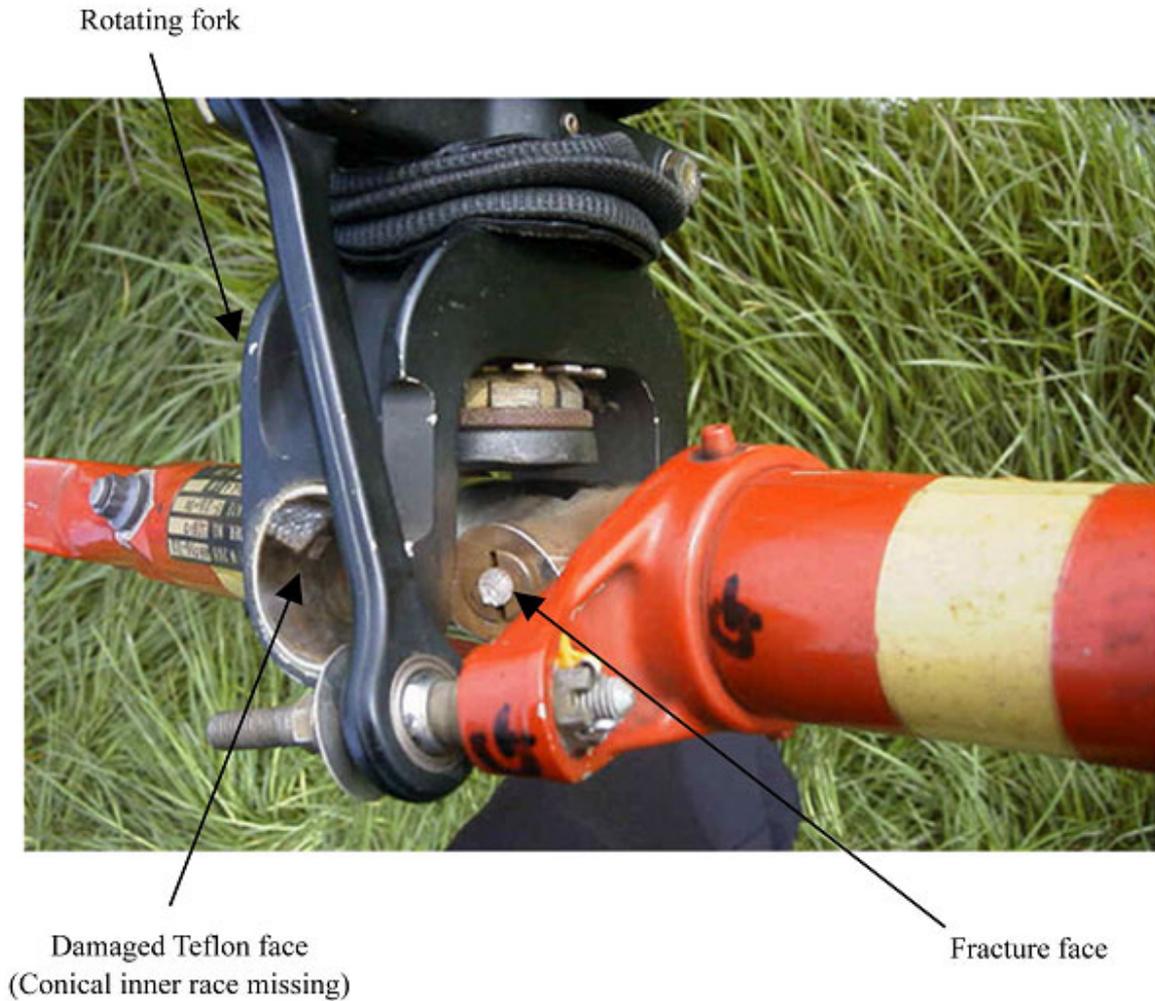
Examination of the fracture face of the fork bolt showed that it had failed in a plane very close to the exposed face of the threaded insert (see Figure 1 and Figure 4), allowing the dust shield and washers on one side of the hub to be lost. The insert is screwed into the hub forging. The fracture face incorporated a raised angular peak and trough at one edge with a ridge or step extending from the peak across the section separating the two halves of the fracture. Each half occupied a slightly different, though parallel, plane and the two were thus independent fracture surfaces. Scanning Electron Microscope (SEM) examination revealed that fatigue cracking had initiated at the side of the shank opposite that of the peak and trough. It appeared to have propagated at different angles on each half of the cross-section, culminating in ductile overload at the angular peak. The fatigue had the characteristics of torsional shear stressing applied in two distinct directions. The torsional evidence was, however, not orientated about an axis coincident with that of the bolt.

Figure 4 – Fracture face of tail rotor fork bolt

The end face of the threaded insert, almost in plane with the two fracture faces, was extensively coated with a brown powdery deposit.

The observations regarding the fracture mechanism cannot be explained conclusively. It is, however, possible that repeated shear loading applied at differing angles to the bolt, as the latter progressively rotated, would produce a fatigue effect which mimicked the appearance of torsional fatigue.

The tail rotor fork bolt failed in fatigue after a period of operation with no pre-load present in the bolt/nut assembly. The lack of pre-load was probably a consequence of failure to establish the correct tension in the bolt at the time of last assembly. Failure to establish the correct tension may have resulted from a tight fit of the bolt within the threaded insert, disguising the fact that the bolt head was not correctly seated as torque was applied.

Implementation of a torque check of the tail rotor retaining nut is required 25 hours after installation of the fork bolt on all versions of the Schweizer 269 helicopter. This requirement applied to the C-1 version, the type of aircraft in question, at the relevant time but was not highlighted amongst the re-assembly instructions. Use of the bolt-stretch method of fitting (the only method now detailed) may have resulted in any incorrect seating of the bolt being identified at installation. Finally, implementation of the 25-hour torque check, if carried out, might have alerted maintenance staff to any incorrect tightening of the bolt.
