ACCIDENT

Aircraft Type and Registration:	Flight Design CTSW, G-CFAZ	
No & Type of Engines:	1 Rotax 912 ULS piston engine	
Year of Manufacture:	2007	
Date & Time (UTC):	8 October 2008 at 0855 hrs	
Location:	Saddleworth Moor, Lancashire	
Type of Flight:	Private	
Persons on Board:	Crew - 1	Passengers - None
Injuries:	Crew - 1 (Fatal)	Passengers - None
Nature of Damage:	Aircraft destroyed	
Commander's Licence:	Private Pilot's Licence	
Commander's Age:	41 years	
Commander's Flying Experience:	123 hours (of which 29 were on type) Last 90 days - 11 hours Last 28 days - 0 hours	
Information Source:	AAIB Field Investigation

Synopsis

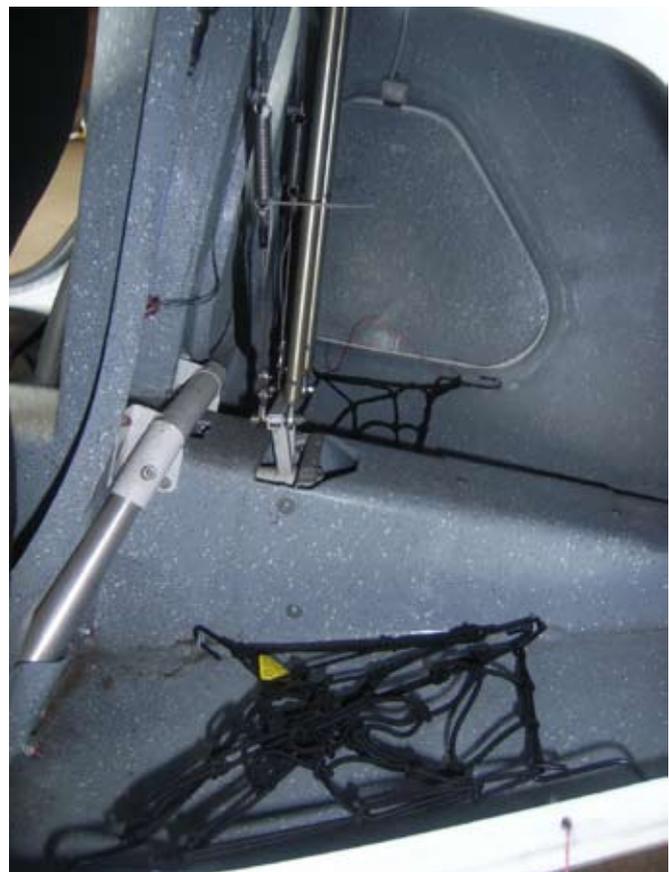
Figure 1

The fuselage is of carbon fibre/foam sandwich monocoque construction, without bulkheads or substantial fuselage frames. The manufacturer's Operator's Manual states that the aircraft has a maximum baggage weight of 25 kg, to be stowed in the rear fuselage immediately behind the rear cockpit bulkhead. Access is provided by a removable panel on either side of the fuselage immediately behind each cockpit door; the seatbacks can also be pulled forward to stow larger items. Any baggage is secured under two bungee nets (Figure 1).

G-CFAZ baggage restraint

The 'open monocoque' structural design of the rear fuselage in this aircraft would allow an unsecured item a significant range of movement, possibly to restrict aileron or elevator movement. While bungee nets may provide sufficient restraint of larger item they will not provide the same level of retention to thin objects. The following Safety Recommendation is made:

It is recommended that P&M Aviation/Flight Design review the design of the current baggage restraints in the CTSW design, to ensure that it provides effective restraint of all stowed baggage.

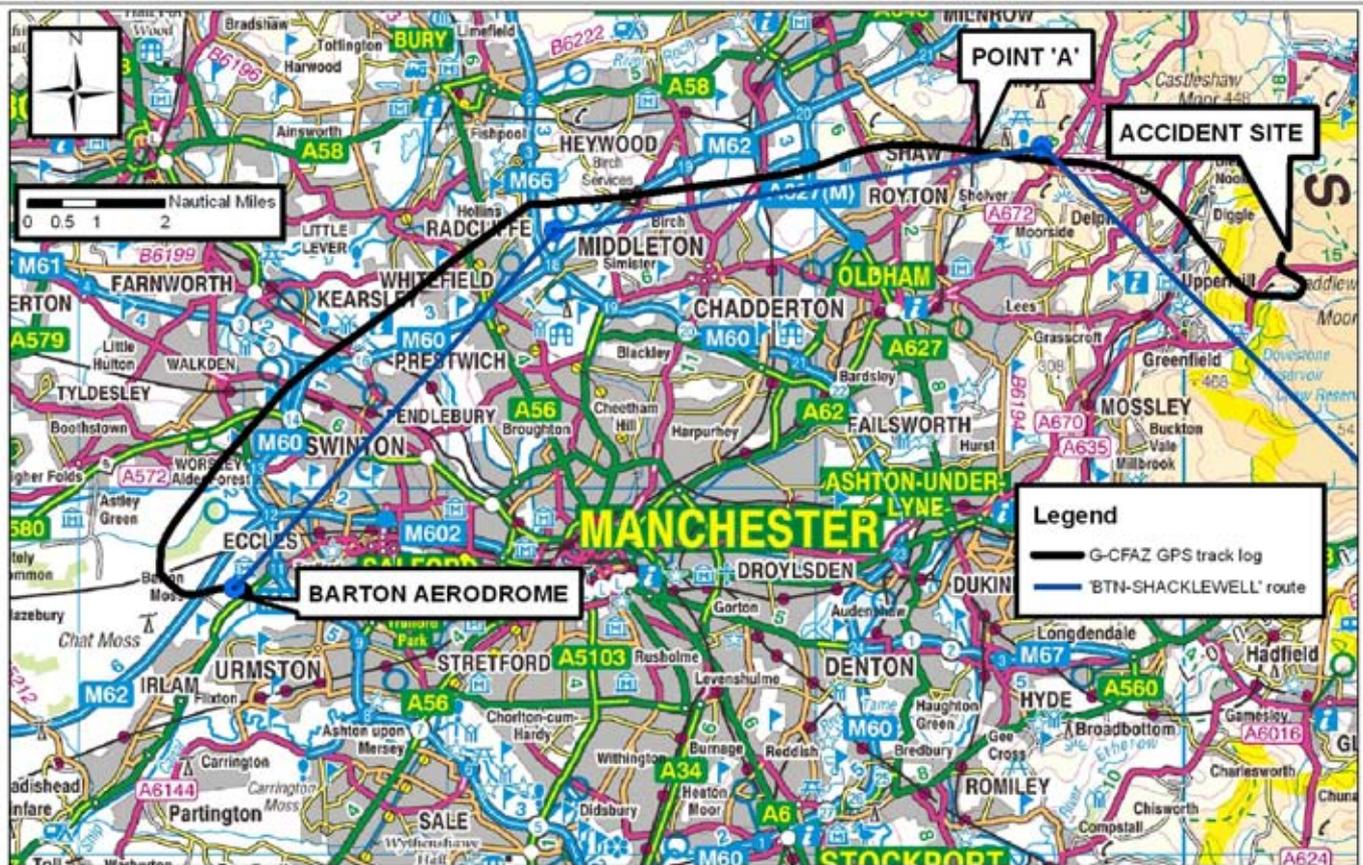
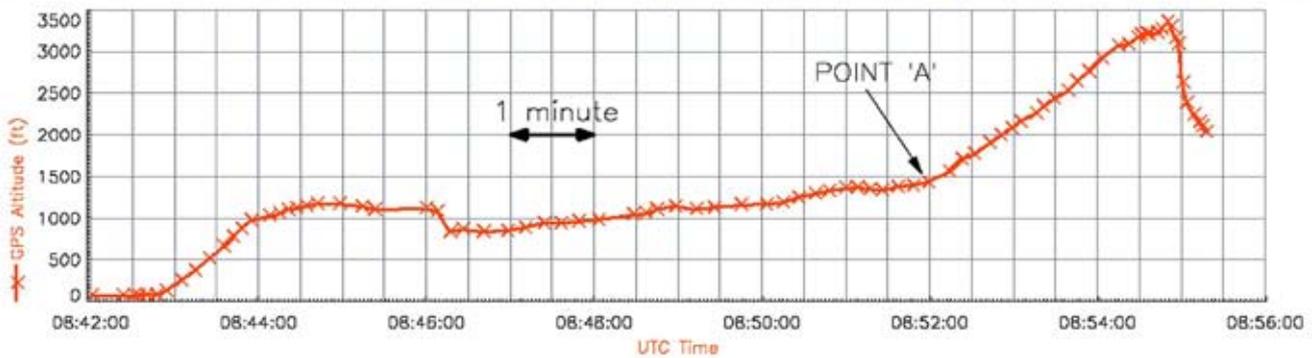
Figure 2

After takeoff, the aircraft climbed to a GPS altitude of around 1,000 ft, turned to the right onto a true heading of approximately 050° and began tracking around the north of Manchester (Figure 2, with expanded final section in Figure 3). Groundspeed, derived from rate of change of position increased to around 110 kt.

'BTN-SHACKLEWELL' route, G-CFAZ began to climb from a GPS altitude of approximately 1,500 ft (Point 'A', Figure 2). This climb continued with the aircraft initially tracking approximately parallel to the 'BTN-SHACKLEWELL' route before deviating to the left, ultimately achieving a maximum GPS altitude of 3,366 ft at 08:54:50 hrs (Point 'B', Figure 3).

G-CFAZ GPS data – accident flight

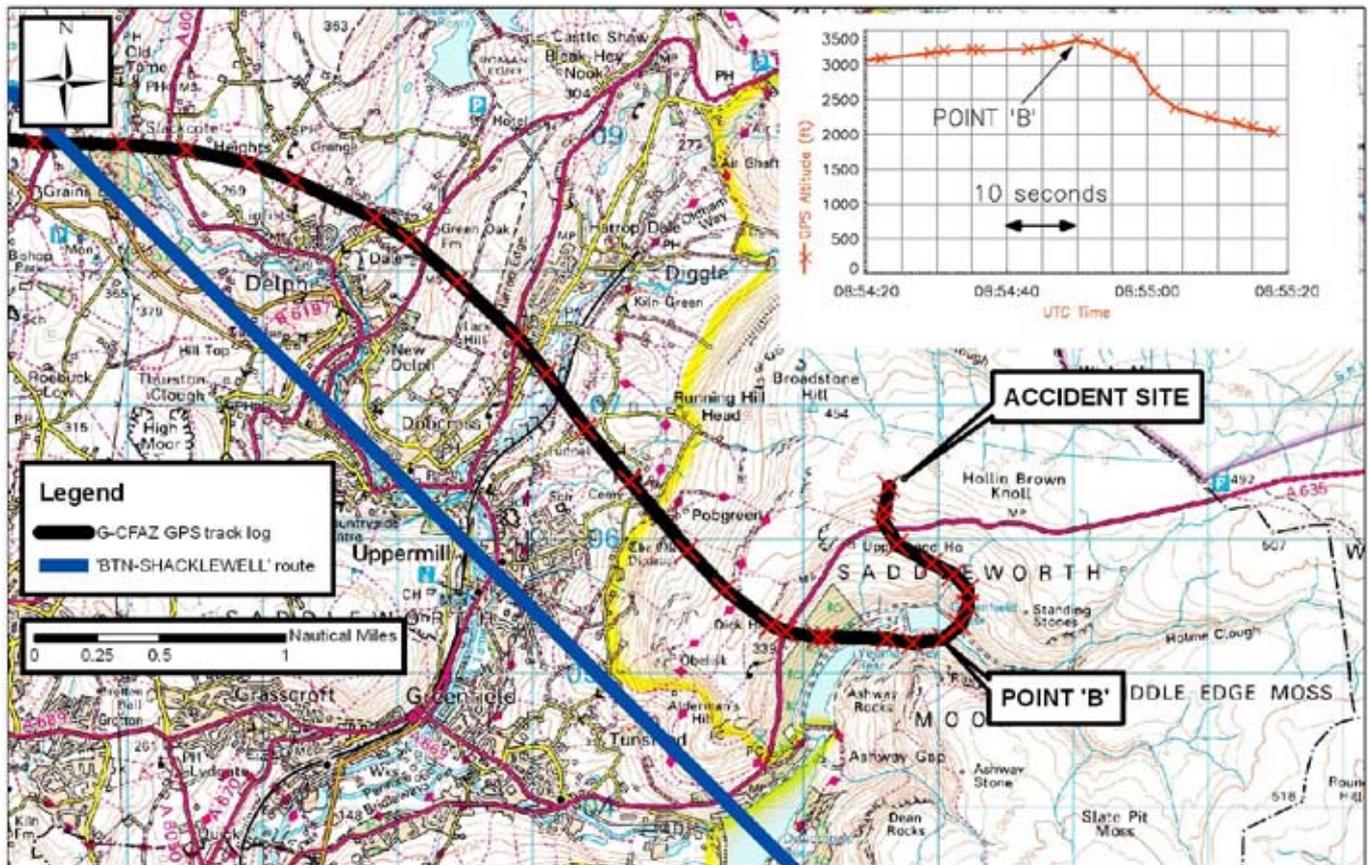
Figure 3

After achieving the maximum GPS altitude, the recorded positions indicate a turn to the left followed by a descent. The derived average rate of descent between the maximum GPS altitude and the final recorded position was 2,800 ft/min. The final recorded GPS position was at 08:55:18 hrs at a GPS altitude of 2,043 ft and heading of 013°T. This position was a distance along the ground of 129 m from the initial ground impact mark. Terrain elevation of the initial impact was estimated at 1,541 ft, around 500 ft below the last recorded GPS altitude

G-CFAZ GPS data – accident flight approaching Saddleworth Moor
