**INCIDENT**

<b>Aircraft Type and Registration:</b>	Airbus A330-323X, N270AY
<b>No &amp; Type of Engines:</b>	2 Pratt & Whitney PW4000 SER turbofan engines
<b>Year of Manufacture:</b>	2000
<b>Date &amp; Time (UTC):</b>	29 May 2008 at 1025 hrs
<b>Location:</b>	Manchester Airport
<b>Type of Flight:</b>	Commercial Air Transport (Passenger)
<b>Persons on Board:</b>	Crew - 12                      Passengers - 250
<b>Injuries:</b>	Crew - None                      Passengers - None
<b>Nature of Damage:</b>	Damage to main landing gear and brake pack; debris recovered from runway
<b>Commander's Licence:</b>	Airline Transport Pilot's Licence
<b>Commander's Age:</b>	60 years
<b>Commander's Flying Experience:</b>	14,650 hours (of which 2,390 were on type) Last 90 days - 58 hours Last 28 days - 26 hours
<b>Information Source:</b>	AAIB Field Investigation

**Synopsis**

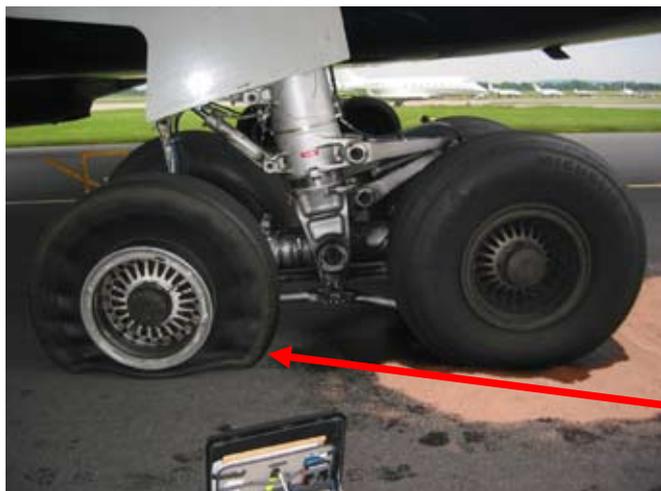
Deflated No 1 tyre

The No 1 tyre (ie the one ahead of the No 5 wheel) had deflated following the RTO as a result of the heat generated during the heavy braking, thereby causing the activation of the fusible plug in the wheel. It was subsequently noted that the No 6 tyre was showing only 65 psi, as opposed to the normal pressure of around 215 psi. It was found that the core within the fusible plug had melted but had resolidified before the tyre had become completely deflated. Otherwise, none of the tyres displayed any evidence of damage, such as skid-induced flats or cuts, that could have been attributable to the incident.

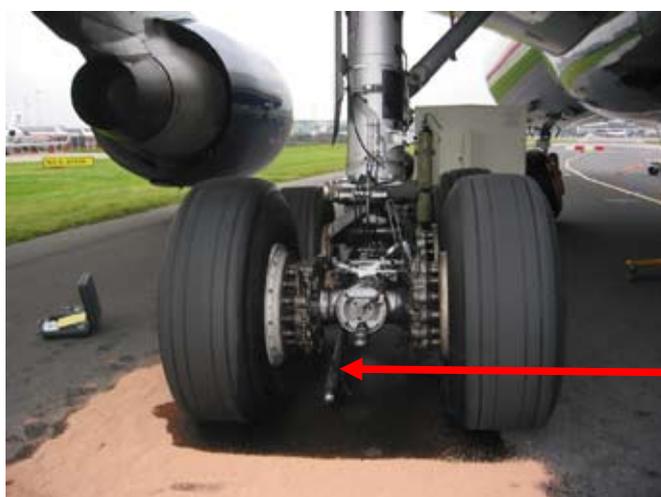
Disconnected brake reaction rod

Upon examination it was immediately apparent that the brake unit on the No 5 wheel (ie rear left wheel on the left landing gear bogie) had become disconnected from its associated brake reaction rod as a result of the failure of the attaching torque pin. As a result, the brake unit had been free to rotate with the wheel, causing the consequent failures of the hydraulic hoses and electrical harness that were attached to it; these failures were responsible for generating the PFR and Maintenance Reports. The tension in the hoses had in turn caused the failure of a bracket/cable guide assembly that was mounted on the bogie beam. It was clear that

It was found that the lanyard linking the two rear brake reaction rods (ie on wheel Nos 5 and 6) had broken, which had allowed the No 5 brake rod aft end to trail on the ground. A flat area had been ground away on the rod end as a result of contact with the runway/taxiway. It was unclear how the brake rod had been able to move the necessary distance to generate a significant tension in the lanyard, since upward and outboard movement is constrained by the close proximities of the axle housing and brake housing respectively. The only other visible damage to the brake rod was the inboard half-bushing at the aft end was missing; this was among the items recovered from the runway. The bushing and brake rod were subsequently returned to the landing gear manufacturer for additional investigation.

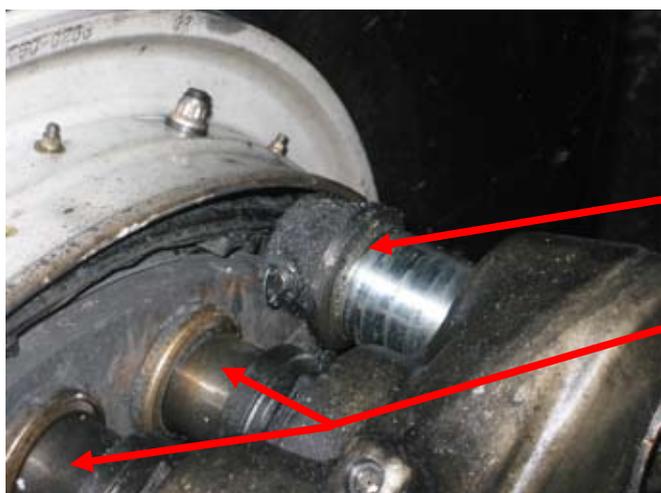
**Figure 2**  
Views of the left landing gear. Note hydraulic fluid spillage

Torque pin migrated into wheel rim following flange failure

The brake rod attachment pin had migrated in an outboard direction within the brake housing to the extent that the end of the pin had been in contact with the wheel rim as it rotated; some swarf had been generated as a result. The pin had been able to move axially in the bore in the brake housing due to the fracture of the flange at the head end. The pin was removed by driving it out of the housing, following which it was subjected to specialist metallurgical examination.

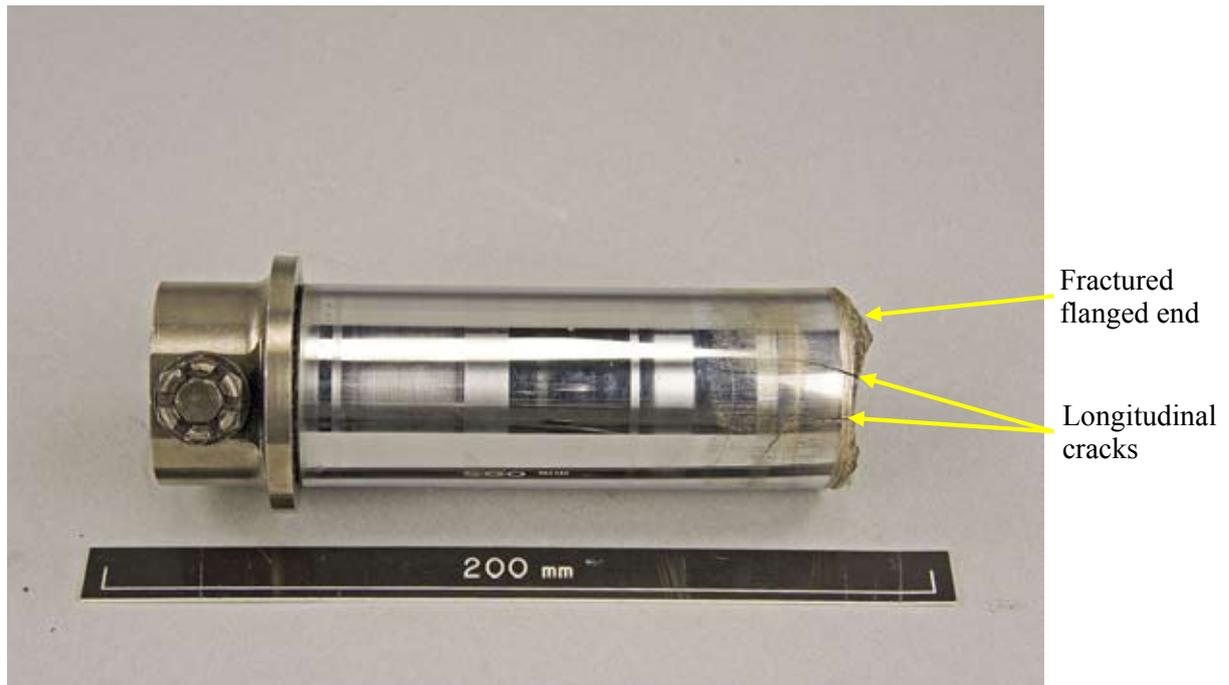
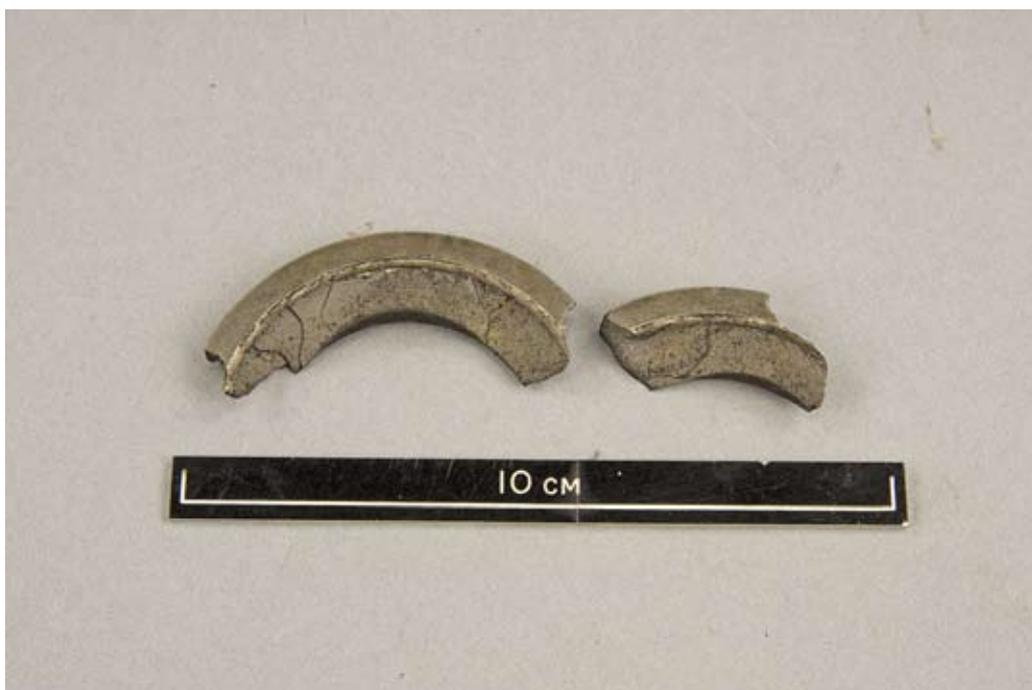
**Figure 4**

The runway debris included fragments of the flange, from the head of the pin, amounting to about 50% of the circumference. The remainder was not recovered. Photographs of the pin and flange fragments in their 'as received' condition are shown at Figure 4.

No 5 torque pin together with flange fragments that were found on the runway

bulletins VSB 2-1577-32-7, issued in August 2004 and VSB 2-1577-32-8, issued in May 2005. However the metallurgical examination revealed no evidence of material or manufacturing defects, so the flange failure was due entirely to overload. However, part of the fracture face on the pin was found to be corroded (Figure 5), leading to the conclusion that the associated part of the flange had failed at an earlier date. Although it was not possible to estimate when this was likely to have occurred, it was noted that there had been minimal accumulation, on the fracture face, of the brake dust that had liberally coated adjacent components, suggesting a relatively recent event. Significantly, none of the recovered pieces of the flange were from the corroded area of the pin. This in turn suggested that the pin flange had failed in overload during the RTO, having been weakened in a previous event in which part of the flange had become detached. There was no evidence to indicate the nature of any previous event, although

Two axial cracks were evident in the pin at the fracture end and it was additionally noted that the pin was bent. It was considered that the pin was subjected to a bending action during the process of the flange failure, with the axial cracks opening up as a consequence of a crushing force applied across the diameter, imposed by the bores of the brake rod and/or housing.

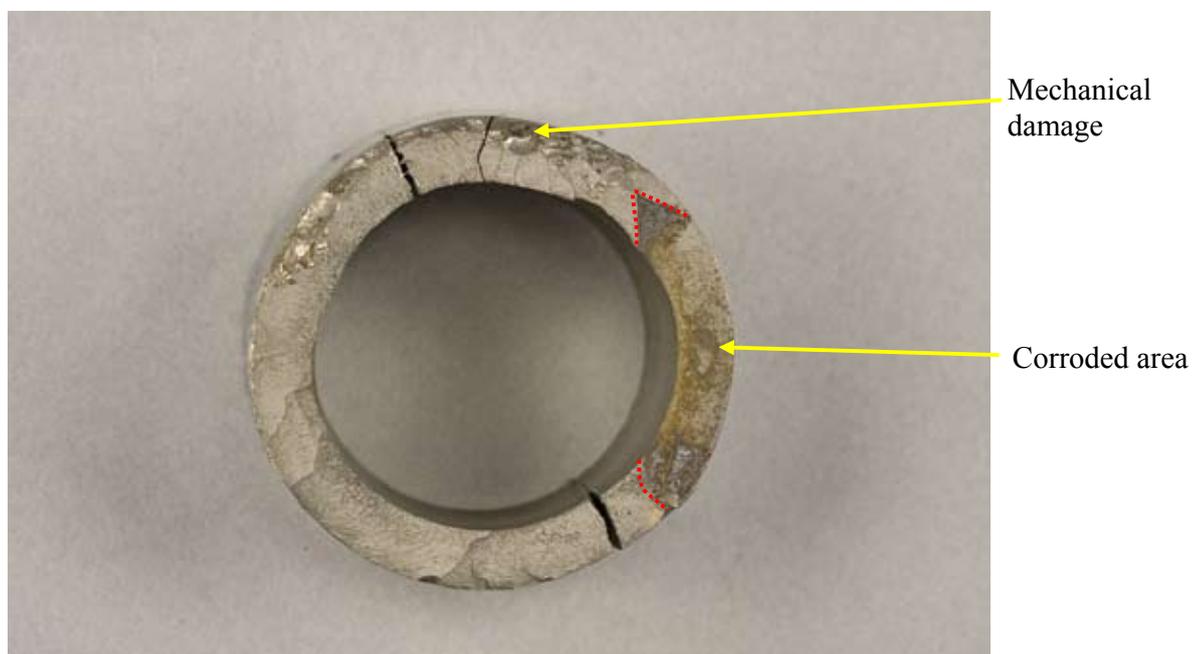
**Figure 5**

View of torque pin fracture face

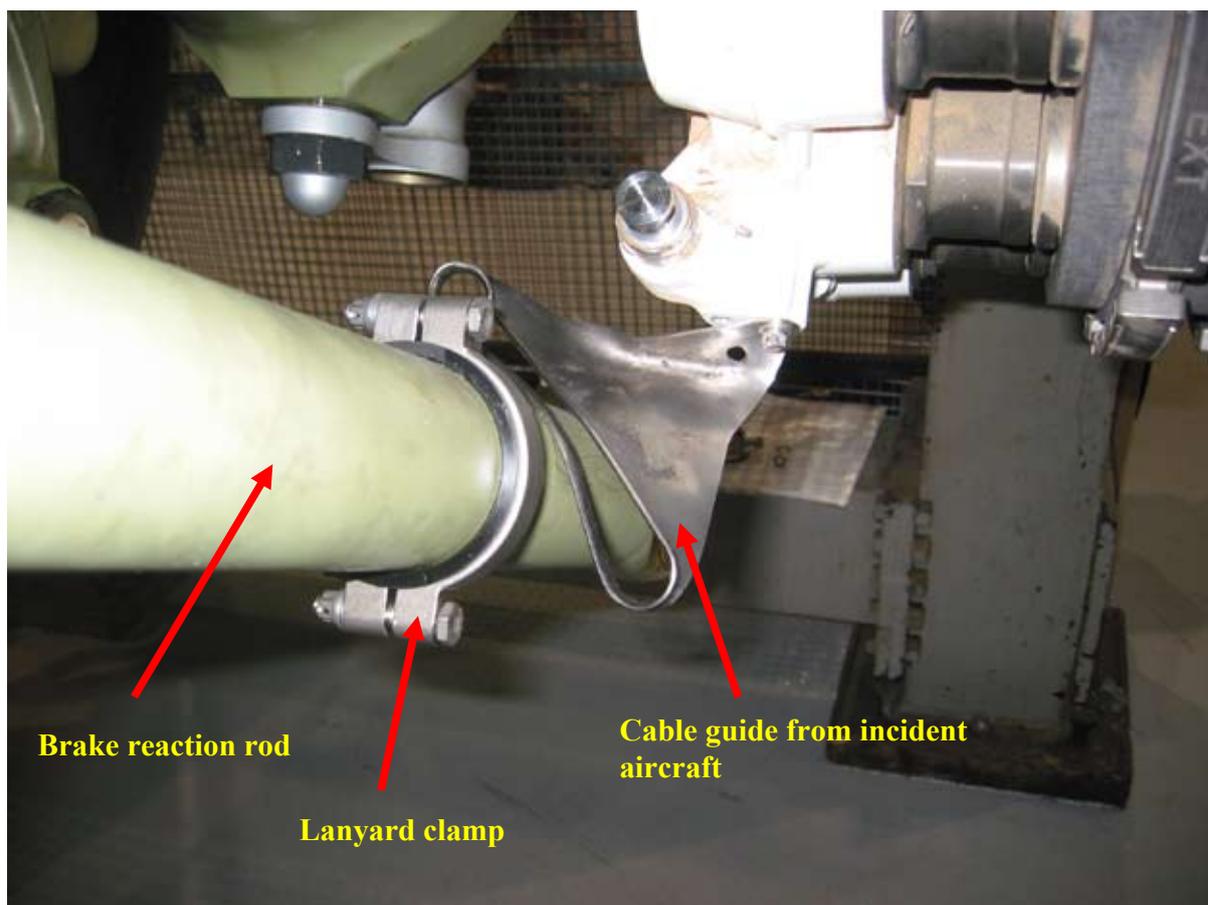
**Figure 6**

View of test showing how cable guide on brake housing may have contacted the brake reaction rod

was also noted that the downward component of the force on the rod, generated during the process of distorting the guide, imparted a tension in the lanyard, thus providing a potential mechanism for failing the lanyard cable.
