No: 8/91

Ref: EW/G91/03/07

Aircraft Type and Registration: Rockwell Aero Commander 114, N5834N

Location: Cardiff Airport, Wales

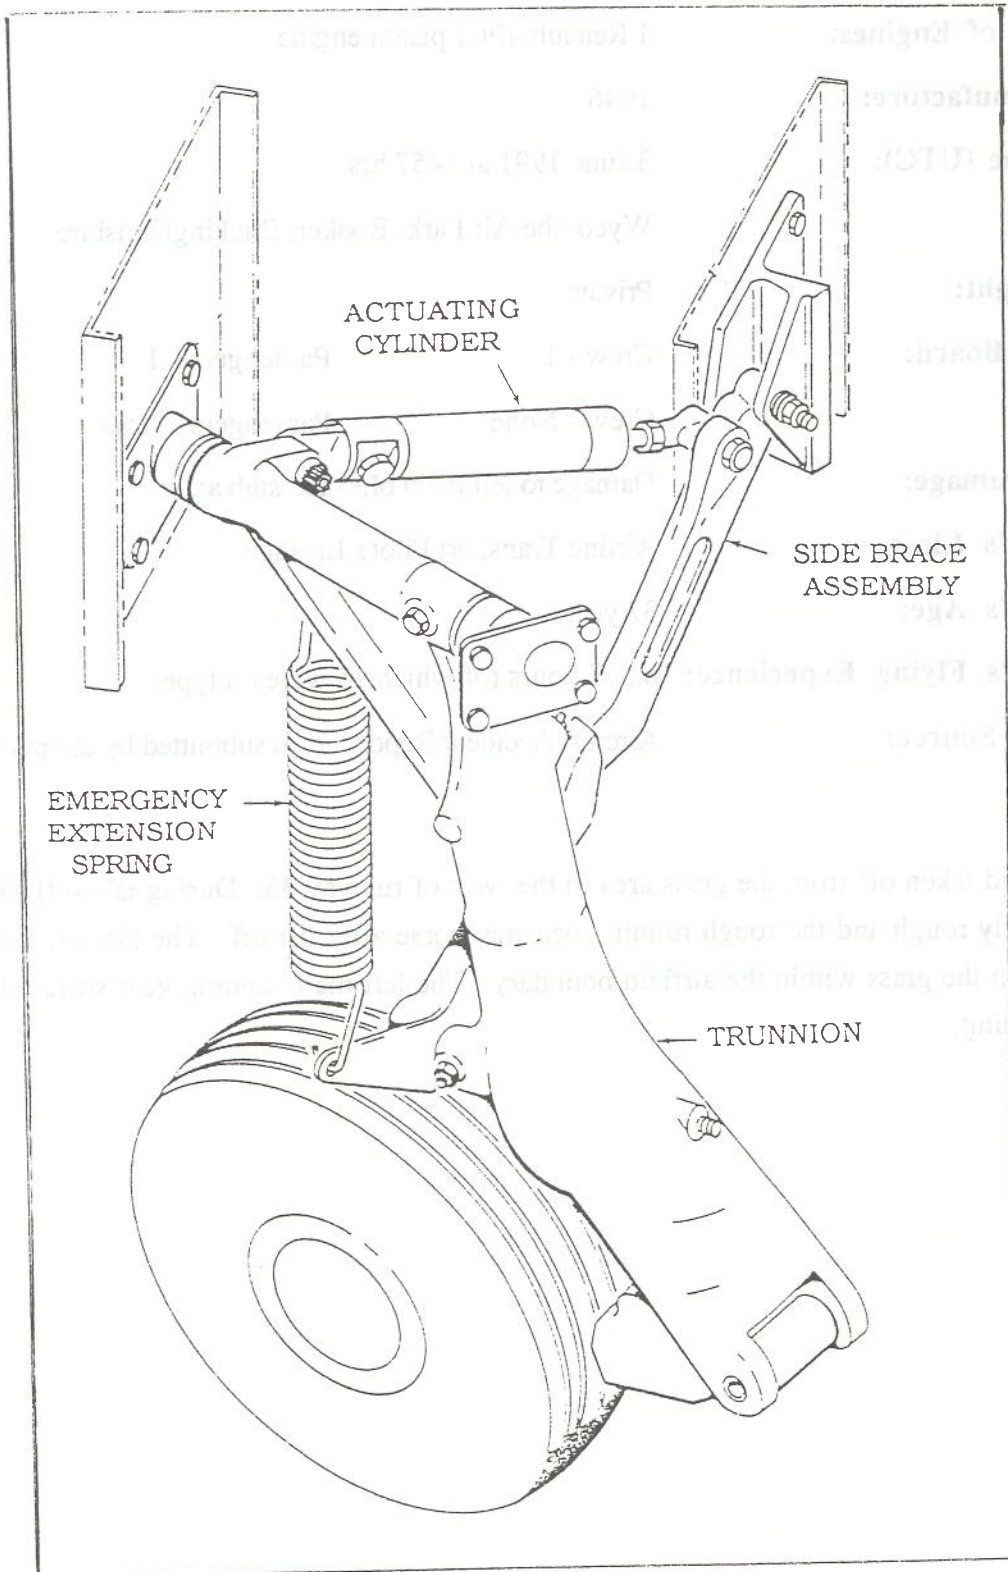
ROCKWELL AERO COMMANDER 114
RIGHT MAIN GEAR LEG

The main gear is illustrated in the attached figure. There is no mechanical uplock; the leg is held in the up position by an hydraulic fluid lock in the cylinder, caused by a check valve closing when the retraction process is complete. During gear extension the cylinder retracts pulling the leg down. Emergency lowering of the gear is effected by release of the hydraulic lock through a venting valve. A large spring is intended to assist the side brace assembly to achieve its over-centred locking condition.

The outboard eye-end of the right main gear actuating cylinder had failed in tensile overload leaving its spherical bearing attached on its pivot bolt on the main gear trunnion. The cylinder is under tensile load when it retracts to lower the mainleg and so the failure would appear to have occurred when the gear was first selected down during the accident flight. From photographs it appears that the cylinder was almost fully extended as found and so the failure must have occurred at the start of the extension sequence. It was found that all the rod ends and pivot points in the leg assembly and its door links and hinges were severely corroded to the point that they were stiff to operate or seized. The trunnion pivots themselves were also stiff to rotate. It would appear that once the actuating cylinder had broken under its own applied load the leg, which presumably had moved by at least a small amount, continued to descend under its own weight, perhaps helped by the aircraft manoeuvres, but failed to achieve the locked condition because of friction in the pivots.
