INCIDENT

Aircraft Type and Registration:	Ikarus C42 FB UK, G-ILRS	
No & Type of Engines:	1 Rotax 912 ULS piston engine	
Year of Manufacture:	2002	
Date & Time (UTC):	5 October 2013 at 1115 hrs	
Location:	East Fortune Airfield, East Lothian	
Type of Flight:	Private	
Persons on Board:	Crew - 1	Passengers - 1
Injuries:	Crew - None	Passengers - None
Nature of Damage:	Damage to left and right wing, and right flap	
Commander's Licence:	National Private Pilot's Licence	
Commander's Age:	61 years	
Commander's Flying Experience:	65 hours (of which 25 were on type) Last 90 days - 8 hours Last 28 days - 0.5 hour	
Information Source:	Aircraft Accident Report Form submitted by the pilot

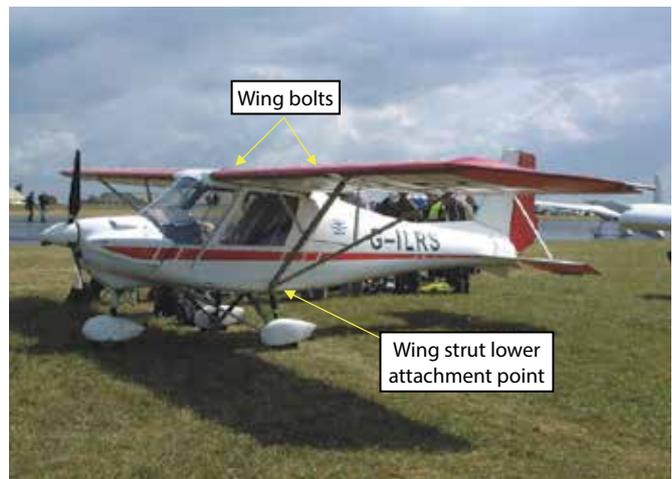
Figure 1

The cause of the wing rotating upwards was the incorrect fitting of the wing strut lower attachment bolt (Figure 1), which had only passed through the fuselage mounting bracket and not through the strut.
