**AAIB Bulletin No: 3/96**

**Ref: EW/C95/7/6**

<b>Aircraft Type and Registration:</b>	Redfern Replica Fokker DR1, G-BEFR	
<b>No &amp; Type of Engines:</b>	1 Lycoming O-360-A4A piston engine	
<b>Year of Manufacture:</b>	1976	
<b>Date &amp; Time (UTC):</b>	20 July 1995 at 1901 hrs	
<b>Location:</b>	Stourhead Gardens, Mere, Wiltshire	
<b>Type of Flight:</b>	Aerial Work (Flying Display)	
<b>Persons on Board:</b>	Crew - 1	Passengers - None
<b>Injuries:</b>	Crew - Fatal	Passengers - N/A
<b>Nature of Damage:</b>	Aircraft Destroyed	
<b>Commander's Licence:</b>	Basic Commercial Pilot's Licence	
<b>Commander's Age:</b>	50 years	
<b>Commander's Flying Experience:</b>	1,776 hours (of which 464 were on type) Last 90 days - 68 hours Last 28 days - 29 hours	
<b>Information Source:</b>	AAIB Field Investigation

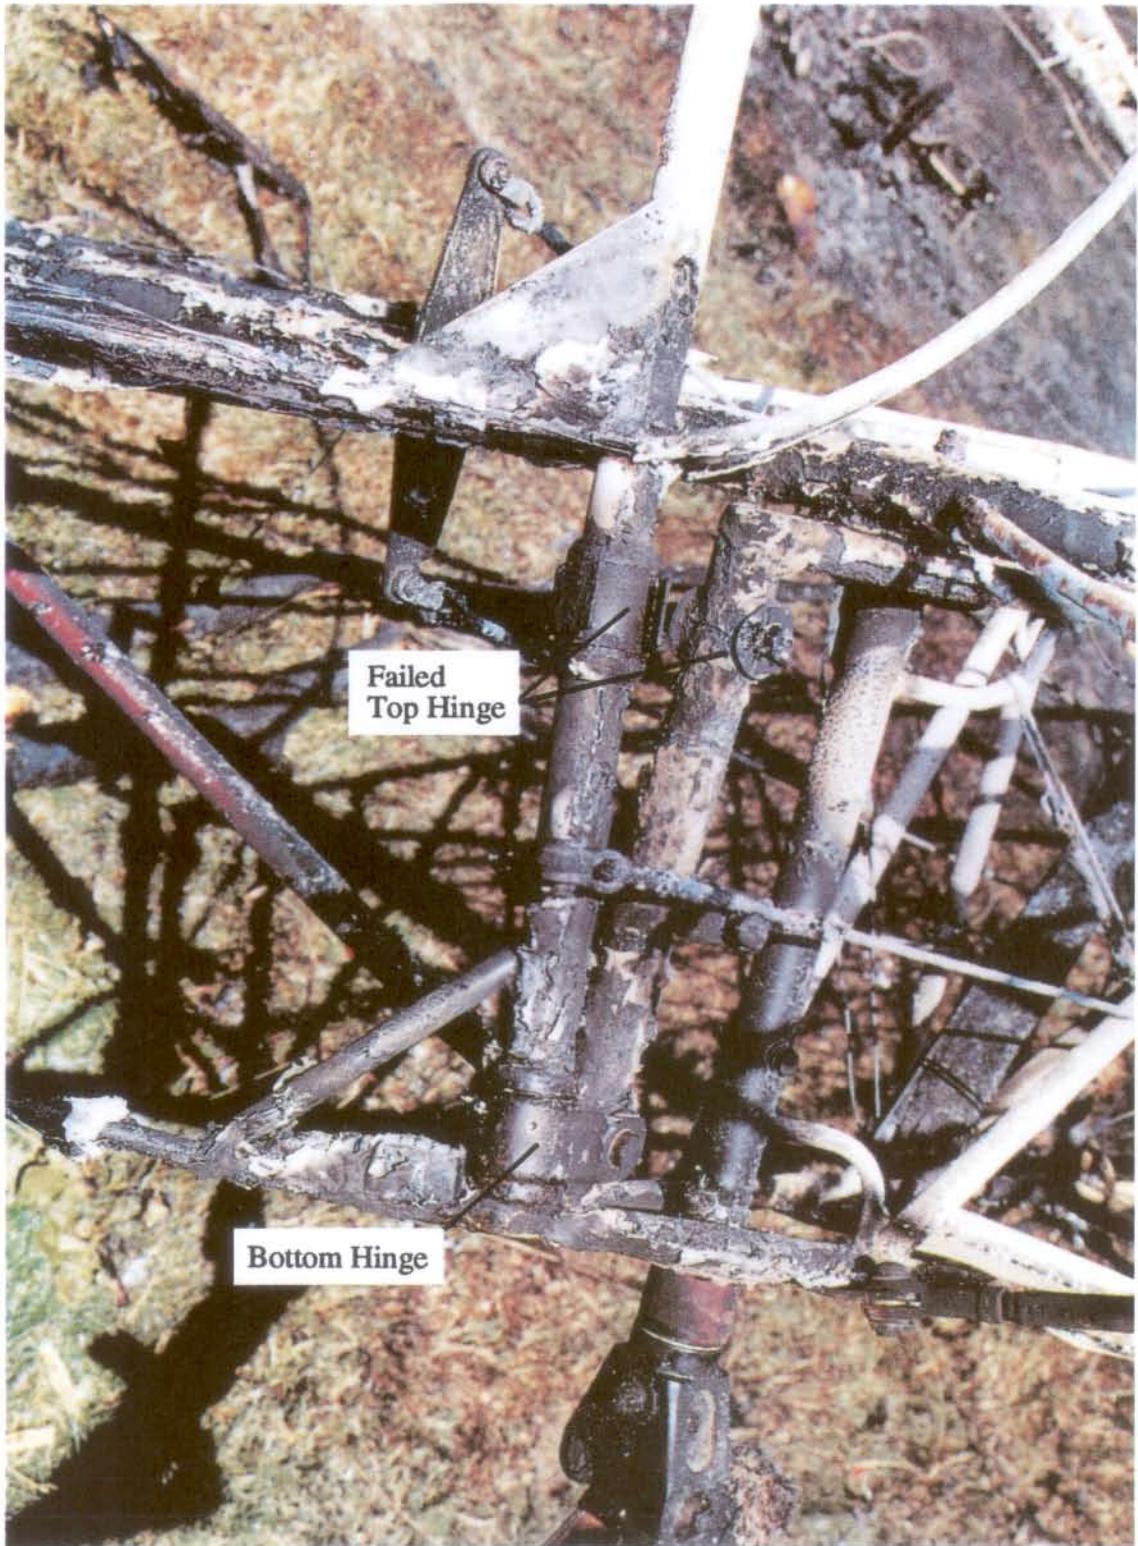
**Figure 1 - G-BEFR Rudder Hinges**

The second failure was in the top rudder hinge (Figure 1). The rudder was supported on two hinges each of which was attached to the fuselage by a steel strap. Each steel strap was wrapped around a hinge bearing on the rudder vertical spar and welded to its outer race. The ends of the straps were attached to the sternpost of the fuselage frame by through bolts. Both sides of the strap on the top hinge had fractured. Each fracture path passed through the bolt hole, aft of its centre. The strap and the surfaces of the two fractures were covered by soot and burned paint or fabric. The hinge had failed in a fashion consistent with the ground impact but metallurgical examination showed that both sides of the strap had suffered fatigue cracking.

The fatigue had developed as a result of reverse bending loads, the result of repeated side loads on the rudder in flight. The extent of the pre-existing cracking through both sides of the strap was such that the strap was virtually severed by the fatigue. This makes it likely that the hinge had become detached in the air before the aircraft hit the ground. The right side strap had also cracked further aft, where it was welded to the bearing's outer race, but it had not separated at that location.

The metallurgical examination revealed that there were two material defects which would have lowered the strap's resistance to the development of fatigue cracks. There was a reduction of the carbon content of the steel in the strap's surface layers and there was some microscopic oxidisation pitting of the surface (from which fatigue cracks had initiated). Both effects could have occurred if the strap had been heated when it was being formed into shape to fit around the hinge. However, the decarburization of the surface could also have been the result of the manufacturing process for the steel sheet from which the strap was made. There was also some corrosion pitting which was the result of slight deterioration with time.

Such a failure of the rudder hinge did not appear to explain fully the eye-witness reports which described the aircraft pitching downwards at the start of the accident sequence with no sign of any yaw. It did not appear likely, because of the amount of clearance available, that the rudder would have fouled the elevator when the top hinge broke. There was no other structural or control failure which could have caused such a pitching manoeuvre.
