ACCIDENT

Aircraft Type and Registration:	DG-800B, G-MSIX	
No & Type of Engines:	1 Solo Kleinmotoren GmbH 2-625-01 piston engine	
Category:	1.3	
Year of Manufacture:	1999	
Date & Time (UTC):	23 June 2005 at 1530 hrs	
Location:	Near to West Trading Estate, south of Gloucester, Gloucestershire	
Type of Flight:	Private	
Persons on Board:	Crew - 1	Passengers - None
Injuries:	Crew - None	Passengers - N/A
Nature of Damage:	Landing gear collapsed and lower fuselage damaged	
Commander's Licence:	Private Pilot's Licence	
Commander's Age:	74 years	
Commander's Flying Experience:	2,506 hours (of which 202 were on type) Last 90 days - 36 hours Last 28 days - 22 hours	
Information Source:	Aircraft Accident Report Form submitted by the pilot and subsequent enquiries by the AAIB

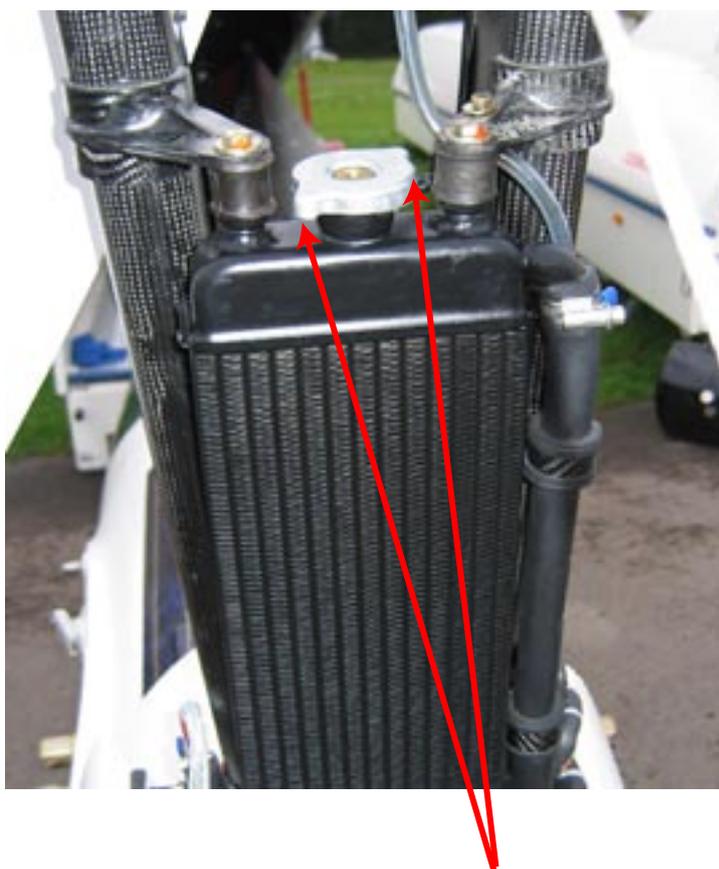
Figure 1

After the accident, the pilot noted that there were severe ruts throughout the field, and the landing gear had collapsed where the aircraft ran over one rut. He found that the engine had seized, and concluded that this had been caused by loss of coolant, although the coolant level had been normal when last inspected, two days prior to the accident flight. Inspection of the engine after the accident identified that there was significantly more

than normal white staining around the radiator filler, consistent with a coolant loss in flight. A maintenance engineer, familiar with the engine, offered the opinion that the position of the radiator within the mast made positioning the cap onto the filler somewhat awkward, and that it was possible to replace the cap incorrectly, allowing coolant to escape under pressure.

Note: Lugs of cap only just pass upper radiator mounts.
Cap shown in fully closed position.

Installation of radiator on mast
