Aircraft type and registration: Boeing 747-136 G-AWNG

Date and time (GMT): 21 April 1987 at 1027 hrs

Location: 1 nm west of London Heathrow Airport

EXAMINATION OF NO 2 ENGINE

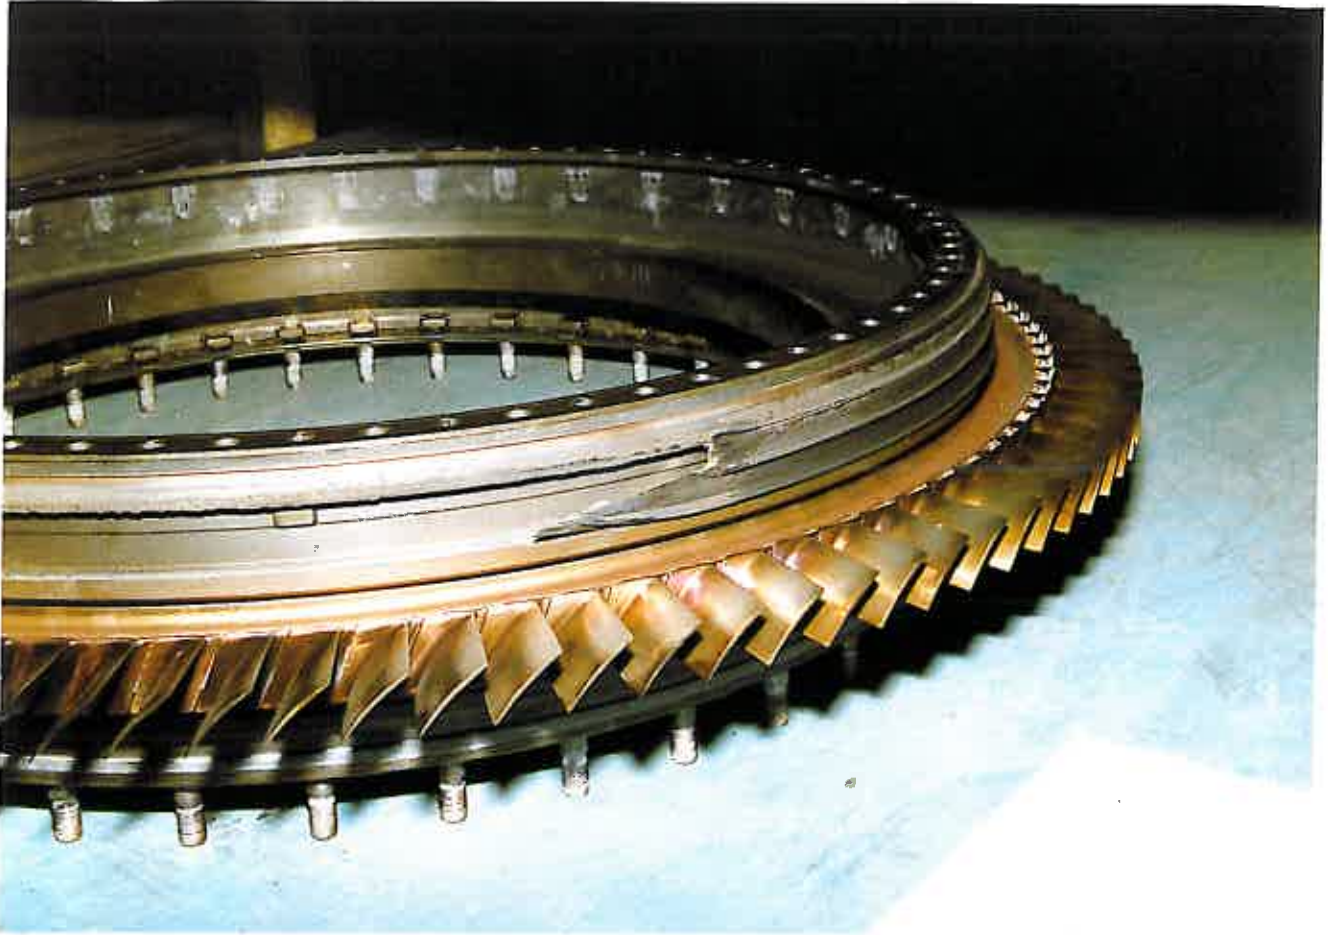
Despite the considerable fire damage and after extensive component replacement and repair, the engine was run for a short time on a test bed. Severe vibration levels were recorded during this run, evidently associated with High pressure (N₂) rotor speed. The modules were then separated and tested individually, during which the HP compressor module was found to have an apparent imbalance of about 140 ounce-inches.

Upon disassembly of this module it was found that the 13th stage stator rotating air seal, P/No 787428 had a considerable amount of material missing from its circumference over an arc of about 90°. See attached photograph. The material had evidently been abraded away and there was severe wear on the mating static air seal. Although the amount of material lost due to abrasion seemed to preclude any meaningful metallurgical examination of the seal ring, the observed damage would appear to be consistent with some form of partial failure of the ring. High centrifugal forces would tend to force a free end of the ring against the static seal, causing progressive wear and overheating such as that observed. This would also be consistent with the apparently increasing magnitude of the vibration, since the out-of-balance moment would increase as the material was lost. The final amount of metal lost from the ring was 13.8 ounces, equating to a moment of about 162 ounce-inches.

The engine manufacturer reports several cases of severe abnormal wear occurring on the 13th stage stator air seal which had been discovered after test running newly overhauled HP compressor modules. A problem with maintaining seal clearances has been cited as a possible cause. The affected parts from G-AWNG's No 2 engine have been despatched to the manufacturer for further investigation.

G-AWNG No engine — view of 14th stage rotor disc with 13th stage stator rotating air seal showing material lost due to abrasion against static seal
