**ACCIDENT**

<b>Aircraft Type and Registration:</b>	Pegasus Quasar TC, G-MWSH	
<b>No &amp; Type of Engines:</b>	1 Rotax 503-2V piston engine	
<b>Year of Manufacture:</b>	1991	
<b>Date &amp; Time (UTC):</b>	6 April 2007 at 1710 hrs	
<b>Location:</b>	Shifnal microlight site, near Telford, Shropshire	
<b>Type of Flight:</b>	Private	
<b>Persons on Board:</b>	Crew - 1	Passengers - None
<b>Injuries:</b>	Crew - 1 (Fatal)	Passengers - N/A
<b>Nature of Damage:</b>	Substantial	
<b>Commander's Licence:</b>	Private Pilot's Licence (Microlight)	
<b>Commander's Age:</b>	58 years	
<b>Commander's Flying Experience:</b>	315 hours (of which 1 hour was on type) Last 90 days - 8 hours Last 28 days - 3 hours	
<b>Information Source:</b>	AAIB Field Investigation

**Synopsis**

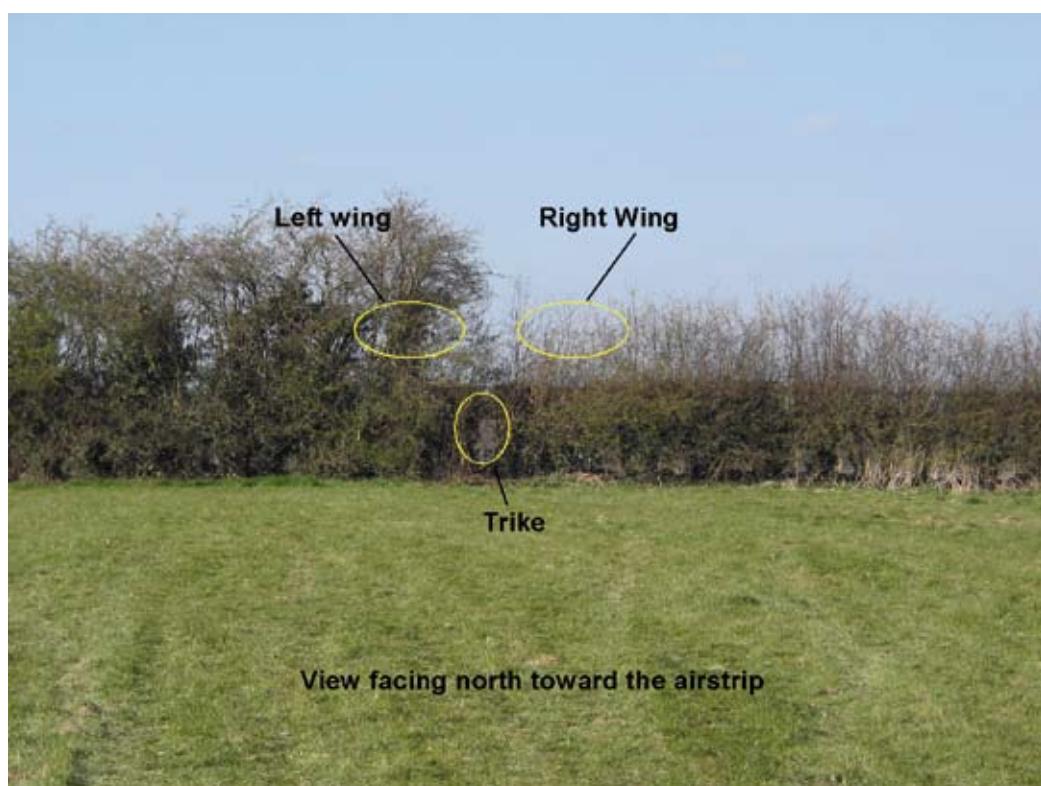
The aircraft had struck a hawthorn hedge and trees located 65 m from the threshold of Runway 36. The hedge, which ran perpendicular to the runway, varied in height along its length. Embedded within the hedge, mainly to the west of the approach path, were several trees that exceeded the height of the hedge (see Figure 1). The lack of any ground marks prior to the hedge indicated that the aircraft had not contacted the ground before striking it.

**Figure 1**  
Hedge and tree damage after the recovery of the aircraft

Damage to the hedge and trees were consistent with the aircraft impacting it in a wings level attitude with the trike about 1 m above the ground. It was not possible to establish the exact pitch attitude at impact.

The leading edge of the left wing had initially struck a tree that had grown to a height above the hedge; the right wing did not strike anything significant except for small branches extending upwards from the hedge. The trike had continued to move forward and into the hedge, under its own engine power. The tree had restricted the wing from moving further forward, causing the trike to rotate about the hang point, before pulling forward against the wing structure, fracturing the wing keel in two places. Additionally, as the A-frame was still attached to the wing, as the trike moved forward in relation to the wing, the pilot became trapped between the lower bar of the A-frame and the trike's seat back. When the trike's rear wheels came into contact with the hedge the trike was brought to a halt.

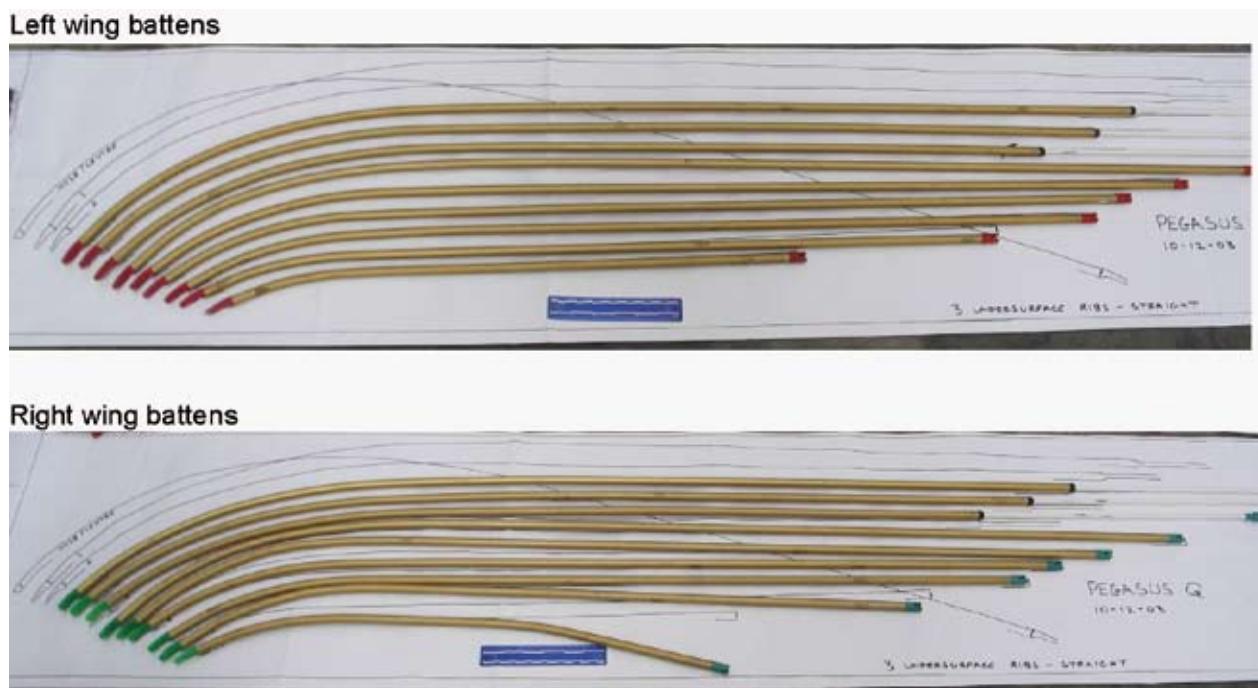
A check of the batten profiles for the wings revealed that the correct battens had been used during the rigging of the wing. However, a comparison of the batten profile against the profile drawings supplied by the aircraft manufacturer revealed that although the left wing battens matched the profile drawing, the right wing battens were significantly different. The outer batten, number 11, had been damaged during the attempts to recover the pilot, however batten numbers 6,7,8,9 and 10 had significant over-camber when compared to the drawing. Batten number 10 showed the greatest deviation, with an additional 46 mm to the camber, (see Figure 2).

As a result of the discovery of the altered batten profiles on the aircraft, a series of test flights was carried out on a similar aircraft by the manufacturer. The battens were set to the same profile as found on G-MWSH and the handling characteristics were assessed. The flight test showed that the aircraft had a tendency to turn to the left and required 1 to 2 kg of right roll effort on the bar to fly in a constant direction, although the test pilot assessed the effect as 'not severe'. Other flight characteristics were not significantly affected and the test pilot noted that the aircraft would have been acceptable for a Permit to Fly (PTF) revalidation except for the tendency to turn left. The manufacturer also advised that although the bungees should have been secured by a double loop, a

**Figure 2**  
Wing batten profiles as found following the accident flight

The unusual batten profiles, found after the accident, should also not have affected the aircraft's handling such that it was unmanageable by an experienced pilot. The air tests carried out by the manufacturer showed that the aircraft was flyable in the configuration in which it was rigged. However, less than ideal or unusual handling characteristics could have contributed to a difficulty for a pilot who was not in current practice on a flex-wing aircraft.

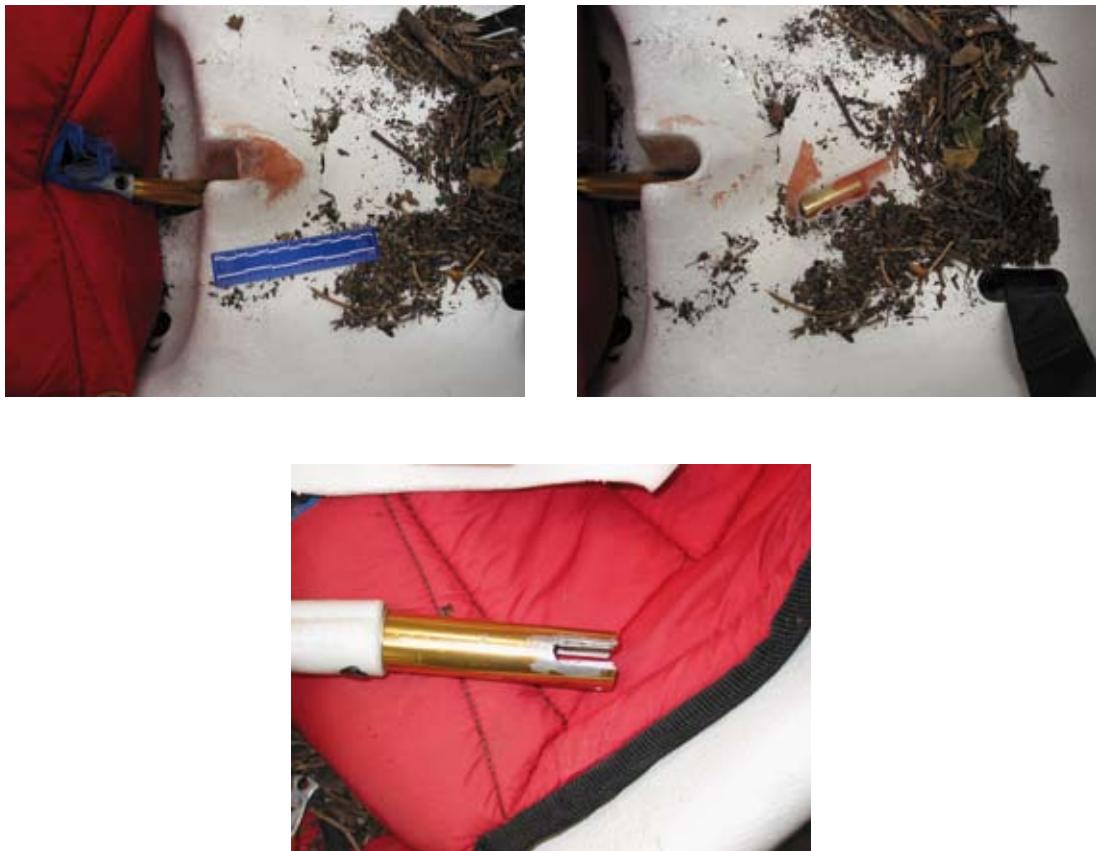
The fatal injuries suffered by the pilot were consistent with crushing between the A-frame and the pilot's seat back. Examination of the seat revealed that repairs and modifications had taken place around the pilot's seat back. The seat back and post had been modified with the addition of an inner sleeve of metal within the seat post. There was also evidence that the seat back had been removed and refitted to the seat post. The fibreglass seat had been subjected to repairs in the past due to cracking. However, additional packing had been added within the recess in which the seat post would sit. The packing consisted of a crushed metal bar secured in place by fibre-glass, using a pink coloured resin, (see Figure 3).

Examination of the seat after accident indicated that bending had occurred to the seat post and that it had

**Figure 3**  
Seat back repair

reacted against the packing in the seat recess. A dent to the plastic outer sheath of the seat post was consistent with a large rearward force being applied. The seat also exhibited cracking to the sides of the seat and behind the recess, again indicative of a large rearward force on the seat post.

There is no requirement for the pilot's seat back to collapse when a rearward force is applied, however had the seat back given way in this accident then the injuries may not have been fatal
