INCIDENT

Aircraft Type and Registration:	Embraer 190-200, G-FBEH	
No & Type of Engines:	2 General Electric CF34-10E7 turbofan engines	
Year of Manufacture:	2007	
Date & Time (UTC):	15 January 2009 at about 0740 hrs	
Location:	Overhead Edinburgh	
Type of Flight:	Commercial Air Transport (Passenger)	
Persons on Board:	Crew - 5	Passengers - 40
Injuries:	Crew - None	Passengers - None
Nature of Damage:	None	
Commander's Licence:	Airline Transport Pilot's Licence	
Commander's Age:	40 years	
Commander's Flying Experience:	6,250 hours (of which approximately 100 were on type) Last 90 days - 137 hours Last 28 days - 33 hours	
Information Source:	AAIB Field Investigation

Synopsis

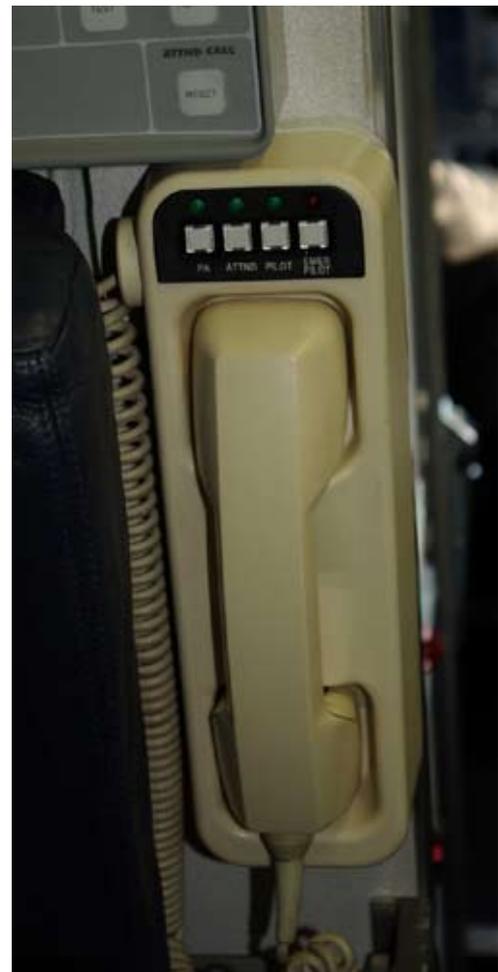
Figure 1
Cabin interphone handset at front galley

The SCCM attempted to call the flight crew on the cabin interphone system, by pressing the PILOT call button. The green light above the button (Figure 1) illuminated, but the flight crew did not answer. Despite repeated attempts, using handsets in both the forward and rear galleys, the SCCM could not establish communication with the pilots in this way.

With emergency power (from the RAT and batteries) applied to the aircraft, the EMER system functions normally. However, if a PILOT call is initiated from either handset in the cabin, the green light above the pushbutton illuminates and a single chime is heard in the flight deck, but the pushbuttons on the pilots' audio panels do not illuminate, and voice communication cannot be established.

The PILOT function of the interphone system seemed, to the cabin crew, to indicate that it was functioning normally. However, the CAB pushbutton in the flight deck did not

The 'false positive' indication of the PILOT call was crucial to the incident; had the PILOT call not appeared to function correctly, it is probable that the cabin crew, instead of contemplating incapacitation of the flight crew or serious emergency on the flight deck, would have attempted to establish communication using the EMER PILOT call.

It is recommended that Embraer (Empresa Brasileira de Aeronautica SA) modify the functioning of the interphone systems of Embraer 190 family aircraft to provide crew with the facility to make both normal and emergency calls when the aircraft is supplied only with emergency electrical power.
