ACCIDENT

Aircraft Type and Registration:	Taylor Titch, G-MISS	
No & Type of Engines:	1 Walter Minor 4-3 piston engine	
Year of Manufacture:	2009	
Date & Time (UTC):	8 November 2009 at 1508 hrs	
Location:	Eldernell Lane, Coates, Whittlesey, Cambridgeshire	
Type of Flight:	Private	
Persons on Board:	Crew - 1	Passengers - None
Injuries:	Crew - 1 (Fatal)	Passengers - N/A
Nature of Damage:	Aircraft destroyed	
Commander's Licence:	National Private Pilots Licence (Aeroplanes)	
Commander's Age:	70	
Commander's Flying Experience:	856 hours (of which 0 were on type) Last 90 days - 14 hours Last 28 days - 4 hours	
Information Source:	AAIB Field Investigation

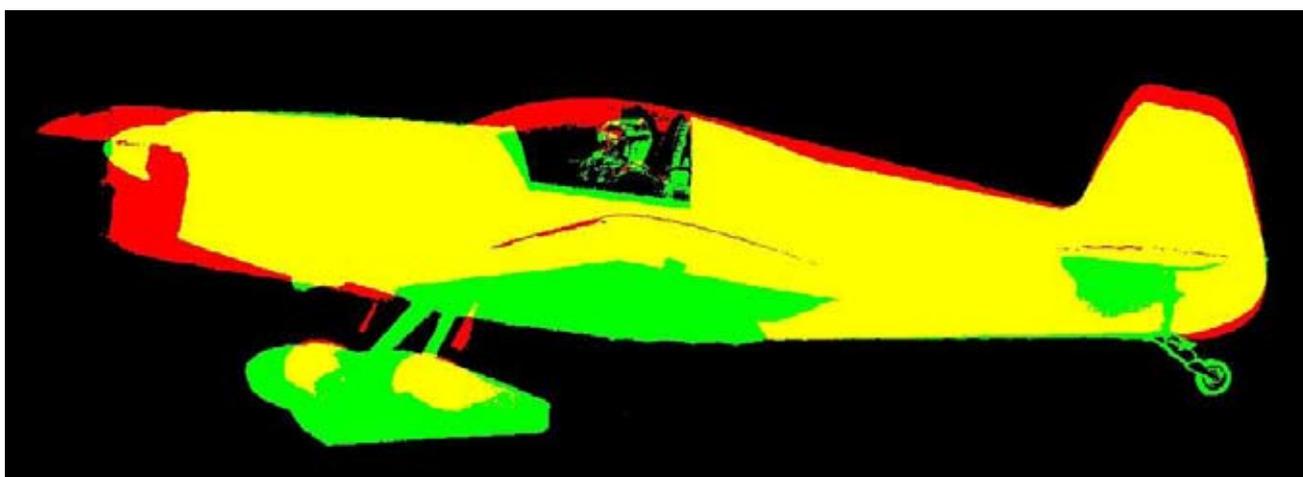
Figure 1

G-MISS was fitted with a Walter Minor engine and had a slightly longer and narrower engine compartment and a larger tail fin to aid its directional stability see Figure 1). This caused an increase in pitch inertia. No spinning trials had been conducted on such a modified Taylor Titch, and neither standard nor modified aircraft of this type were cleared for spinning.

Comparison of the profile of a 'standard' Taylor Titch aircraft (green) with G-MISS (red), overlap region in yellow
