**SERIOUS INCIDENT**

<b>Aircraft Type and Registration:</b>	Boeing 757-236, G-OOOZ	
<b>No &amp; Type of Engines:</b>	2 Rolls-Royce RB211-535E4 turbofan engines	
<b>Year of Manufacture:</b>	1992	
<b>Date:</b>	22 June 2009	
<b>Location:</b>	En-route from Boa Vista, Cape Verde, to Manchester	
<b>Type of Flight:</b>	Commercial Air Transport (Passenger)	
<b>Persons on Board:</b>	Crew - 8	Passengers - 230
<b>Injuries:</b>	Crew - None	Passengers - None
<b>Nature of Damage:</b>	Engine fuel pipe ruptured	
<b>Commander's Licence:</b>	Airline Transport Pilot's Licence	
<b>Commander's Age:</b>	45 years	
<b>Commander's Flying Experience:</b>	12,100 hours (of which 6,580 were on type) Last 90 days - 195 hours Last 28 days - 40 hours	
<b>Information Source:</b>	Field Investigation, delegated by GPIAA, AAIB metallurgical examination of the ruptured pipe and extensive testing by the engine manufacturer

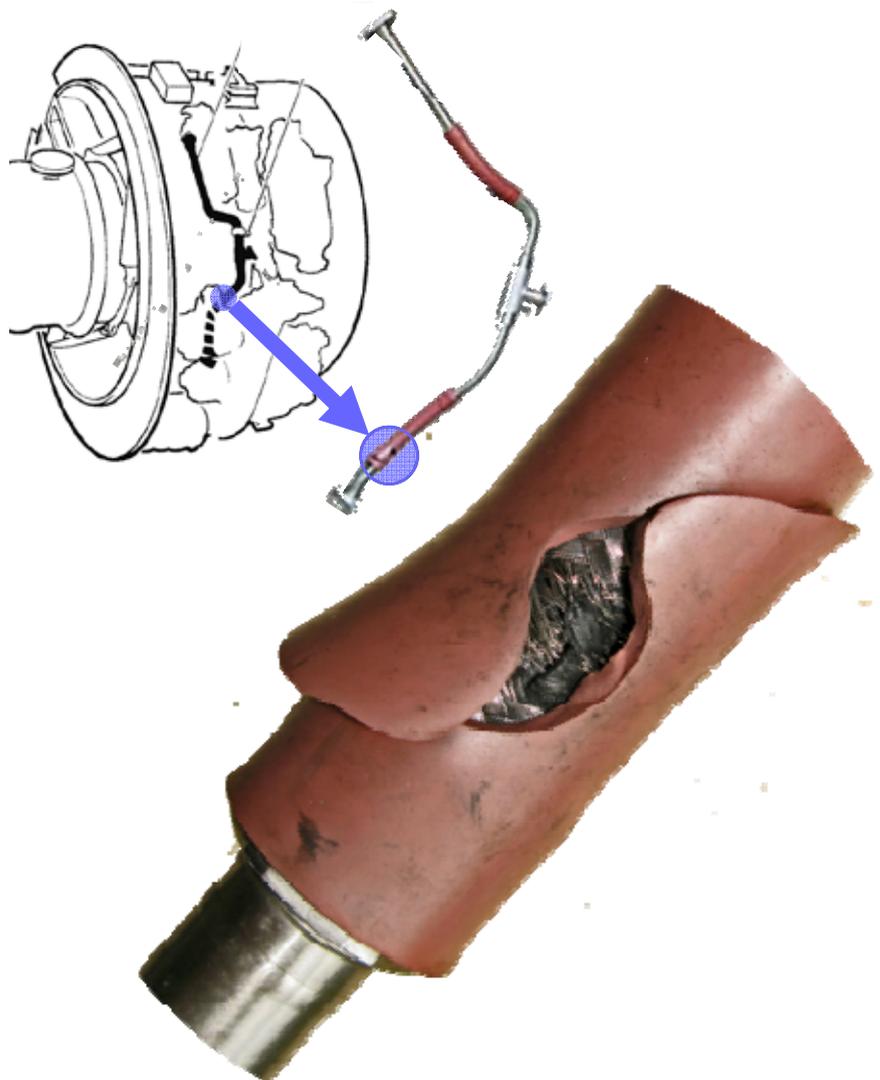
**Figure 1**

The fuel pipe, located on the right side of the engine (Figure 1), comprises an assembly of three rigid stainless steel tubes connected together by two flexible segments. The flexible segments have an inner core made of polytetrafluoroethylene (PTFE), within a closely fitting double-layer braided stainless steel sheath, enclosed within an outer silicone rubber sleeve to provide fire

LP fuel pipe failure – G-OOOZ

The rupture in the segment of flexible hose had occurred close to the HP fuel pump inlet. The HP fuel pump has a gear-type design and there are two types of pump available which can be fitted to the engine, with different numbers of gear teeth.

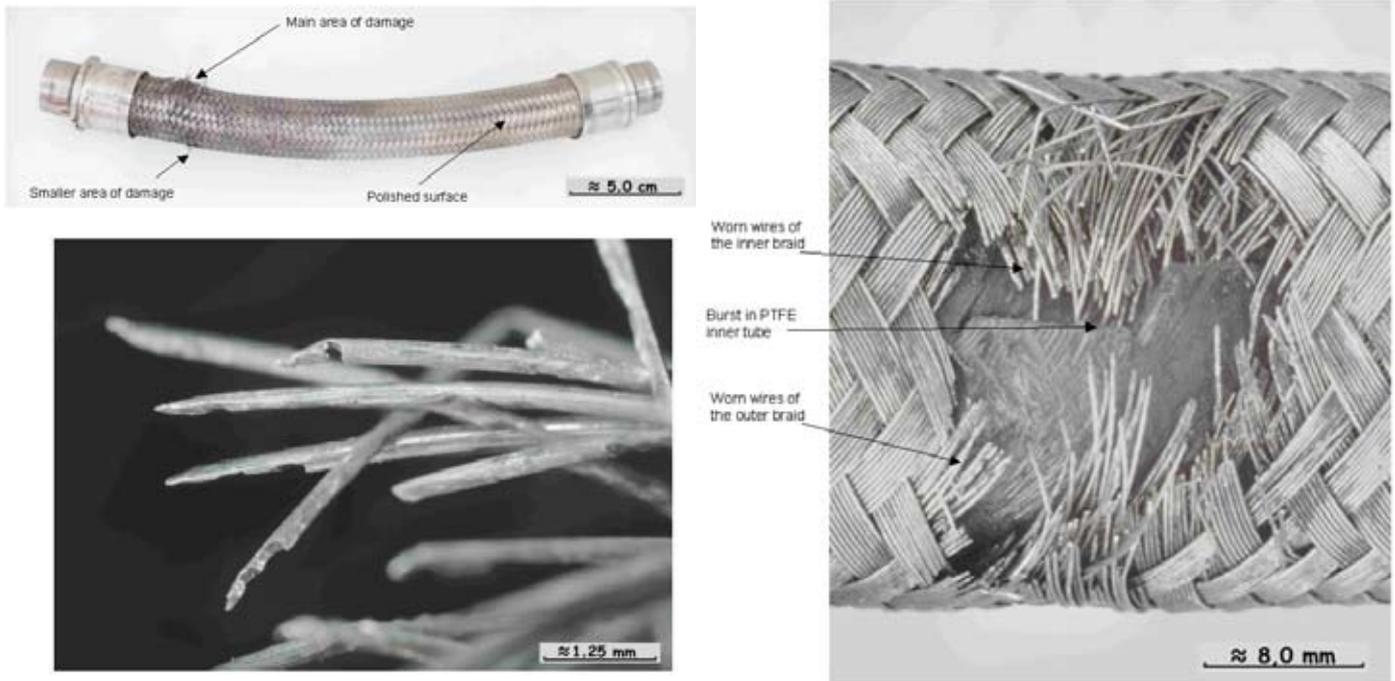
Microscopic inspection of the rupture site revealed a pattern of localised but extensive inter-braid fretting in both the inner and outer braids. The stainless steel braid wires were worn and notched; the damage had been caused by relative movement between overlaying strands. In many cases this process had completely severed the wire strands (Figure 2). It was evident that the resulting loss of hoop integrity had left the inner core of the pipe unsupported, allowing the inner tube wall to rupture and burst through the compromised region of braid. Damage, probably caused by relative movement of the braid, was apparent to the outer surface of the PTFE core tube, sufficient to cause significant weakening.

**Figure 2**  
Detail of fuel pipe failure

Wear of the braid wire was evident throughout the length of the lower flexible hose; there was no evidence of similar wear on the upper flexible hose section.

The testing confirmed that the fretting which had led to the failure of the pipe was a result of high-frequency vibrations driven by the HP fuel pump pressure ripple. Extended time spent in the critical N3 speed range could accelerate the wear and the effect of an individual pump could cause additional variability in the time to failure.

There is a repair approved by the engine manufacturer, Field Repair Scheme (FRS) 6887, which involves replacement of both flexible hose sections.

From the history of previous events the associated risk assessment predicts an event rate of up to 1.5 per year, which would include minor leaks discovered on the ground. A hardware redesign has been initiated by the manufacturer with a design definition planned before the end of May 2011.
