**SERIOUS INCIDENT**

<b>Aircraft Type and Registration:</b>	Boeing 757-21B, G-LSAI	
<b>No &amp; Type of Engines:</b>	2 Rolls-Royce RB211-535E4 turbofan engines	
<b>Year of Manufacture:</b>	1987	
<b>Date &amp; Time (UTC):</b>	7 September 2011 at 1135 hrs	
<b>Location:</b>	In the cruise, in Bulgarian airspace	
<b>Type of Flight:</b>	Commercial Air Transport (Passenger)	
<b>Persons on Board:</b>	Crew - 7	Passengers - 219
<b>Injuries:</b>	Crew - None	Passengers - None
<b>Nature of Damage:</b>	None	
<b>Commander's Licence:</b>	Airline Transport Pilot's Licence	
<b>Commander's Age:</b>	38 years	
<b>Commander's Flying Experience:</b>	10,232 hours (of which 3,611 were on type) Last 90 days - 178 hours Last 28 days - 53 hours	
<b>Information Source:</b>	Aircraft Accident Report Form submitted by the pilot and subsequent AAIB enquiries

**Synopsis**

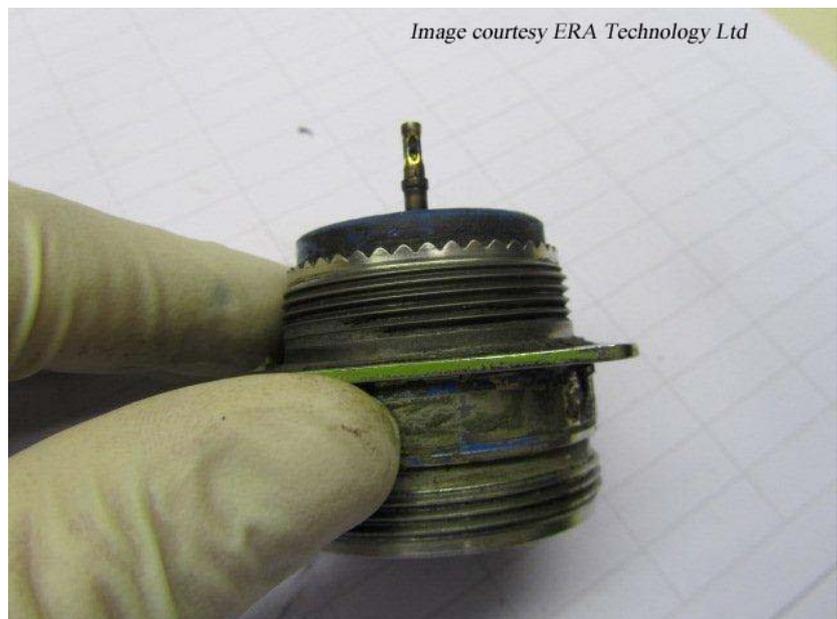
The D1114J bulkhead connector was sent to the AAIB for detailed examination. The connector holes at the pin 11 and 12 positions were blocked by crimp terminals that were pushed to the bottom of the connector; they were withdrawn (Figure 1) and examined using visual and scanning electron microscopy. Both crimp terminals showed that the multi-strand wire had completely parted within the crimped portion of the terminal and the exposed surface of the wire was heavily contaminated with black corrosion products. The wire end's surface had a rounded appearance, with no evidence of ductile overload. A significant quantity of dark-coloured powder was removed from

inside the connector's holes by tapping the body of the connector. Analysis of the chemical composition of this powder revealed high levels of copper, carbon, silicate and oxygen, consistent with corrosion of the connector's internal components.

The cause of the intermittent disconnection of the left IDG from the left AC electrical bus was traced to a corroded crimp terminal at pin 12 of the left pylon's D1114J bulkhead connector. The backshell of the connector was loose due to stripped threads, probably caused during previous over-tightening and this defect allowed moisture to enter the connector, causing corrosion of the connector's internal components. The loose backshell also prevented support of the connector's wiring loom, which allowed the loom to vibrate during flight, promoting mechanical damage of the individual wires at their point of attachment to the crimp terminals.

**Figure 1**  
D1114J connector,  
showing the detached crimp terminal at pin 12

Loss of electrical continuity at pin 12 caused the left IDG's differential protection current transformer to erroneously sense that the 'A' output AC phase carried zero current, causing the left GCU, via logic within the BPCU, to disconnect the left IDG from the left AC bus. The intermittent nature of the connection, due to corrosion within the crimp terminal, made isolation of the defect difficult to diagnose and following two occurrences of an in-flight loss of left AC power, the defect cleared and the aircraft produced left AC power during subsequent ground running.

All the crimp terminals were renewed, the D1114J bulkhead connector was replaced with a new component and the electrical continuity of the associated wiring looms was checked, with reference to the Wiring Diagram Manual, and determined to be satisfactory. Following this maintenance action there was no further recurrence of a fault with the aircraft's left AC power generation system.
