## **BULLETIN ADDENDUM**

**AAIB File:** EW/G93/08/04

**Aircraft Type and Registration:** Sportavia RF5B Sperber, G-SSWV

**AAIB Bulletin No 11/93, page 65 refers**

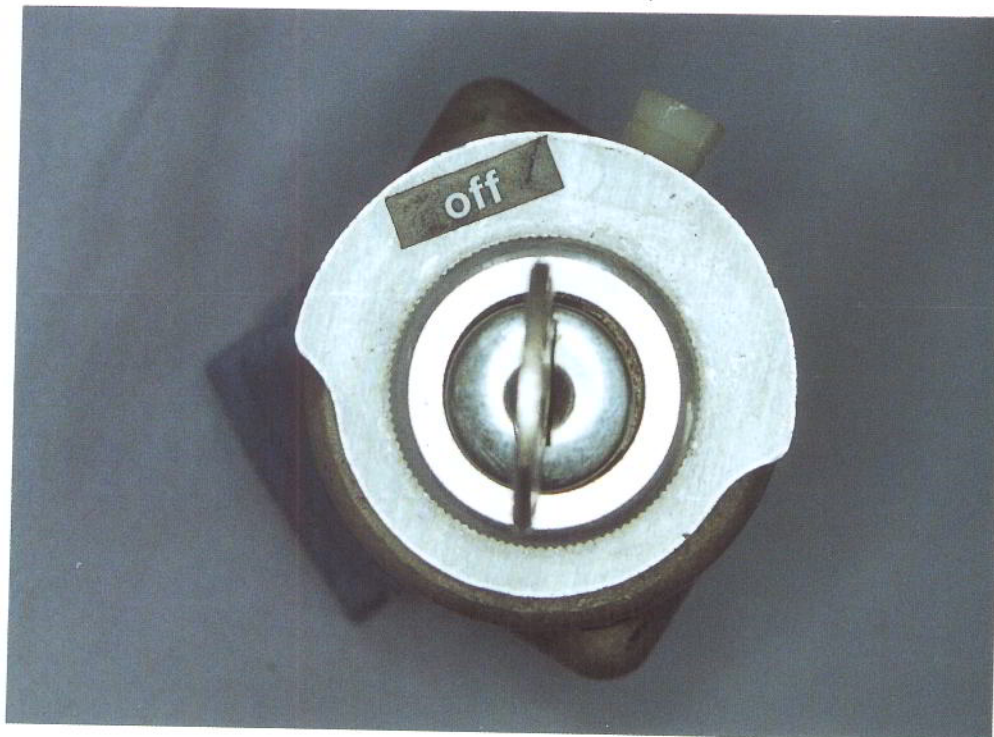
G-SSWV, a motorglider, has a single magneto. The magneto switch, a Bendix type GM, had been modified from its original 'OFF R L BOTH' configuration to a two-position configuration (Fig 1). This kind of switch, as modified, had been an optional fit when the aircraft was manufactured in 1973. A screw, in nylon bushing, had been set into the switch body, the tip of the screw projecting into the switch to form a stop which prevented the internal cam, which is rotated by the key through the lock, from turning beyond the second key position (first position being 'OFF'). The four key positions are normally located by a leaf spring which settles into notches in the cam periphery at the required locations with a final stop at the 'BOTH' position. The cam also carries the movable (earthing) contacts. The switch's faceplate with the 'OFF R L BOTH' positions marked on it had been turned around and the 'OFF' position (only) marked on its blank reverse side. The second position, which would be 'ON', was not indicated on the reversed faceplate.

place the barrel could be rotated by a small amount and tended to return to the 'OFF' position under the effect of the leaf spring settling in the cam notch but the rotation available with the key in place was marginally greater and sufficient to take the spring out of the notch. The movement of the spring over the cam was sufficient to give a positive 'feel' to the action, making it appear that the key was positively located in the new position. There was, of course, no indication on the faceplate of the correct rotational position for the key when 'ON'.

**Fig 1 Magneto switch - key in partial ON position**

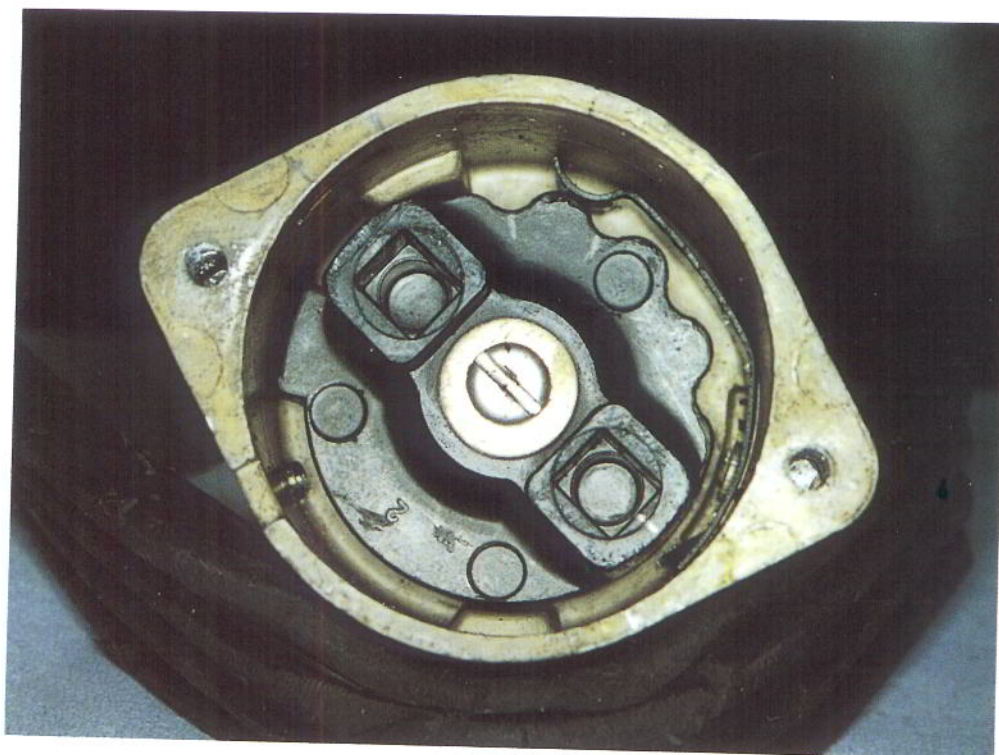
When the switch was opened (Fig 2) it was found that the cam, as turned by the key, was not able to be rotated fully to the second position. The 'R' terminal was not being fully uncovered and could have provided an erratic contact. When the lock was opened up it was found that the key was not fully retracting the tangs into the barrel and it was evidently the wrong key for the lock. Without the key in

It was evident that the plastic cam had previously been rotated fully and had come into contact with the stop screw, presumably with the use of the correct key, because some plastic debris was found adhering to the screw thread. The sharp edges of the screw thread had, in fact, damaged the contact surface on the cam and had created plastic debris which was loose within the switch and which had the potential to become lodged under the terminals and prevent the magneto from being earthed when the switch was turned to 'OFF'.

**Fig 2 Magneto switch internal cam - key in partial ON position**
