# Airbus A310-304, D-APON, 21 April 1996

**AAIB Bulletin No: 6/96 Ref: EW/C96/4/8 Category: 1.1**

**Aircraft Type and Registration:**Airbus A310-304, D-APON

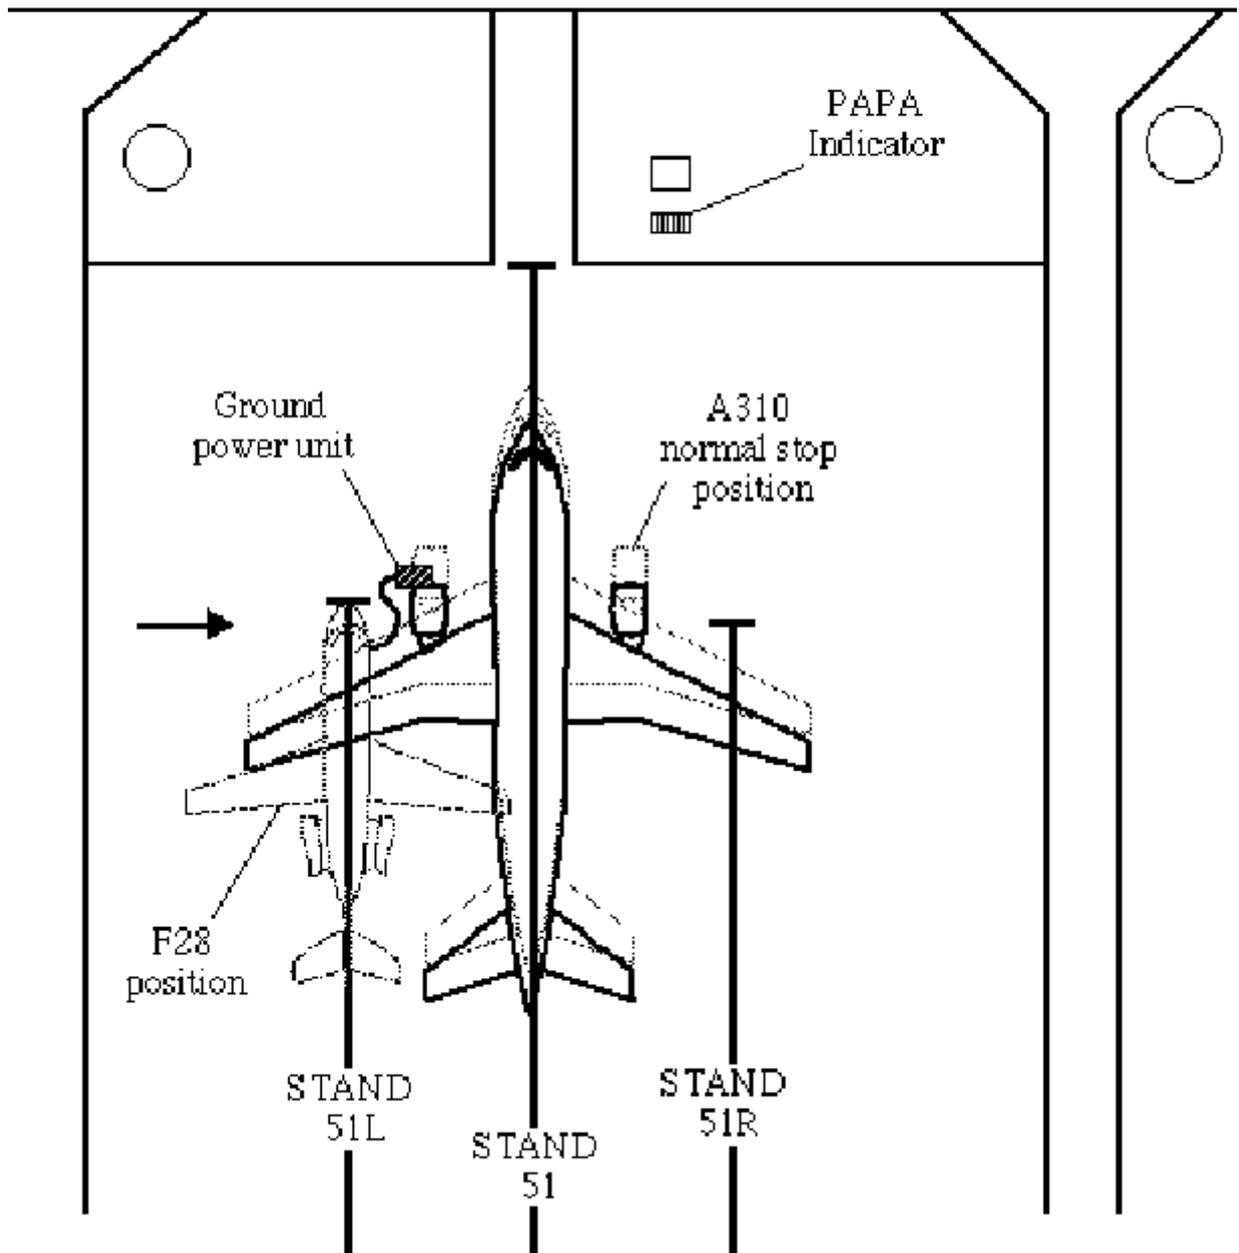
Impact marks were found on the GPU in question which showed that the engine intake lip had struck the rear part of the unit on the left side, approximately as shown in Figure 1. The positioning of the ground power unit on the stand was consistent with expected position for such a unit when connected to an F28 aircraft, the previous aircraft on stand 51 (the dotted aircraft outline shown positioned on stand 51 Left in Figure 1). The normal stop position for A310 aircraft on Stand 51 is also shown as a dotted outline in Figure 1.
