**INCIDENT**

<b>Aircraft Type and Registration:</b>	Airbus A319-111, G-EZIU	
<b>No &amp; Type of Engines:</b>	2 CFM56 turbofan engines	
<b>Year of Manufacture:</b>	2005	
<b>Date &amp; Time (UTC):</b>	6 February 2007 at 1146 hrs	
<b>Location:</b>	En route to from Barcelona to Liverpool	
<b>Type of Flight:</b>	Commercial Air Transport	
<b>Persons on Board:</b>	Crew - 6	Passengers - 78
<b>Injuries:</b>	Crew - None	Passengers - None
<b>Nature of Damage:</b>	None	
<b>Commander's Licence:</b>	Airline Transport Pilot's Licence	
<b>Commander's Age:</b>	46 years	
<b>Commander's Flying Experience:</b>	Total 12,500 hours (of which 2,166 were on type) Last 90 days - 81 hours Last 28 days - 26 hours	
<b>Information Source:</b>	AAIB Field Investigation

**Synopsis**

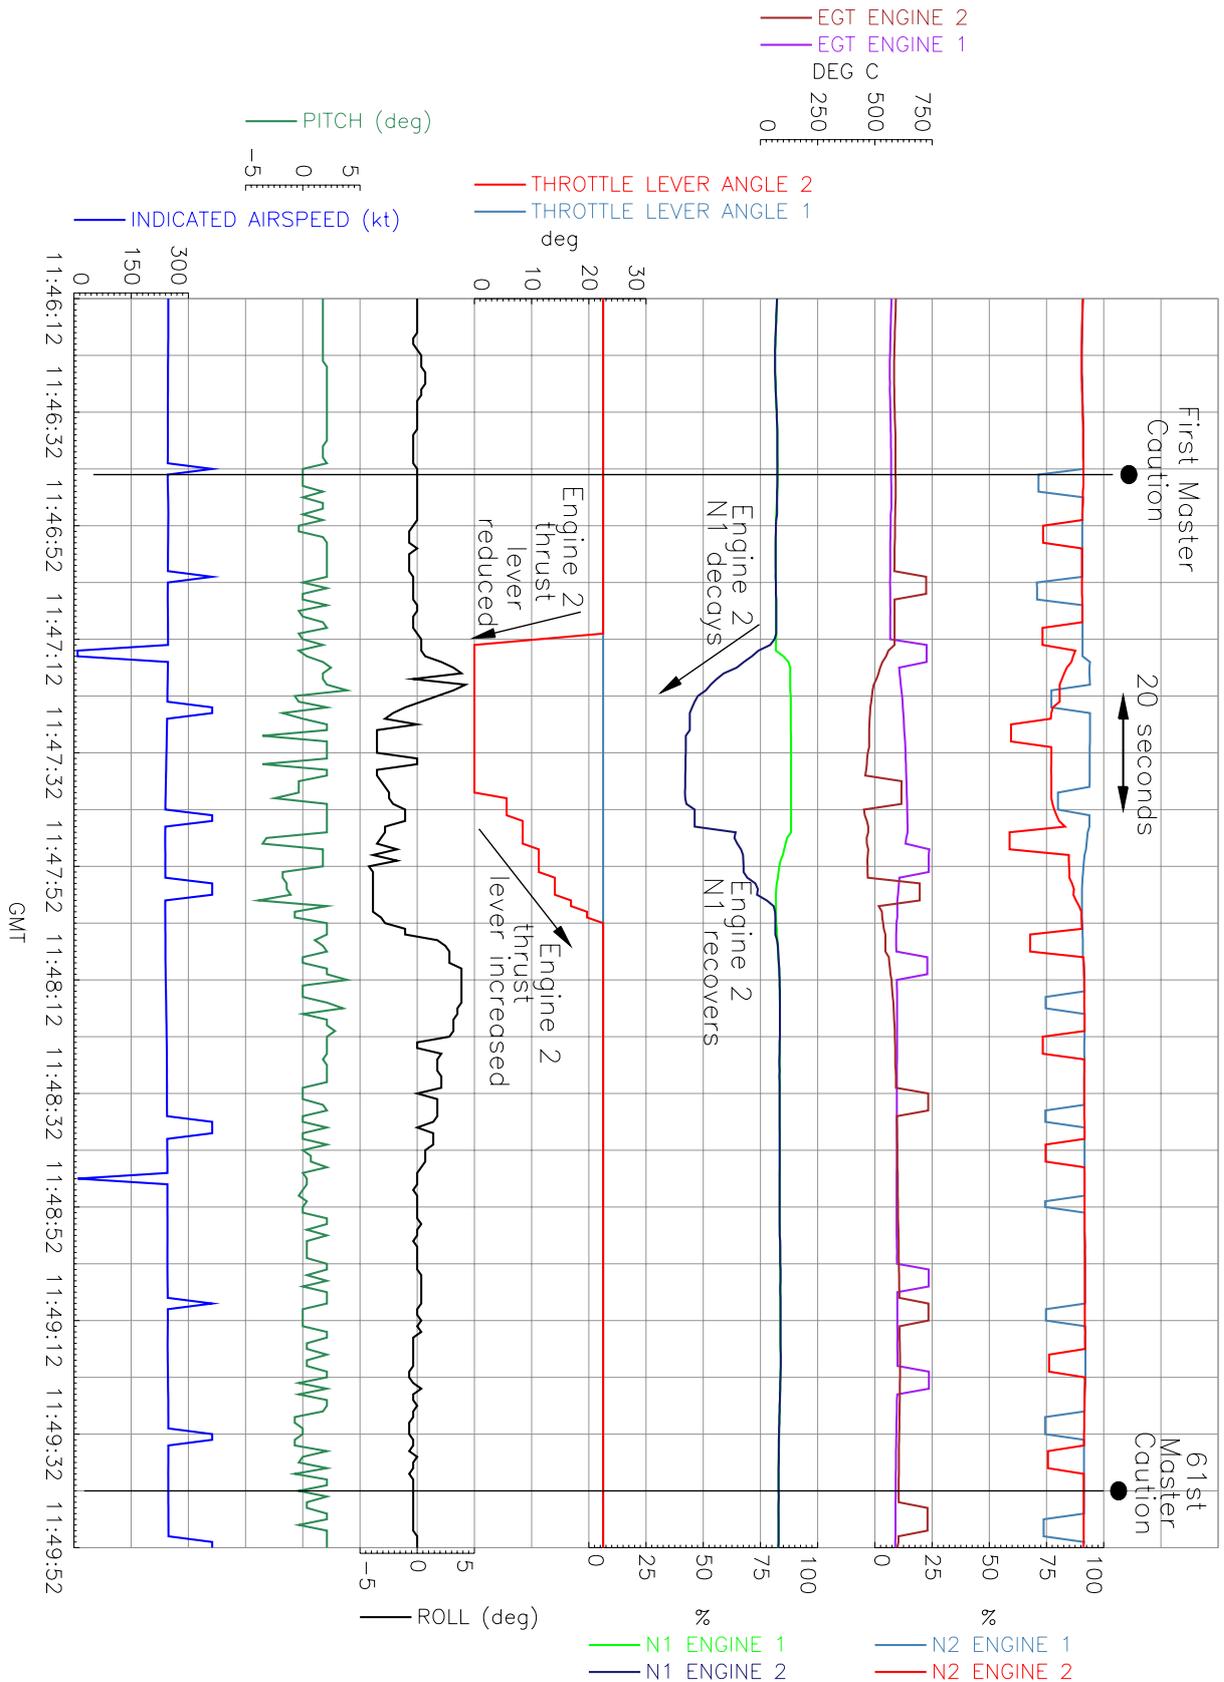
**Figure 1**  
G-EZIU Relevant FDR Parameters

The relevant FDR data started with G-EZIU just north of the Isle of Wight, heading north, cruising at FL380, at an indicated airspeed of 246 kt. The autopilot and autothrottle were engaged and the engines were operating normally. At 11:46:43 hrs, the CVR recorded the sound of a Master Caution single chime tone<sup>1</sup>. At around the same time, a number of FDR parameters exhibited unusual behaviour (Figure 1).

After the first Master Caution tone, three more were recorded over the next 11 seconds. A further three were recorded before the commander stated "THRUST LEVER TO IDLE OK". Master Caution tones continued to be generated at the rate of one approximately every four seconds. The data shows the No 2 engine thrust lever was retarded around 28 seconds after the first Master

Caution. The autothrottle responded by increasing the No 1 engine  $N_1$  from 82% to 88%. The data showed that, 26 seconds after being retarded, the No 2 engine thrust lever began to advance over a period of 38 seconds, after which it was in the same position as that of the No 1 engine.

During the first three minutes after the first ECAM caution, a total of 61 Master Caution chimes were recorded on the CVR. During the taxi after landing, the rate of Master Caution triggering reduced to roughly one every six to ten seconds. In the 33 minutes between the first and last audible Master Caution, around 460 Master Cautions were recorded by the CVR.

No indication of any DMC fault was recorded by the FDR during the entire flight.
