SERIOUS INCIDENT

Aircraft Type and Registration:	DHC-8-402 Dash 8, G-JECR	
No & Type of Engines:	2 Pratt & Whitney Canada PW150A turboprop engines	
Year of Manufacture:	2006	
Date & Time (UTC):	3 September 2009 at 0544 hrs	
Location:	Isle of Man (Ronaldsway) Airport	
Type of Flight:	Commercial Air Transport (Passenger)	
Persons on Board:	Crew - 4	Passengers - 27
Injuries:	Crew - None	Passengers - None Others - 1 (Minor)
Nature of Damage:	None	
Commander's Licence:	Airline Transport Pilot's Licence	
Commander's Age:	40 years	
Commander's Flying Experience:	6,947 hours (of which 855 were on type) Last 90 days - 116 hours Last 28 days - 45 hours	
Information Source:	Aircraft Accident Report Form submitted by the pilot

Synopsis

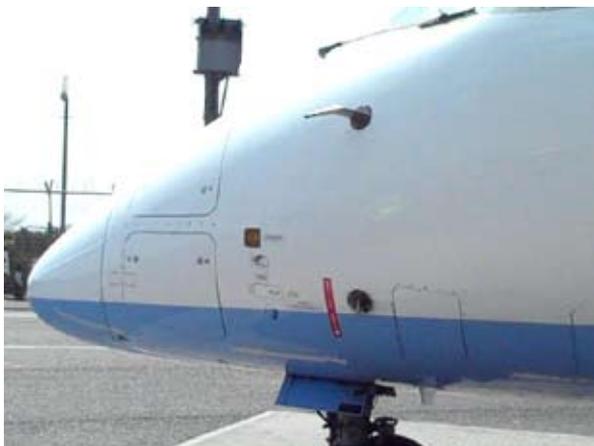
Figure 1
Doors closed

'Before disconnecting the tow bar on any Dash 8 Q400 aircraft, ground operators must ensure that the 'forward' nose wheel undercarriage doors are in the fully closed position.'

If the forward nose wheel undercarriage doors are not in the fully closed position, the Captain must be informed and the tow bar must not be disconnected from the aircraft.

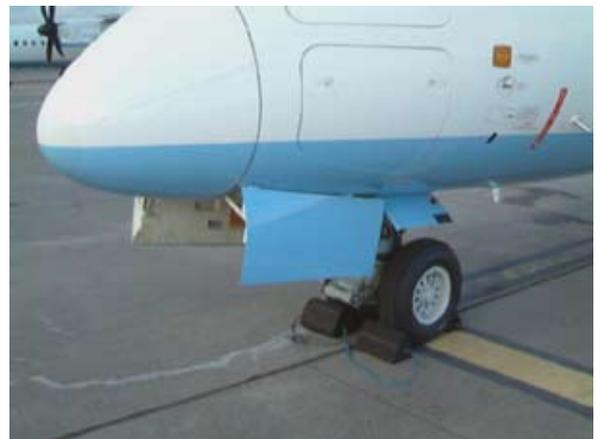
Before the first flight of the day, the operator's engineering department carries out an inspection on the aircraft, including the nose landing gear bay. In order to perform this inspection, the two forward nosewheel undercarriage doors are opened fully and left in that position until the right engine is started. The landing gear and associated doors are operated using the No 2 hydraulic system, the pump for which is driven by the right engine. When the right engine is started, the hydraulic system pressurises and the forward nosewheel undercarriage doors close. Subsequently, the doors close after the nose landing gear has been raised or lowered and remain closed until the landing gear is next cycled.

Figure 2
Doors open

*When engine start clearance is given the nose wheel bay area must be clear. **DO NOT ALLOW ANYONE TO APPROACH THE WHEEL BAY DURING ENGINE START.***

During the engine start, hydraulic pressure will close the doors automatically. If the doors still do not close, inform the Captain again. Only once the doors have fully closed may the tow bar be disconnected.'
