**INCIDENT**

<b>Aircraft Type and Registration:</b>	ATR42-300, EI-SLD	
<b>No &amp; Type of Engines:</b>	2 Pratt and Whitney PW120 turboprop engines	
<b>Year of Manufacture:</b>	1985	
<b>Date &amp; Time (UTC):</b>	18 January 2007 at 2225 hrs	
<b>Location:</b>	London Stansted Airport	
<b>Type of Flight:</b>	Commercial Air Transport (Cargo)	
<b>Persons on Board:</b>	Crew - 2	Passengers - None
<b>Injuries:</b>	Crew - None	Passengers N/A
<b>Nature of Damage:</b>	None	
<b>Commander's Licence:</b>	Airline Transport Pilot's Licence	
<b>Commander's Age:</b>	41 years	
<b>Commander's Flying Experience:</b>	2,732 hours (of which 2,144 were on type) Last 90 days - 147 hours Last 28 days - 35 hours	
<b>Information Source:</b>	AAIB Field Investigation

**Synopsis**

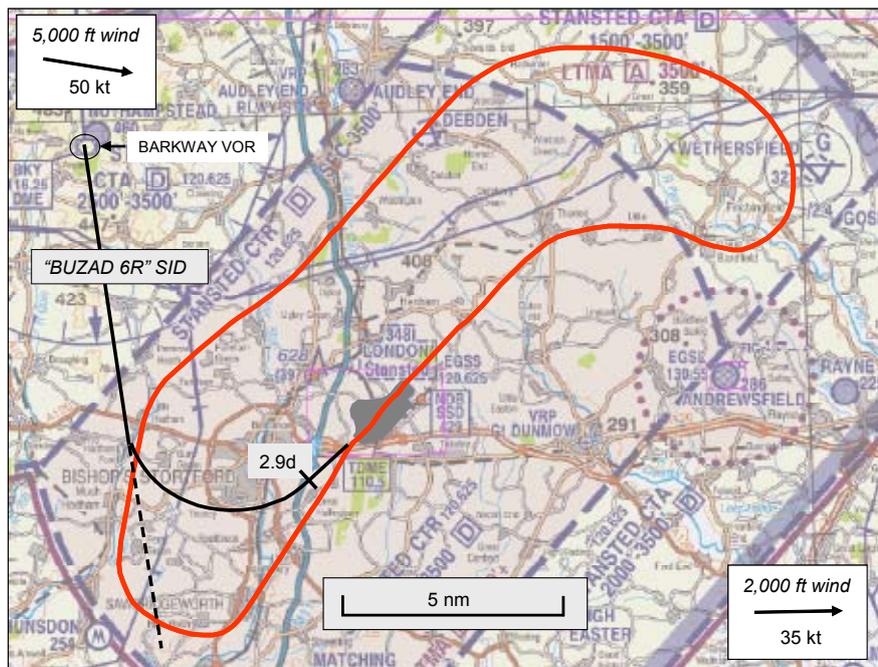
**Figure 1**  
Aircraft ground track, SID and wind data

The aircraft took off from Stansted’s Runway 23, with a reported wind from 240° at 14 kt. Almost immediately after becoming airborne, the crew experienced a yawing motion, which developed into a motion described later by them as being similar to a Dutch roll. In accordance with standard flight procedures, the co-pilot attempted to engage the yaw damper after takeoff but it would not engage. The commander told the co-pilot she was having difficulty controlling the aircraft. The aircraft climbed to 3,000 ft above mean sea level (amsl) and maintained approximately the runway heading. When the aircraft was seen by Air Traffic Control (ATC) to be deviating from the cleared ‘BUZAD 6R’ Standard Instrument Departure (SID), the controller instructed the crew to turn right. The co-pilot informed the controller of the control difficulties and requested radar vectors for an immediate return to the airport. Figure 1 shows the aircraft’s ground track, based on recorded radar data.

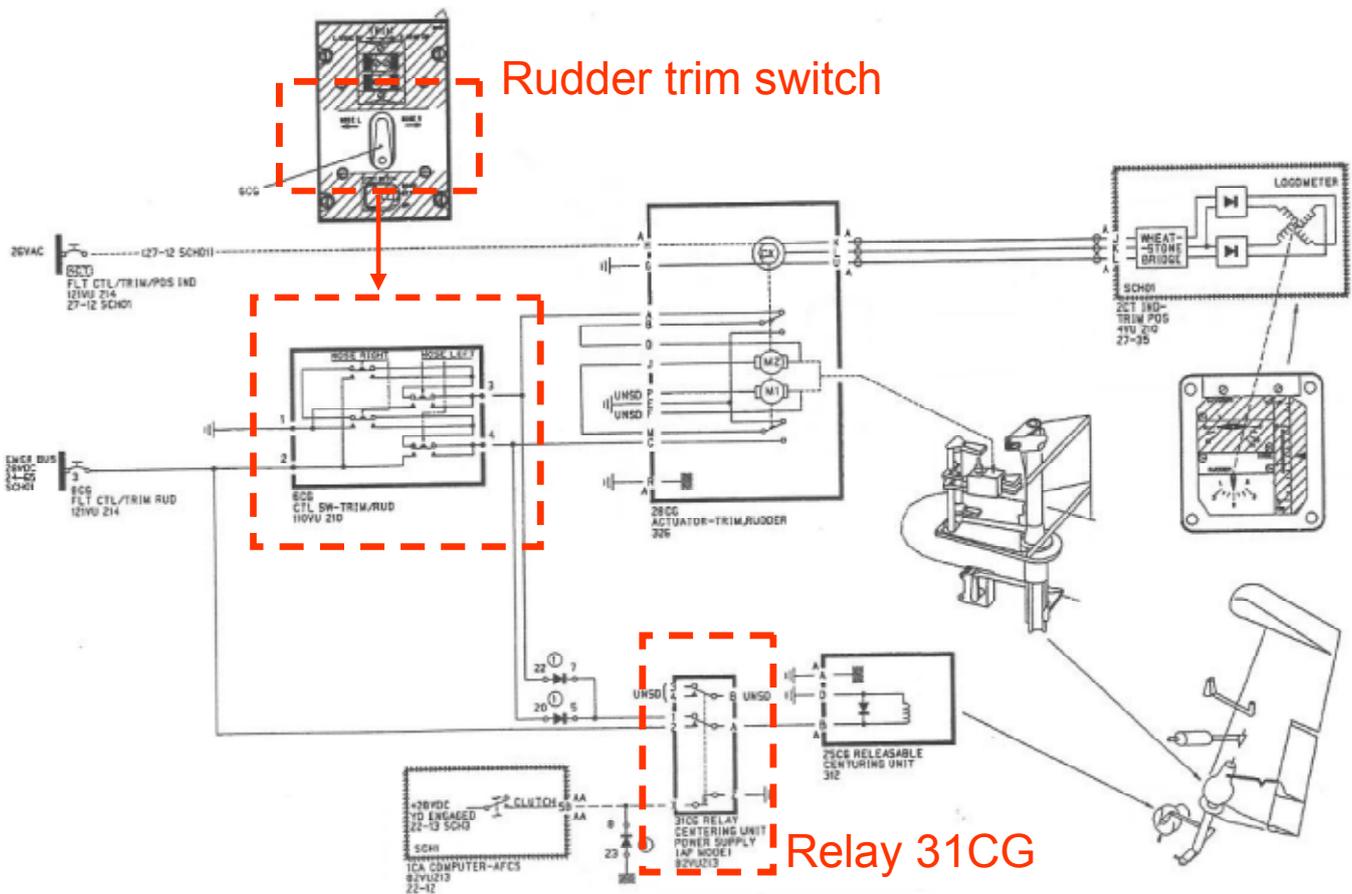
The 31CG relay was tested and found to be satisfactory. It can be seen in Figure 4 that three of the contact pins are unused. The active ones were noted to be blackened as a result of electrical arcing in service but this was stated to be a normal phenomenon and had not resulted in erosion of the contacts.

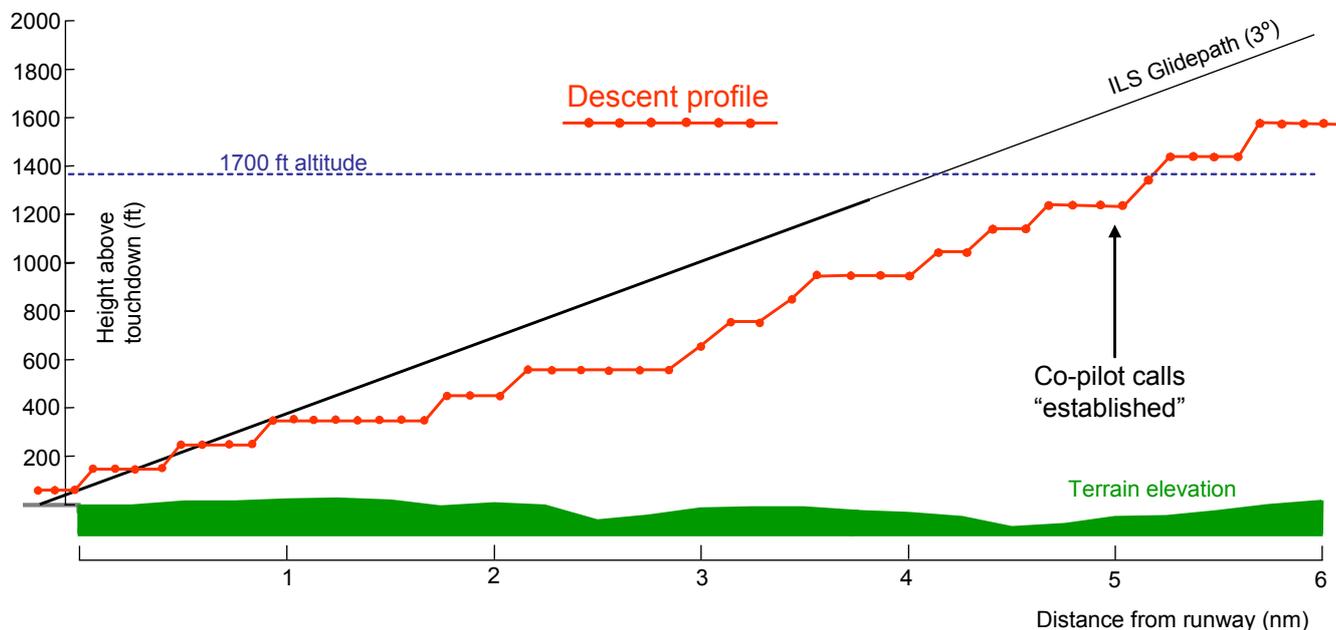
**Figure 5**  
Final approach

the controller cleared the crew to descend on the ILS. However, the aircraft descended below 1,700 ft before reaching the glideslope and was about 300 ft to 400 ft below it at 4 nm. At about 3.5 nm from touchdown the aircraft started to deviate further below the glideslope until it levelled at about 500 ft above airfield level (aal). It then descended further to about 300 ft aal which it maintained until intercepting the normal approach path at about 1 nm from touchdown.

At about 2 nm from touchdown there was a significant speed reduction below about 160 kt which, from the pilots’ reports, would be coincident with the selection of flap 15. Wind reports from ATC showed a fairly steady surface wind from 240° at 16 to 18 kt. After landing, ATC asked if the crew were able to vacate the runway normally. The co-pilot replied “AFFIRM, FULL CONTROL ON THE GROUND”.

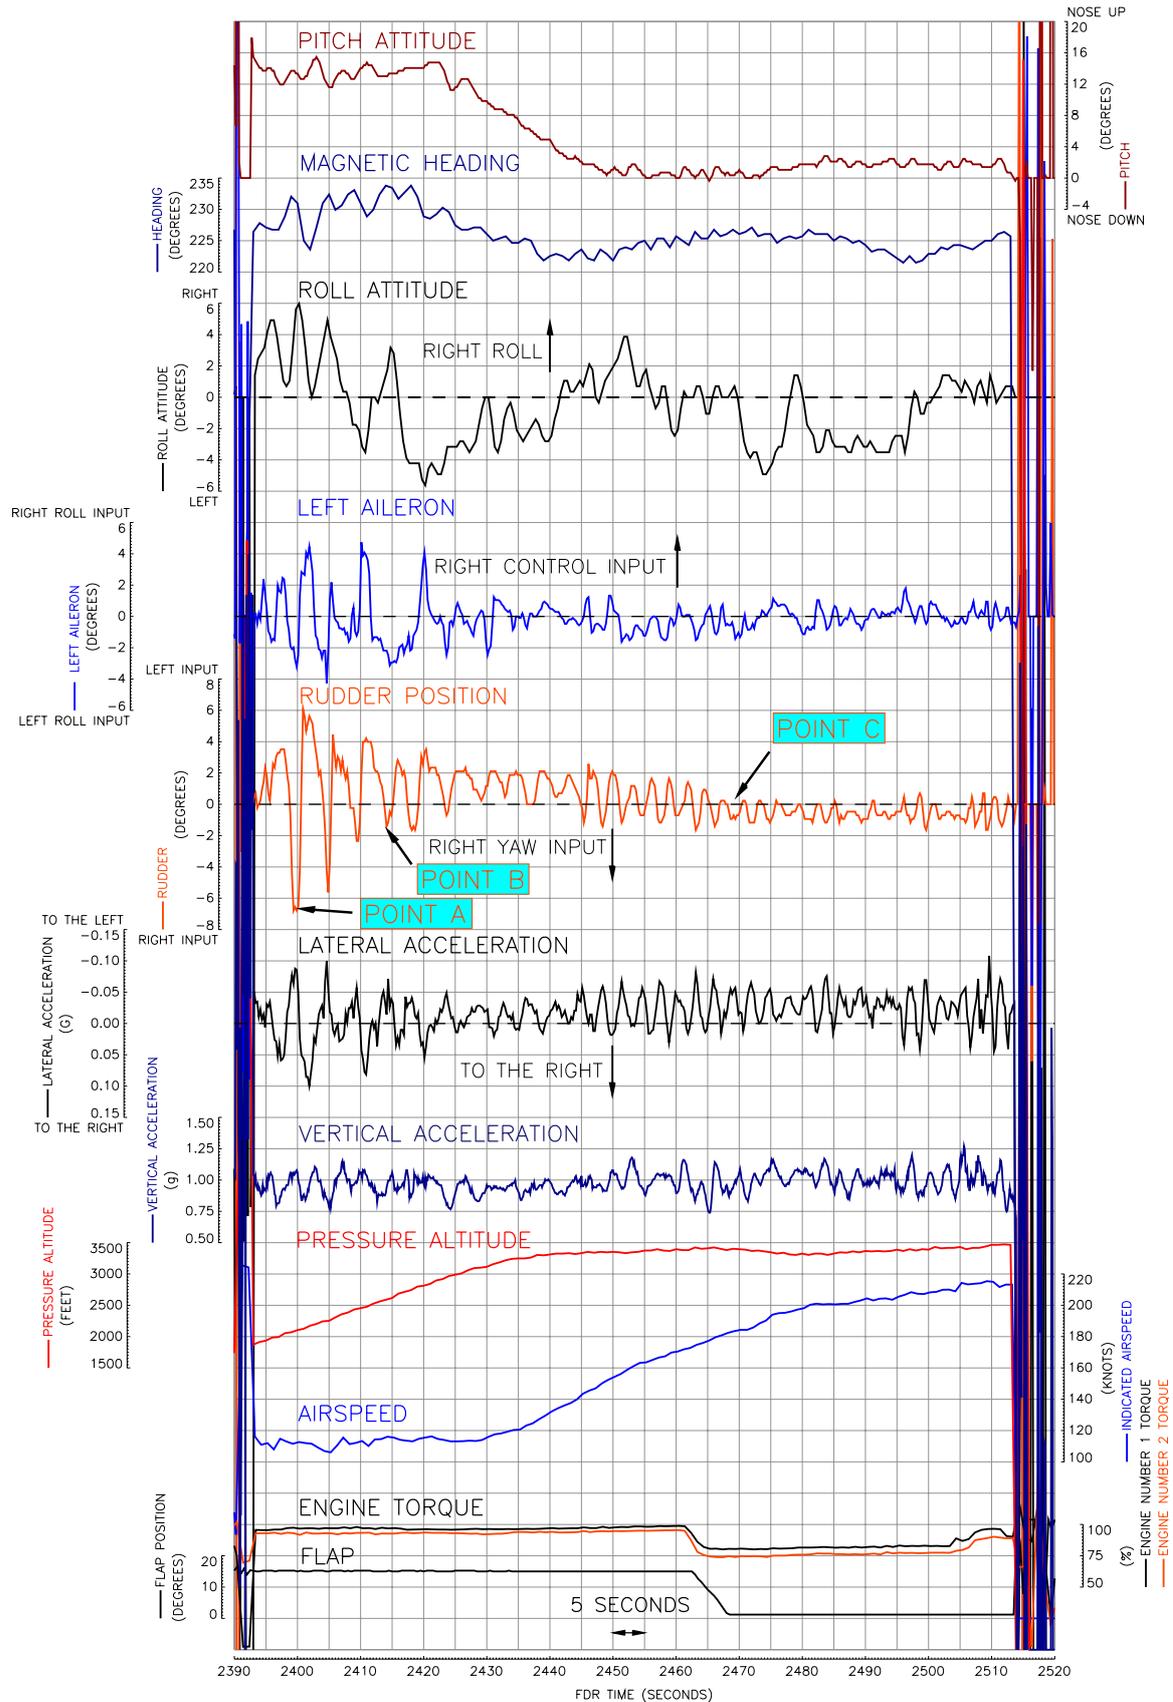
Figure 6

The next three oscillations shared similar characteristics of rudder motion and lateral control input. On each occasion the rudder moved rapidly from its right deflected position to the left (maximum travel was nearly 13°), in one second or less, accompanied by an opposite roll control input over the same duration. The rudder then returned to the right at a slightly lower rate, with a similarly slower roll input. The period of these oscillations was between 4.3 and 5 seconds.

The applied lateral control input did not always appear to be in response to aircraft rolling motion, particularly during the most significant recorded oscillations. From Point A, the rapid reversal of roll input to the right was initiated when the aircraft was both banked slightly to the right and rolling to the right, a situation repeated during the next oscillation. The initial right bank coincided with the correction back to the runway centreline, after the aircraft drifted left just after lift off. The subsequent left bank resulted in the aircraft stabilising about a mean heading of 225°, which was also the runway heading, and consistent with the ground track seen on radar.

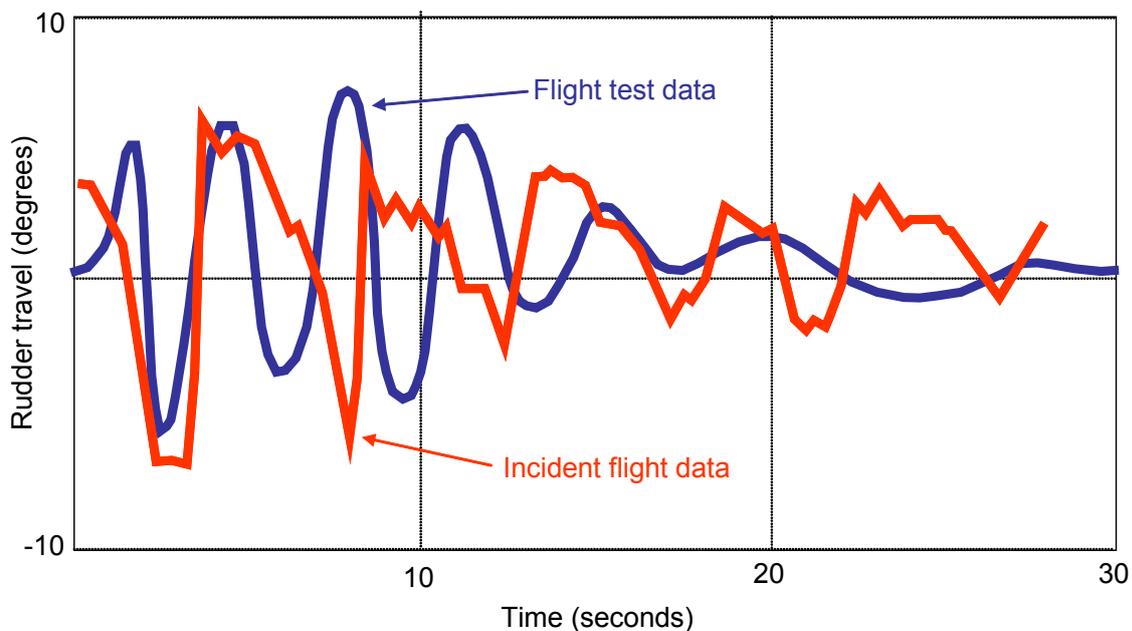
**Figure 7**  
Incident FDR plot overlaid on flight test Dutch roll data

Although the observed motion bore some similarities to a Dutch roll, it was not the same. In particular, the uneven and high rates of rudder travel were not natural motions, and the frequency was different. Although coarse use of roll control (involving activation of wing spoilers) would induce yaw, it was considered that the only way in which the rudder could move in the way it did was through the direct assistance of the spring tab, ie by pilot application. It was stressed that the rudder damper also operates during flight, so always acts to limit the rate of rudder travel.
