ACCIDENT

Aircraft Type and Registration:	P&M Aviation Ltd Flight Design CTSW, G-VINH	
No & Type of Engines:	1 Rotax 912ULS piston engine	
Year of Manufacture:	2006	
Date & Time (UTC):	12 August 2009 at 1550 hrs	
Location:	Caird Park Golf Course, Dundee	
Type of Flight:	Private	
Persons on Board:	Crew - 1	Passengers - None
Injuries:	Crew - 1 (Minor)	Passengers - N/A
Nature of Damage:	Aircraft destroyed	
Commander's Licence:	National Private Pilot's Licence	
Commander's Age:	63 years	
Commander's Flying Experience:	136 hours (of which most were on type) ¹ Last 90 days - 20 hours Last 28 days - 13 hours	
Information Source:	AAIB Field Investigation

The pilot made a forced landing in a tree after the engine stopped near Dundee. The investigation identified flight planning as a contributory factor. One Safety Recommendation is made.

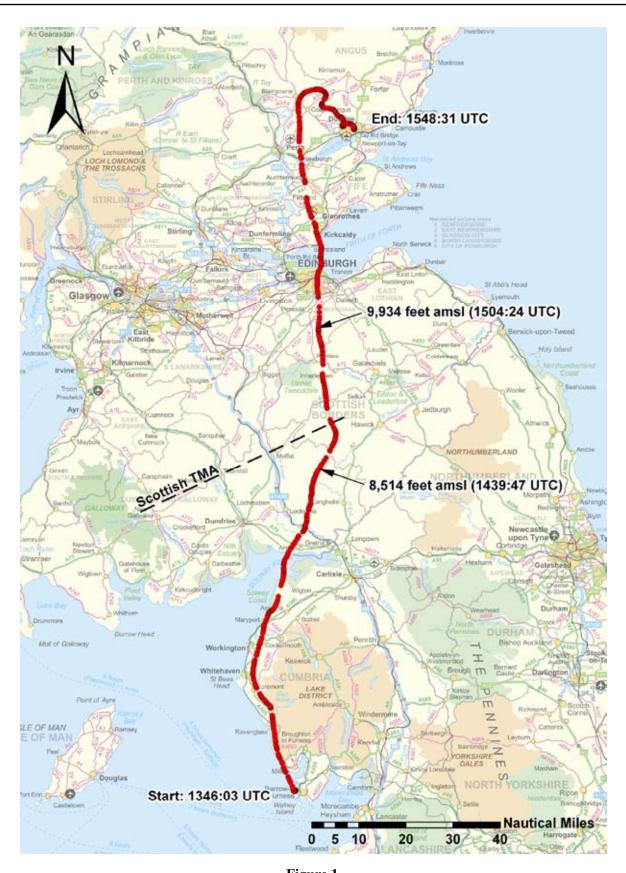
Figure 1 The aircraft's GPS track ©Crown copyright. All rights reserved Department for Transport 100020237 [2010]

The GPS unit had a complete log of the accident flight starting at 1346:03 hrs at Walney Airfield, Barrow-on-Furness, and ending at 1548:31 hrs at the Caird Park golf course, Dundee. The recorded track included altitude information and is presented at Figure 1. The highest altitude the aircraft reached was 9,935 ft amsl, at 1504:24 hrs, when it was approximately 15 nm south of Edinburgh. Altitude and groundspeed, averaged between consecutive points, are plotted in Figure 2. This shows a descent from 9,935 ft to 1,663 ft amsl, as the aircraft crossed the A91 north of Glenrothes, before it climbed again.

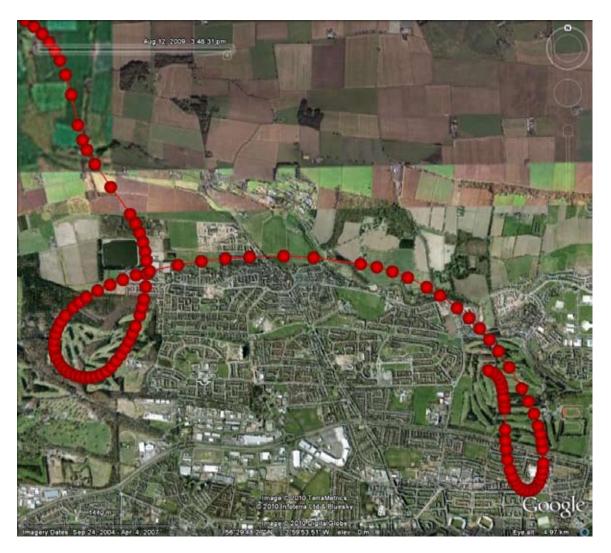
Figure 3 Image of the aircraft's GPS track just prior to the accident

The final descent was at a rate of approximately 900 ft/min, reducing to 600 ft/min as the aircraft flew a descending turn, clockwise, through 270° (see Figure 3) The aircraft continued descending at about this rate until the final recorded GPS position, which placed the aircraft at 340 ft amsl (110 ft agl), close to the accident site.

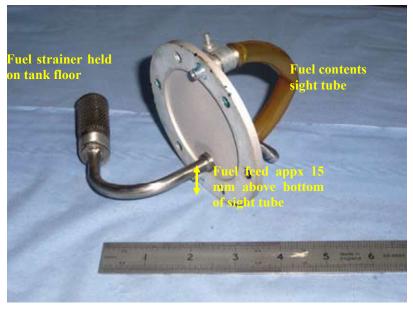
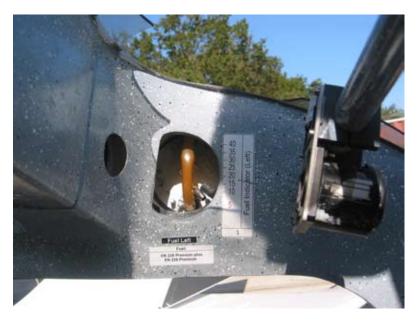
View of left tank fuel contents sight tube and gauge Figure 4

The CTSW is a high-wing aircraft equipped with integral wing tanks, with the fuel stored in the volume ahead of the main spar. Each 65 litre capacity tank extends from the wing root to approximately mid span. A circular plug in each root rib incorporates a fuel contents sight tube and the fuel off-take tube (see photographs at Figure 4). The latter comprises an inlet strainer assembly attached to a short length of rigid tube that serves to hold the inlet strainer close to the fuel tank floor at the aft inboard corner. The wings have a 1.5° dihedral angle, which, in balanced flight, would assist in keeping the fuel towards the inboard ends of the tanks. Each tank contains a single baffle located approximately 0.45 m from the wing root; its purpose is to limit the span-wise fuel surge that occurs

There is no sump or depression in the tank that would tend to keep the end of the fuel off-take tube immersed in fuel; neither is there a weir, nor a flap valve within the baffle, that would assist in maintaining a quantity of fuel within the inboard section of the tank.

The pilot reported that, shortly before the engine lost power, he had observed zero fuel indication in the right tank and approximately 5 litres in the left. It is apparent from Figure 4 that the 5 litres represents a low value, and it is noteworthy that it is written in red on the adjacent fuel contents scale. In addition, the location of the sight tube relative to the scale would be prone to parallax error. However, any such error is likely to be insignificant compared with the inherent inaccuracy arising from the tank geometry, the width to length ratio of which could give rise to considerable span-wise movement of fuel in response to lateral accelerations. Thus an accurate reading, or at least one with the least amount of error, would only be achieved with the aircraft in a level attitude and in balanced flight in smooth conditions.

The reported circumstances of the accident indicate that the engine became starved of fuel. The nature of the tank design is not conducive to accurate gauging, with any sustained sideslip or nose-down attitude effectively generating quantities of unusable fuel in excess of the 0.5 litres stated by the aircraft manufacturer. In fact the manufacturer's own tests, conducted with the aircraft on the ground, indicated a significant increase in the unusable fuel quantity when the aircraft attitude changed from the straight and level. The manufacturer additionally noted that it was possible to restart the engine following temporary fuel starvation; however, this might not be a practical procedure for pilots in the course of a normal flight and, moreover, would not comply with BCAR S959, which refers to the **first** evidence of malfunctioning. The BCAR allows up to 5% of the tank volume to be unusable, which equates to 3.25 litres. This would seem to represent a more realistic figure in actual flying conditions, despite the manufacturer having conducted flight tests in which lower quantities were demonstrated.

It is recommended that Flight Design GmbH, together with P&M Aviation, revise their assessment of the unusable fuel in the CTSW aircraft.

Following this accident, P&M Aviation declared their intention to publish a Service Letter which will explain the effects of aircraft attitude and turbulence on fuel feed at low fuel levels. In addition, it will point out that the minimum quantity that the fuel sight gauge will indicate is 3 litres. Finally, a placard will be required to be fitted to the aircraft advising the pilot that he or she must ensure that at least 1 cm of fuel is visible on both fuel contents sight gauges at all times.
