ACCIDENT

Aircraft Type and Registration:	Europa, G-HOFC	
No & Type of Engines:	1 Rotax 912-UL piston engine	
Year of Manufacture:	1996	
Date & Time (UTC):	1 June 2007 at 1445 hrs	
Location:	Near Magor, Gwent	
Type of Flight:	Private	
Persons on Board:	Crew - 1	Passengers - 1
Injuries:	Crew - 1 (Fatal)	Passengers - 1 (Fatal)
Nature of Damage:	Aircraft destroyed	
Commander's Licence:	Private Pilot's Licence	
Commander's Age:	66 years	
Commander's Flying Experience:	1,631 hours (of which 1,054 hours were on type) Last 90 days - 17 hours Last 28 days - 8 hours	
Information Source:	AAIB Field Investigation

Synopsis

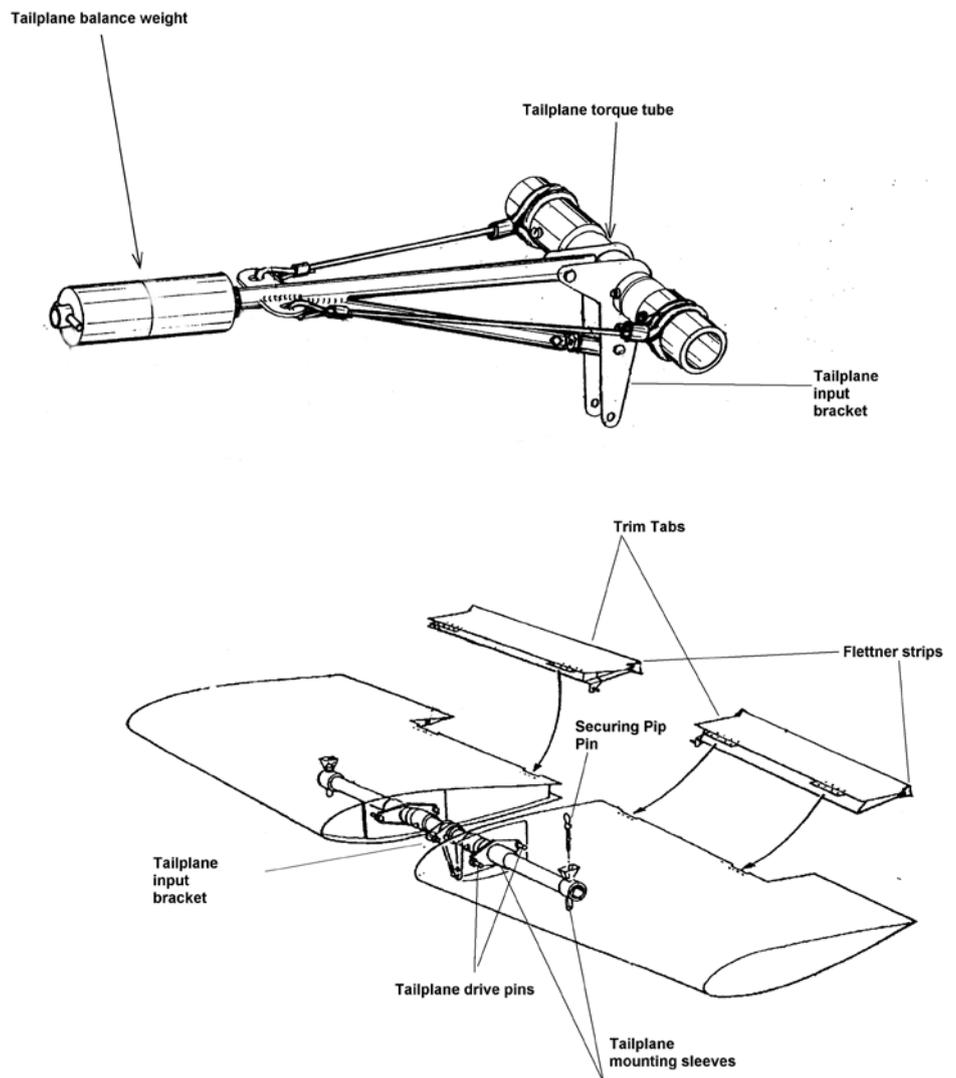
Figure 4

All four of the tailplane locating sleeves (see Figure 4) which had been bonded within the tailplanes, remained on the torque tube; the outer sleeve on each side was secured by its pip pin. Examination of the holes drilled into the outboard sleeves and the tailplane torque tube showed distortion and folding of the fore and aft edges of the holes which confirmed the application of a torque load between the sleeve and the torque tube. Discussions with both the Light Aircraft Association (previously the PFA) and Europa confirmed that the purpose of the outer sleeve and pip pin was to prevent the outboard movement of the tailplane and had not been designed to carry tailplane torque loads. Damage to the tailplanes confirmed that a failure had occurred in the bonding of the outboard sleeves. This had allowed both tailplanes to migrate outboard, disengaging both the tailplane drive pins and the trim tab drive pin and pulling the pip pins through the foam infill. Examination of the pip pin recesses in both tailplanes showed that they did not appear to have been constructed in accordance with the Europa Aircraft Build Manual, see Figure 5. The recesses in G-HOFC's tailplanes were significantly smaller than those shown in the manual; they consisted of a hole, and possibly an insert, of only slightly greater diameter than the pip pin whereas the build manual showed a significantly larger recess which made use of several layers of glass fibre cloth bonded to the sleeve. No abnormalities or inconsistencies which may have initiated the failure of the bond were found. Given that the bonded joint of the outboard sleeve had not been designed to carry torque loads even had it been constructed in the manner shown in the Build Manual, it is probable that it would also have failed due to the application of loads which it had not been designed to withstand.

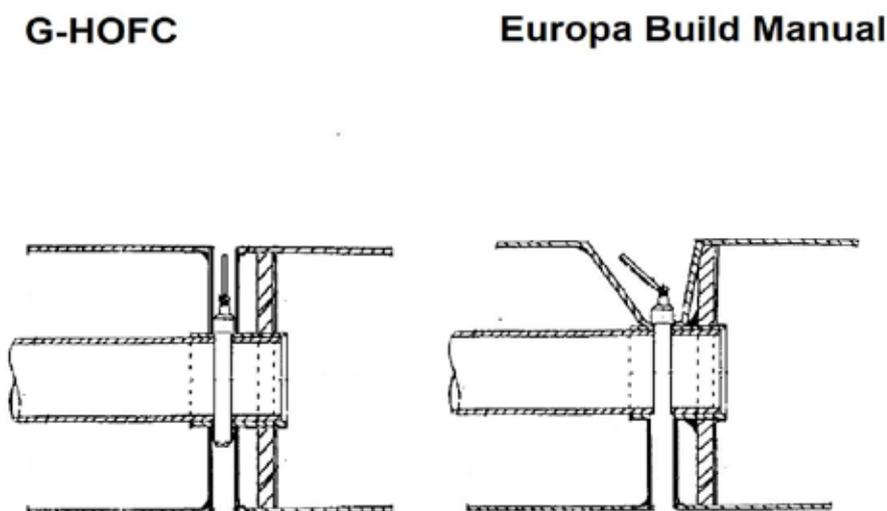
Figure 5

Disengagement of the drive pins would have caused the tailplanes to become free to rotate about their hinges, making the aircraft uncontrollable in pitch. This would have also subjected the airframe to significant loads beyond its design limitations. Scoring on the left side of the fin structure above and below the trim tab drive slot indicated that the left tailplane tab drive pin had become disconnected from the 'T' bar within the fin and had been moving beyond its normal range of movement prior to the tailplane becoming detached. Given that the tailplanes has been partially de-rigged at Bodmin, tests were carried out on another Europa to determine if it would have been possible to re-rig the tailplanes without engaging the trim tab drive, allowing the tab to be unrestrained. These test showed that the pin on the inboard edge of the tab could sit on top of the input drive 'T' bar and, when the tailplane was moved, the tab would move in a manner similar to that when properly engaged. The application of a very small load (a gentle push with a finger) caused the tab pin to slide off the 'T' bar, allowing the tab to drop. Discussions with pilots involved in the flight testing of the Europa confirmed that in cases where this has happened, pilots have become aware of a significant change in the control forces either during or shortly after takeoff but have also been able to land the aircraft successfully. Significant damage

was found on the tailplane tab hinges and the tab drive pins, which appeared to be characteristic of the presence of a vibratory load. The Flettner strips on the trailing edge of the tailplane tabs were measured and found to be at or just below minimum depth requirements of the Build Manual. In view of the rebuilding of the Flettner strips and the re-bonding of the tailplane drive bushes, together with the play found between the tailplane input arm and the torque tube, a microscopic examination of the tailplanes, tabs and torque tube was carried out to determine if aerodynamic flutter or another vibratory condition had been present in the tailplane system. This examination confirmed that all the damage identified on the tailplane input arm, the tab hinges and the tab drive pins was caused by the break-up of the aircraft and there was no evidence of aerodynamic flutter originating within the tailplane system.

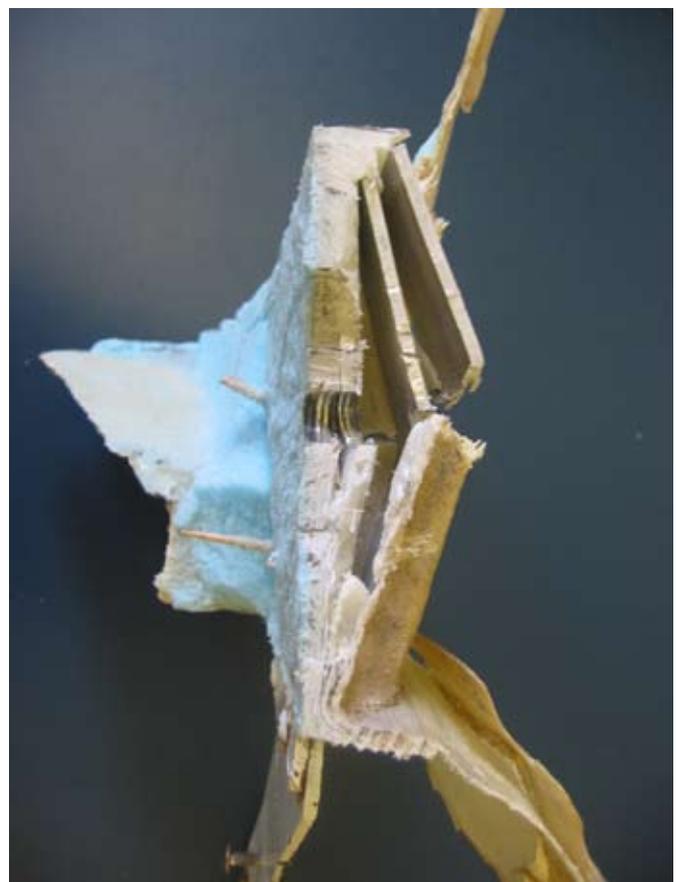
Figure 6

Both the left and right wing lift pins had failed together with the drag pin of the left wing. The mountings for these pins, together with the threaded portion of the pins, remained in place in their respective wing ribs. Examination of the fracture surfaces of the pins showed that they had all failed due to the application of large cyclic bending loads. A section of the right wing inboard rib which contained the right drag pin mounting was recovered from the accident site some distance from the remains of the right wing. The mounting structure of the pin, which consists of several aluminium plates laminated together (including the one which hinges the flap), appeared to have failed due to the application of a tensile load. The innermost (closest to the wing rib) plate and flap plate remained in situ, but the outer two plates (closest to the fuselage) had been deformed and pulled away from the structure, see Figure 6. The outermost plate together with the right drag pin remained attached to its mounting point on the fuselage. The corresponding mount was removed from the left wing for comparison. This showed that whilst the left wing mount had been constructed in accordance with the Europa Build Manual, the right mount had not. The laminated plates of the right drag pin mount had become staggered during the lay-up, so that the forward edge of the outermost plate (closest to the fuselage) had been placed 5.5 mm ahead of the edge of the plate immediately below it, and that plate was 3 mm further forward of the innermost (closest to the rib) plate. The forward edge of the innermost

plate was aligned with the forward edge of the flap hinge plate. The hole had also been drilled 2.5 mm forward of the vertical centreline of the outermost plate. This had reduced the edge clearance of the hole in that plate from 7.5 mm to 5 mm.

Due to the staggered lay-up of the mount, the edges of all of the subsequent laminations had been breached. The edges of the innermost plate and flap hinge plate had been breached to the extent that the hole consisted of little more than a semi-circular cut-out of the forward edge. The description of how to assemble the lift and drag pin mounts, given in the Europa Build Manual issued at the time of the aircraft's construction, requires that all three plates are laid up at the same time and does not show any method of maintaining the alignment of the assembly while it cures. It does however provide the following advice:

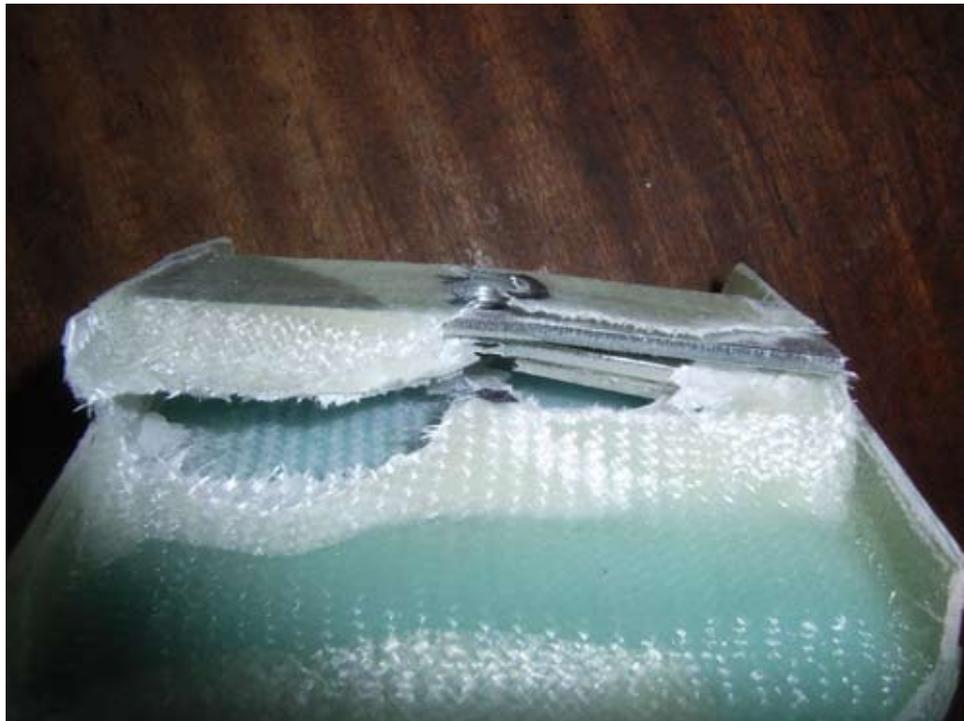
Figure 7

In order to determine the load-carrying capability of the incorrectly built joint, a tensile load test was carried out using two test specimens, one replicating the construction of G-HOFC's right drag pin mount, and one constructed in accordance with the build manual. Due to the limitations of the test equipment the full range of loads experienced by the drag pin could not be reproduced and the tests were limited to the determination of the ultimate tensile strength of the specimens. The results from the test confirmed that both test specimens were capable of holding the unfactored tensile design limit load of 10.03 kN without failure. The test was then repeated and both specimens loaded until they failed. Examination of the specimen replicating G-HOFC's right rear pin mount showed that the innermost (closest to the rib) plate had pulled away from the GRP surface of the specimen, bending under the load, which had disrupted the bond with the next plate, see Figure 7. This showed that the inner plate of the test specimen had carried a significant load prior to disbonding. The damage observed to G-HOFC's right

rear lift pin mounting suggested that it had not been subject to a similar load. Therefore measurements were taken of G-HOFC's rear right lift pin and lift pin mount. These measurements showed that the lift pin was dimensionally correct (12 mm diameter) and that the thread had been cut to the required depth of 2 mm through all of the lamination plates. The diameter of the hole in the outer plate of the mount met the requirements of the Europa Build Manual. Measurement of the second plate confirmed that the partially complete hole within it had been 10 mm in diameter. However, there was some distortion and 'opening' of its circumference where the hole breached the edge of the plate. The partial holes through the innermost plate and the flap plate had become distorted and were found to have a diameter of 11.62 mm. The magnitude of this distortion would have significantly reduced their ability to carry loads from the drag pin and allowed a degree of movement of the pin within the mounting. This, together with the distortion to the second plate, would have meant that the majority of the tensile loads within G-HOFC's right drag pin mounting would have been carried by the outermost plate alone, whereas the undistorted holes in the test specimen allowed load to be carried by all the plates.
