**ACCIDENT****Aircraft Type and Registration:**

- 1) Taylorcraft BC12D, Twosome, G-BVXS  
 2) Pitts S-2C, Pitts Special, G-IICI

18 December 2011 at 1400 hrs

Leicester Airport

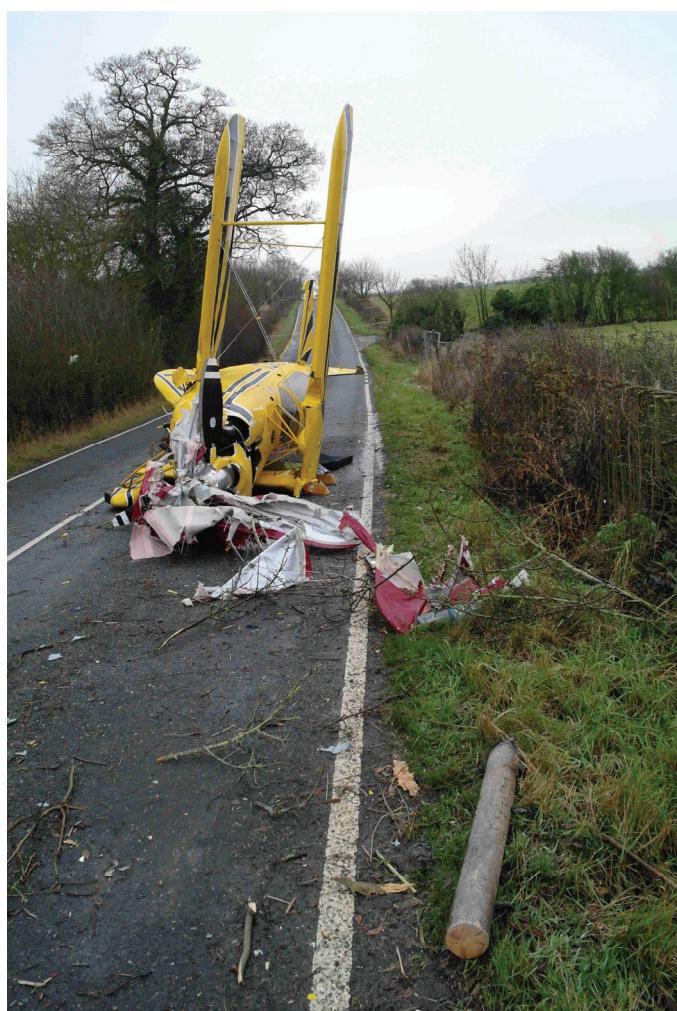
**Figure 1**

field and the road. A tree stump and a fence post in the hedge were no longer in the ground and were close to the location of the aircraft. Attached to the propeller of the G-IICI was the wreckage of the empennage and some of the rear fuselage of the G-BVXS (see Figure 1).

Location of G-IICI - note some wreckage from G-BVXS (silver and red) attached to the propeller of G-IICI

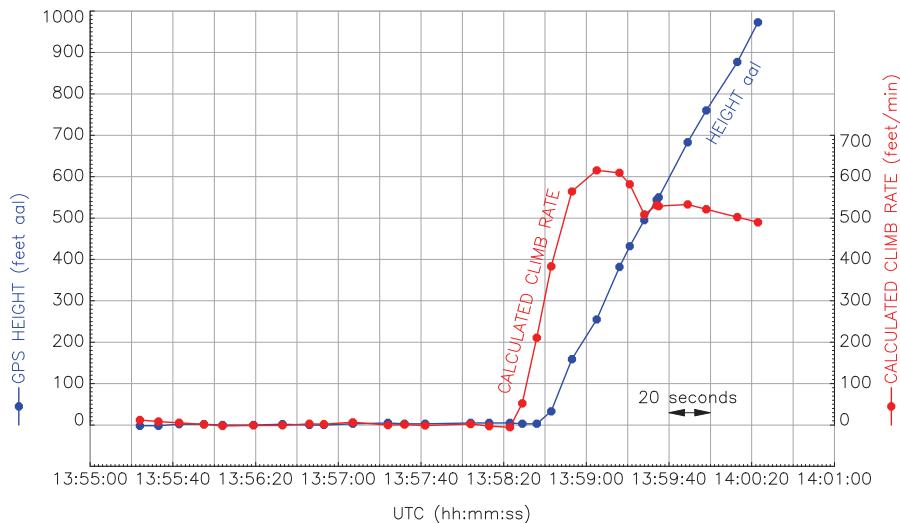
**Figure 2**

GPS derived height above airfield level for G-BVXS

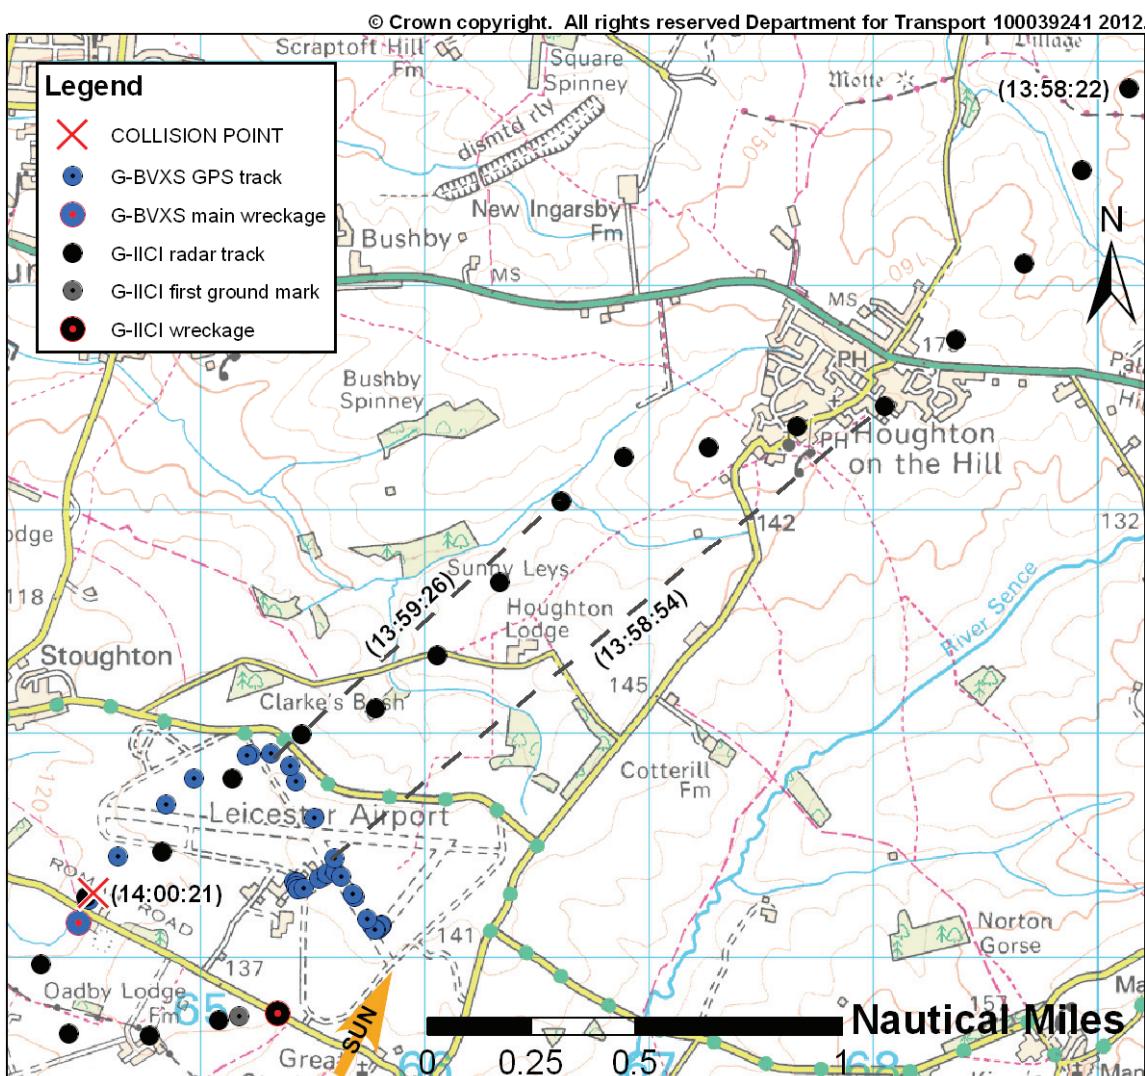
**Figure 3**

The complete GPS track of G-BVXS and the radar track of G-IICI from time 1358:22 hrs (coincident with G-BVXS beginning its takeoff rollout) are illustrated at Figure 3, together with the collision point and wreckage

G-BVXS and G-IICI ground tracks from GPS and radar

locations of both aircraft. Also indicated are the relative positions of both aircraft to each other at a number of points leading up to the collision. They show that G-BVXS was either directly ahead, but under the nose (and in the general direction of the sun – also indicated), of G-IICI, or on a constant bearing from the time G-IICI turned onto the crosswind leg, until the collision.

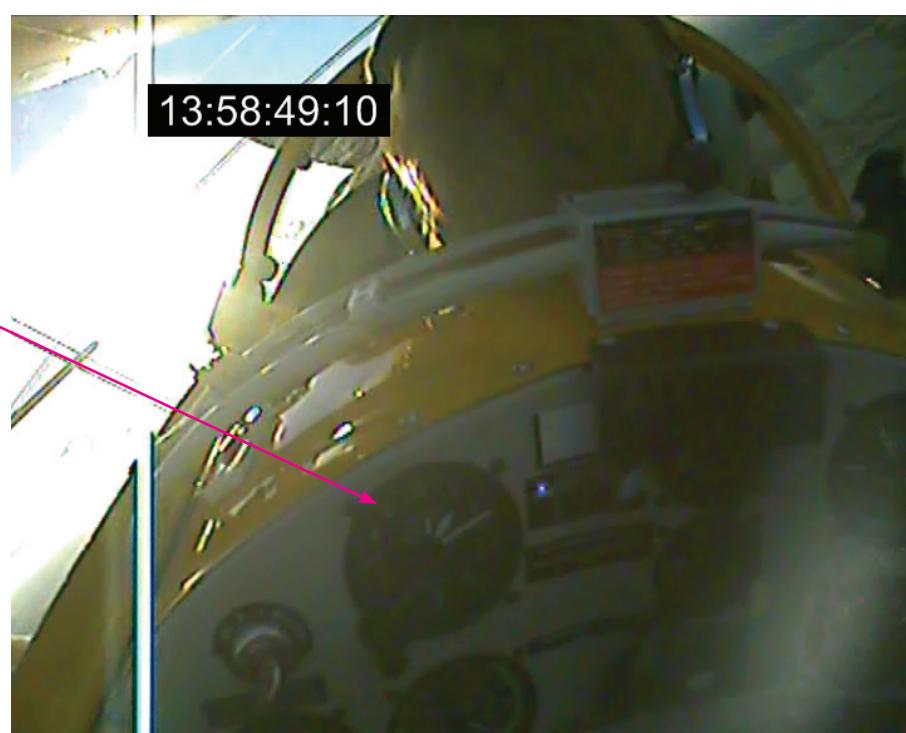
**Figure 4**

Head-down view from helmet-mounted camera video recording as the aircraft reaches Houghton-on-the-Hill with the altimeter visible and indicating 1,200 ft

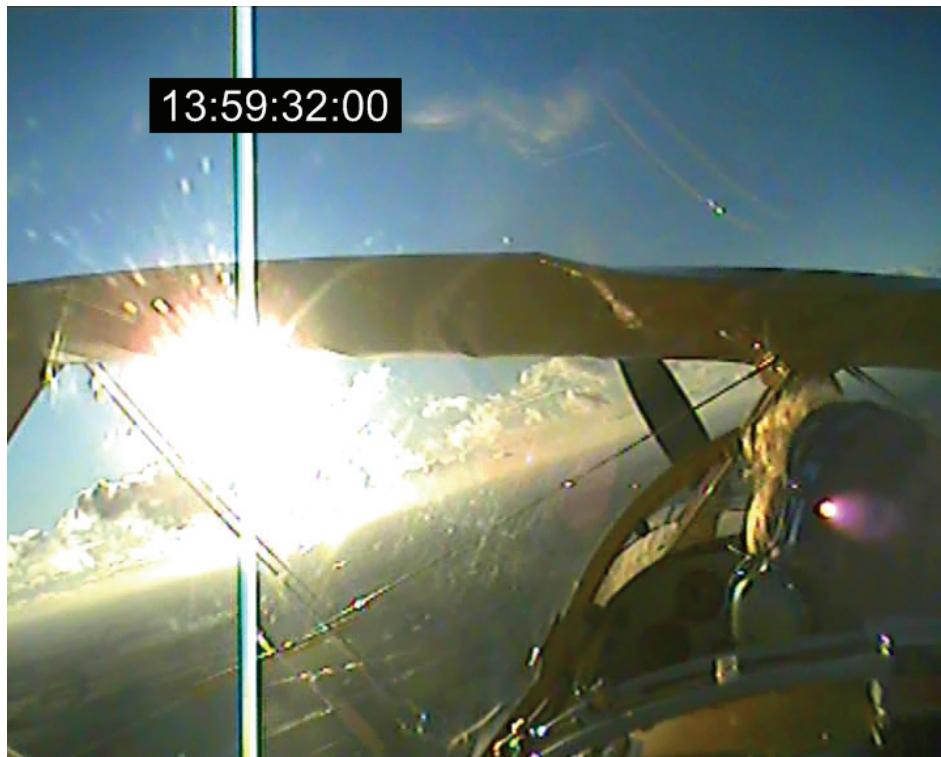
**Figure 5**  
View from helmet-mounted camera with the airfield just in view

Figure 5 is an image from the video recording with the airfield just visible at the bottom and left of centre, with the sun clearly in the view. G-BVXS would have been out of view, masked by the nose of G-IICI. This image also shows that, given the lack of contrast between G-BVXS and the surrounding countryside and the position of the sun<sup>5</sup>, the aircraft would have been difficult to detect visually<sup>6</sup>.

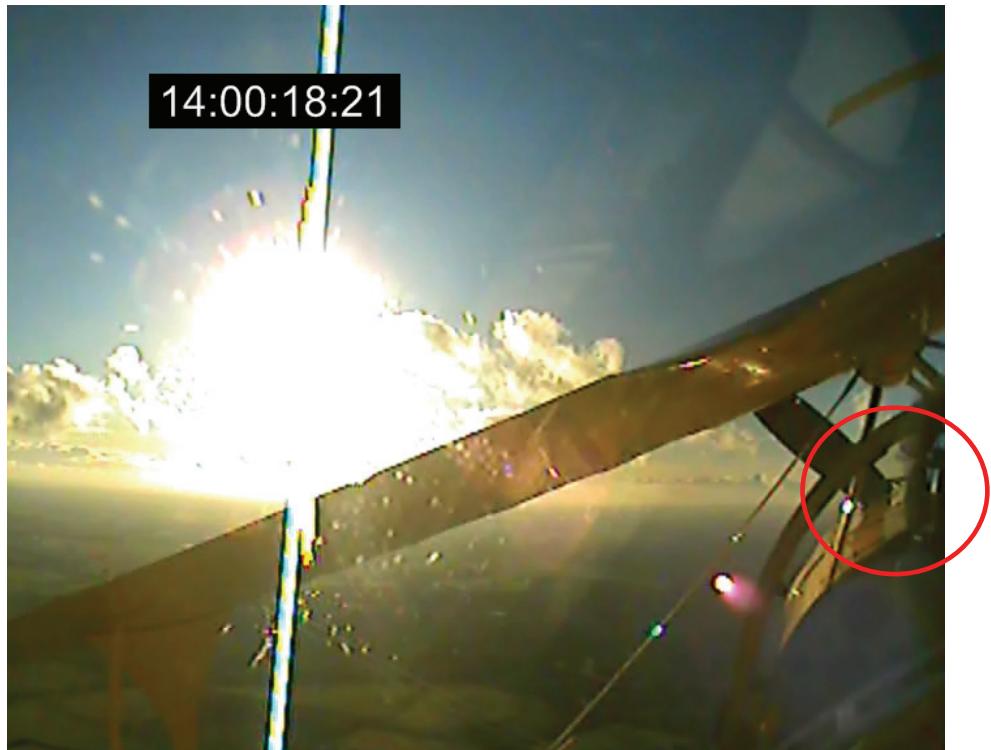
**Figure 6**

The first recorded view with G-BVXS in the image occurred just before 1400:19 hrs, as the pilot moved his head from left to right (Figure 6). The collision

occurred two seconds later during which time the pilot continued this look out scan to the right and then scanned back to the left and right again. The nose of G-IICI was not always in the camera's field of view during the head turns so only glimpses of G-BVXS were seen in the subsequent video images.

First recorded image with G-BVXS in view (a small portion of the left wing and strut is visible at the junction of G-IICI's propeller blade and upper nose cowling)
