ACCIDENT

Aircraft Type and Registration:	ARV Super 2 (ARV1), G-TARV	
No & Type of Engines:	1 Hewland AE75D piston engine	
Category:	1.3	
Year of Manufacture:	2001 (rebuilt)	
Date & Time (UTC):	30 April 2005 at 1135 hrs	
Location:	Naish Farm, Clapton in Gordano, Bristol	
Type of Flight:	Private	
Persons on Board:	Crew - 1	Passengers - None
Injuries:	Crew - 1 (Fatal)	Passengers - N/A
Nature of Damage:	Aircraft destroyed	
Commander's Licence:	Private Pilot's Licence	
Commander's Age:	71 years	
Commander's Flying Experience:	624 hours (of which approximately 33 were on type) Last 90 days - 3 hours Last 28 days - 1 hour	
Information Source:	AAIB Field Investigation

Synopsis

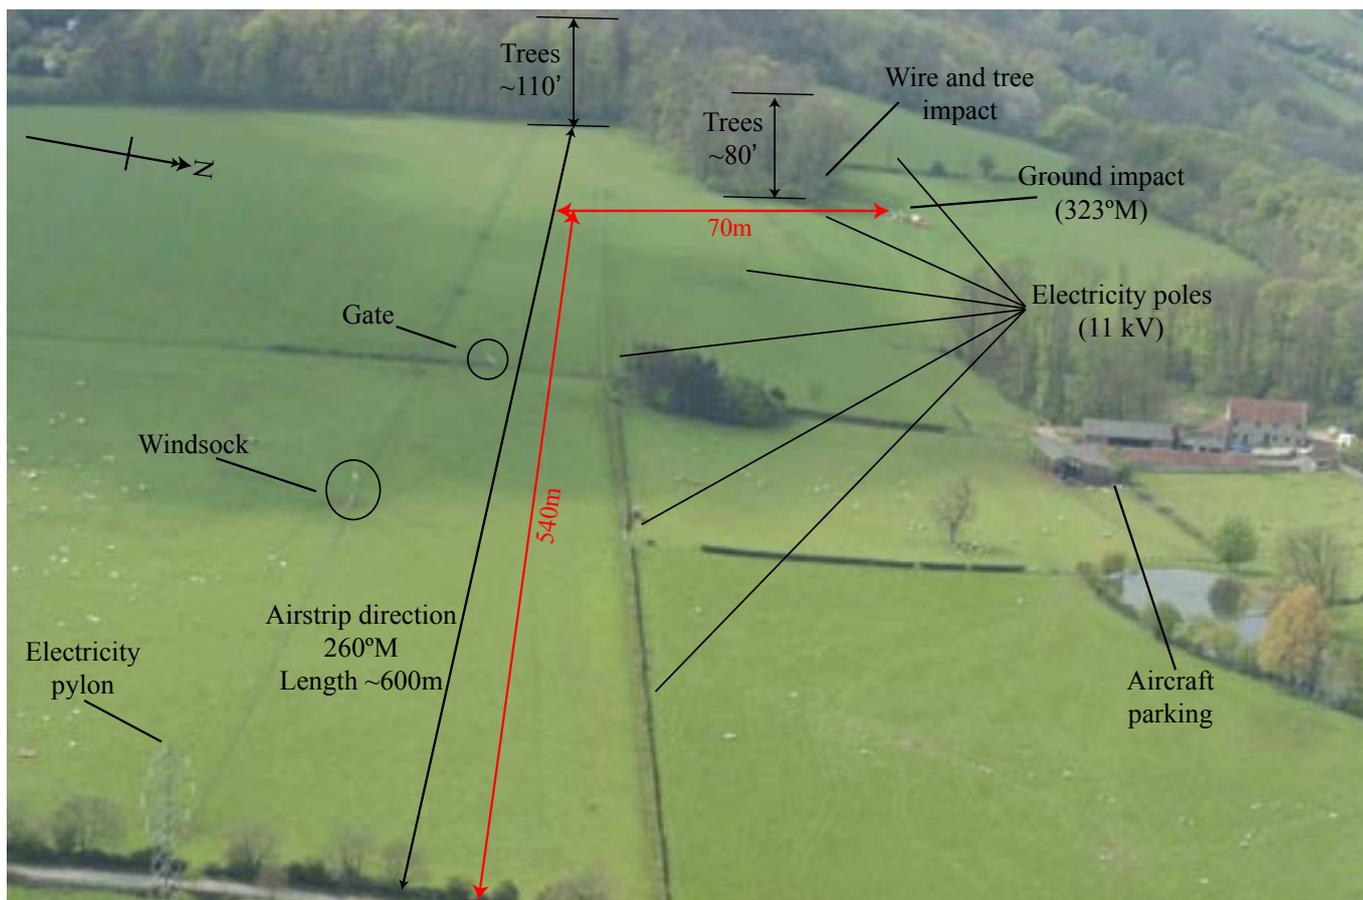
The airstrip is orientated 260°/080° and is approximately 600 m long. It is at an altitude of approximately 400 ft amsl and has a level grass surface, which was firm and dry at the time of the accident. The area is normally used for sheep grazing and the grass varied in length from no greater than two inches long in some areas up to four inches long in other areas. To the east, a road with a hedge bounded the end of the airstrip and there were power lines, on pylons, crossing north to south just beyond the airstrip boundary. Further 11 kV power lines, on wooden poles some 27 ft high, were located parallel to the northern edge of the airstrip and these diverged towards the northwest from a point approximately 420 m along the airstrip. At the western edge of the airstrip, there was a line of trees orientated north/ south; these were approximately 110 ft high. Entries in the pilot's log book indicated that G-TARV was the only aircraft that he had operated from the airstrip. He had first flown the aircraft into the airstrip in October 2001. His next recorded flight from the airstrip was in July 2003 and he had subsequently flown out of the airstrip on 15 occasions prior to the accident. There was no evidence that any other aircraft had operated from there. Witnesses commented that the pilot would only takeoff in a westerly direction. Figure 1 shows the layout of the strip in the direction of takeoff on the accident flight.

Airstrip at Naish Farm, 30 April 2005
