AAIB Bulletin No: 3/94 **Ref: EW/A93/8/2** **Category: 1.1**

Aircraft Type and Registration: Boeing 747-436, G-BNLS

Nature of Damage: No 2 engine core cover panels severely burnt

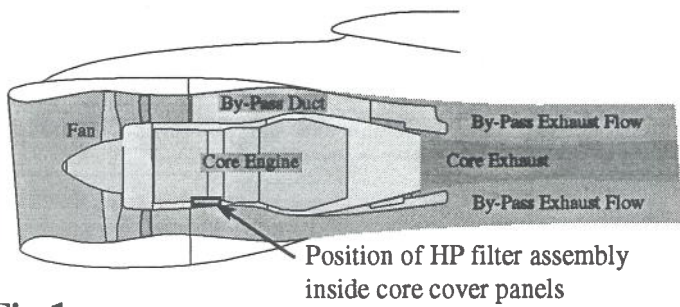
Fig.1
Diagrammatic Cross Section of RB 211-524H

The first examination confirmed that there had been a fierce fire, centred in the vicinity of the high pressure (HP) fuel filter on the underside of the core engine (Fig.1). Although the use of dye penetrant had masked the major proportion of the evidence of the development of the fire, there was some evidence of fuel 'washing' of the HP compressor case. This evidence was apparent immediately above the downstream self-aligning connection of this filter, which is fitted as a free mounted component (*ie.* not directly attached to the engine) in the high pressure fuel line. (see Fig.2). The composite honeycomb core cover panels, which form the inner wall of the by-pass duct, had been severely burned on their lower arc and there was evidence of fire inside the core panels.

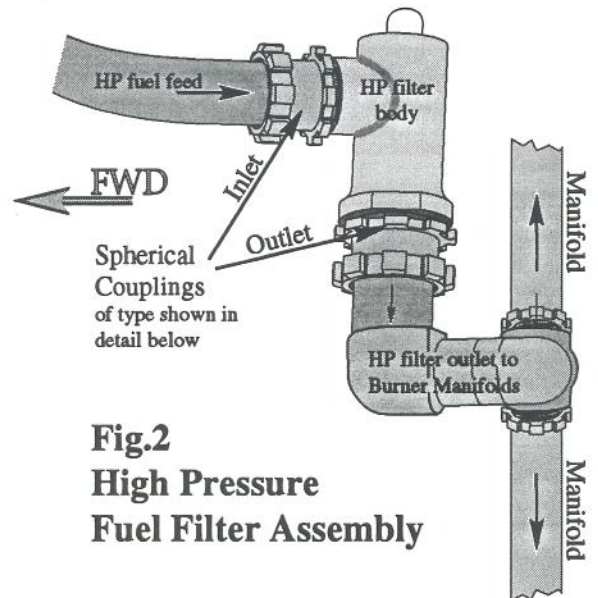
Fig.2
High Pressure Fuel Filter Assembly

As the pressure from the test rig was gradually increased, the whole length of the pipework under pressure was observed. At a pressure of 250 psi, the spherical coupling at the outlet of the HP filter (see Fig.2) became wet, at 300 psi there was a very slow, but steady, drip from both couplings and at 400 psi there were measurable leaks of 1.6 ml/min at the inlet and 3.4 ml/min at the outlet. At 550 psi the leak from the inlet coupling was still a drip but that from the outlet had increased to a steady stream of about 150 ml/min. At 800 psi, whilst the inlet connector leak was similar to the outlet leak at 550 psi, that at the outlet connector was a powerful spray directed against the underside of the HP compressor case (see Plate 1).

As a result of this investigation and its associated trials, the overhauler has introduced a revision to their standard practices used to fit and align this type of spherical coupling.

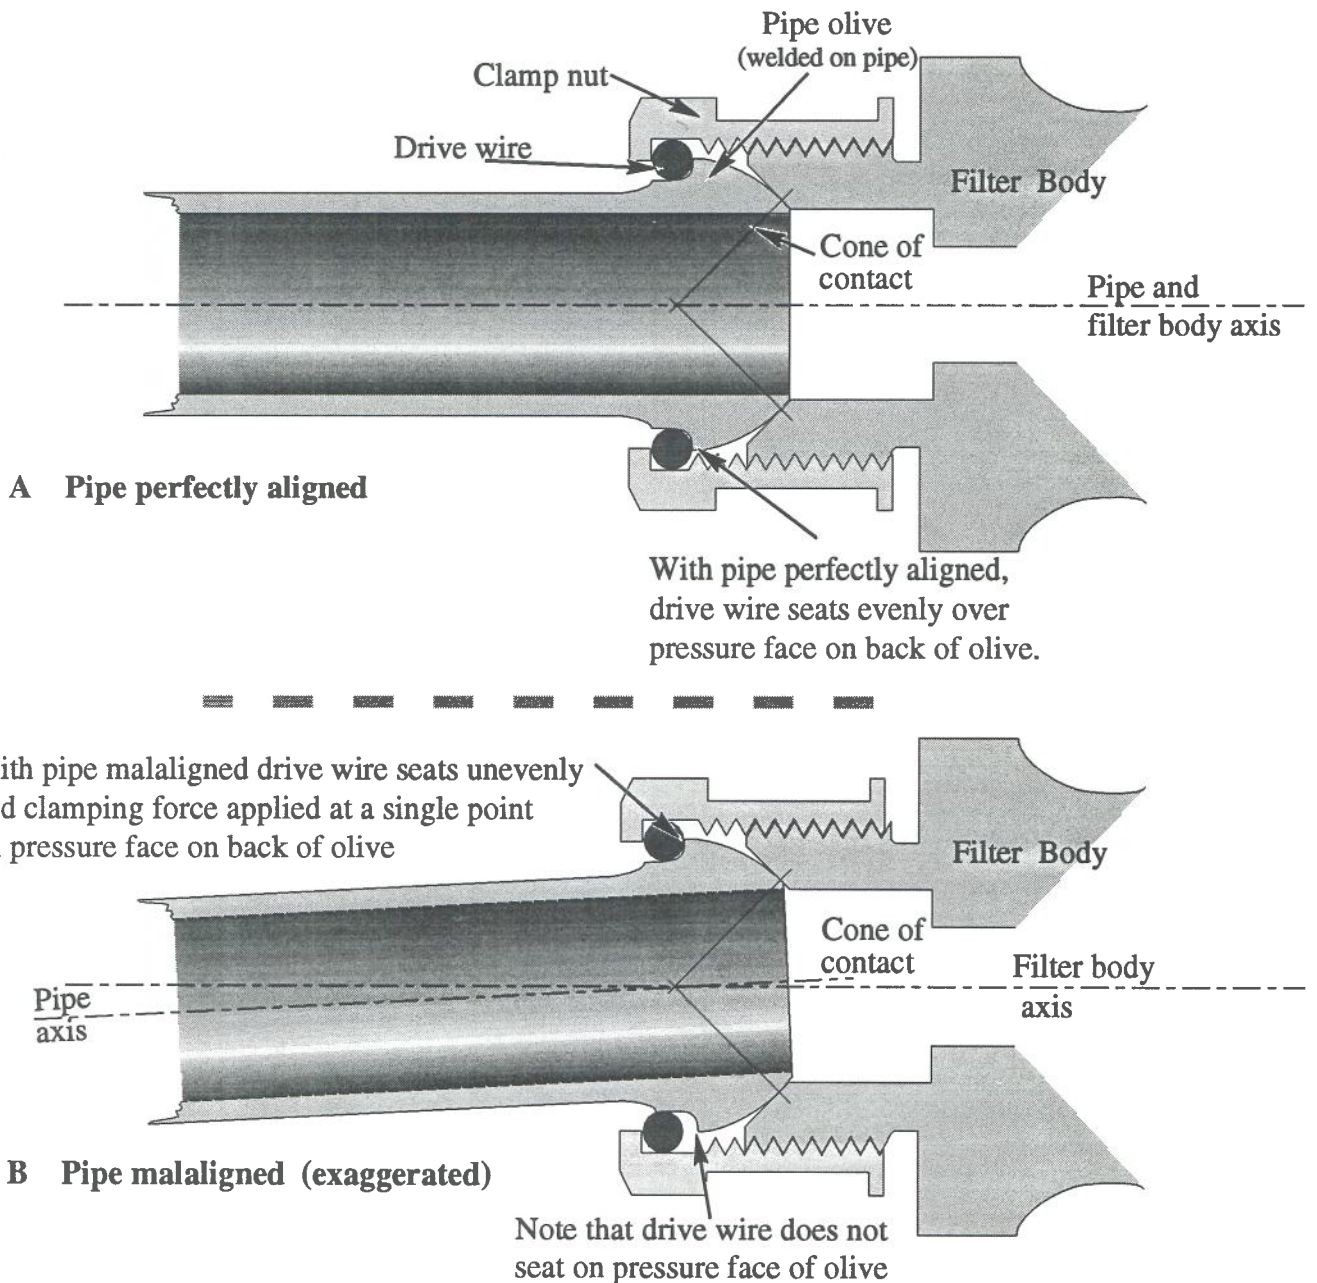
Fig.3
Details of clamping action in Spherical Couplings

A trial was performed to obtain an estimate of the order of distance that the nut advanced down the thread of the union to obtain these torque values. This showed that, to achieve the specified torque values, the large union nut, at the filter outlet, advanced about 0.0052 inch and the smaller nut, at the inlet, about 0.0045 inch. Referring to Fig.3, A & B, the inference of this trial was that the specified clamping torque could theoretically be lost by a change in misalignment of about 10 minutes of arc.

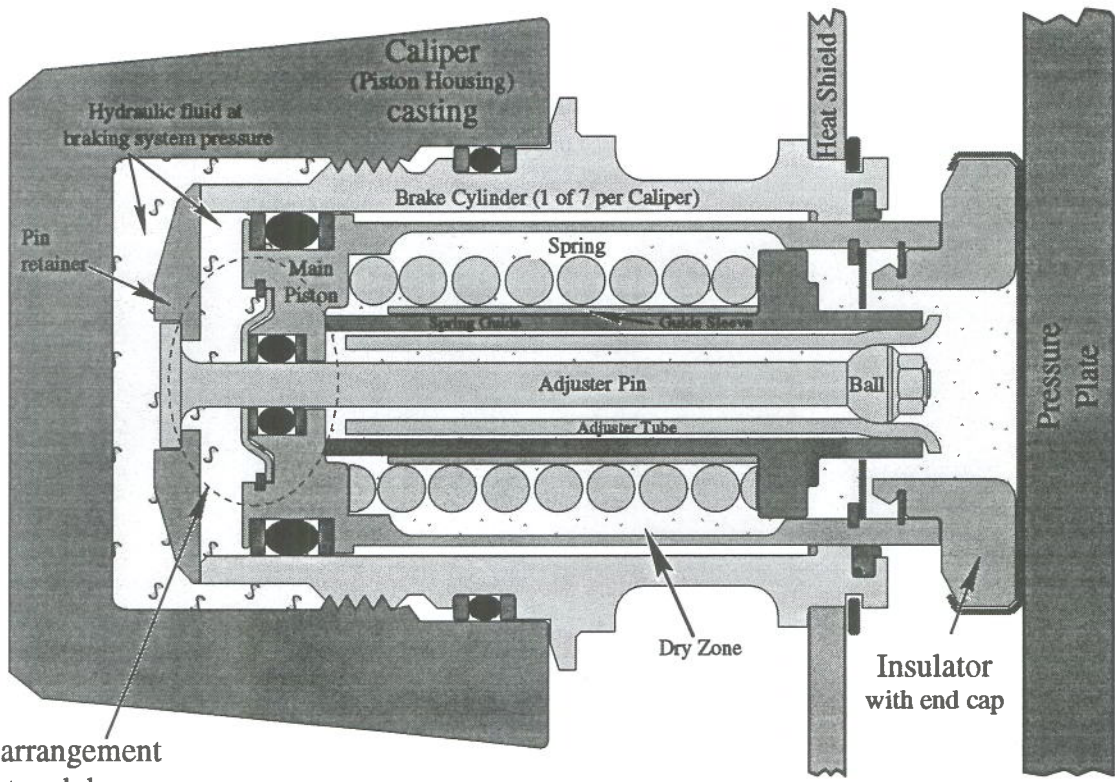
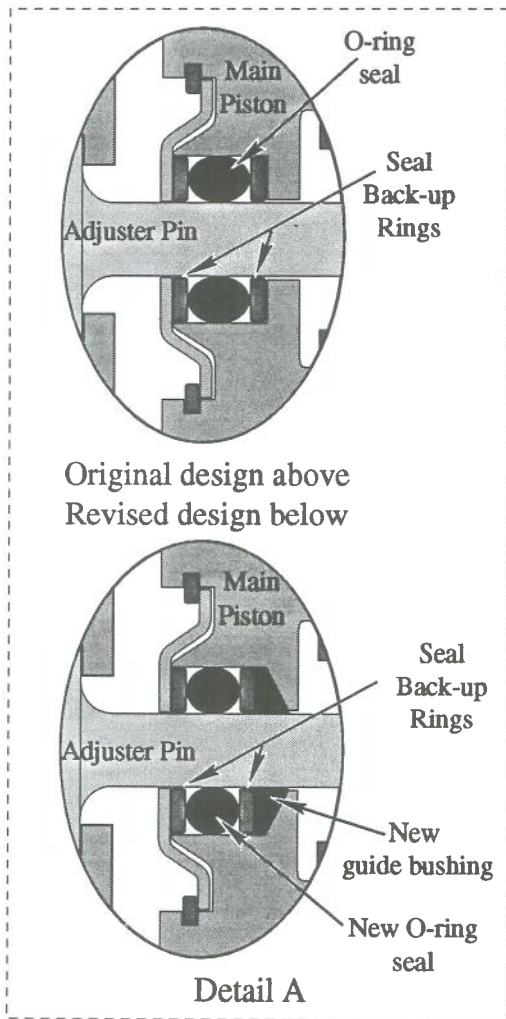
Fig.4 Cross section of individual brake actuation mechanism

The brake pack was dismantled and the insulator feet removed from all of the actuators. This revealed that the actuator which had leaked was visibly wet inside the adjuster mechanism which is in the dry zone in the piston (see Plate 3 & Fig.4). The actuator was removed from the caliper unit and the seal assembly between the pressure and dry sides of the main piston was dismantled. This revealed that both the O-ring seal and its back-up washer had become entrained into the hole between the two sides

Sealing arrangement between wet and dry zones (see Detail A below)

The brake manufacturer has issued a Service Bulletin (2-1515-32-9) introducing a modified adjuster assembly (Part No 107-369-3). They recommend that operators should fit modified adjusters to all brake units which have leaking adjusters and to units which are being overhauled. They also recommend that these adjusters are fitted to spare brake units before these are fitted to aircraft.

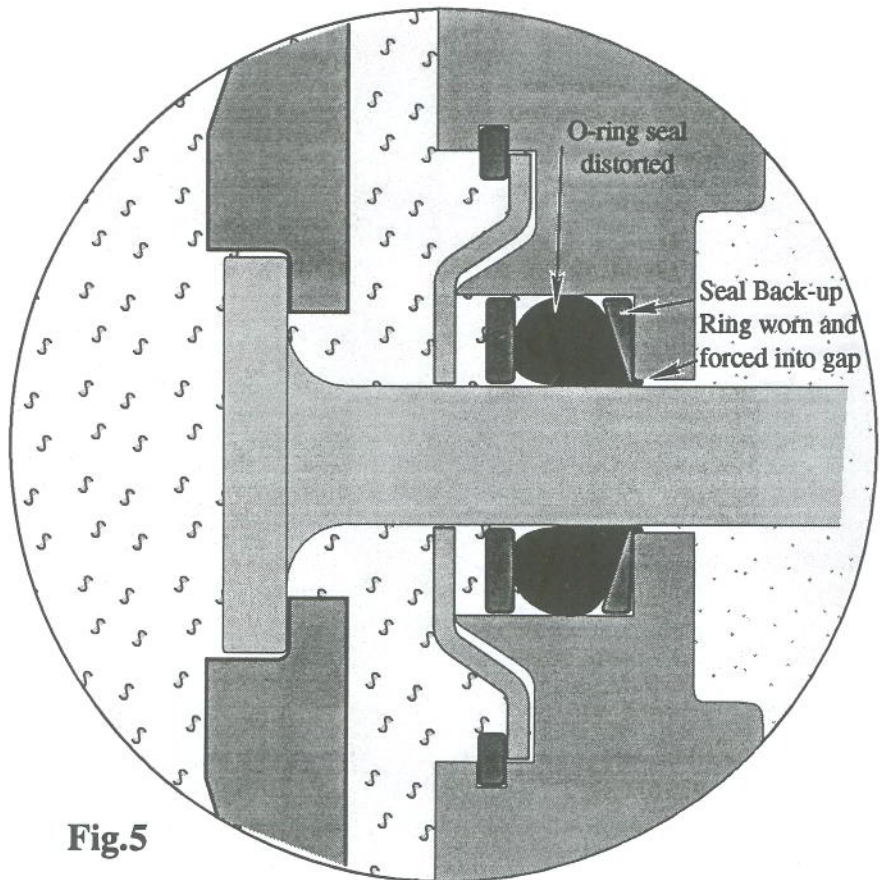
Fig.5

of the piston and become damaged (see Plates 4 & 5 and Fig.5). This damage was similar to that seen by the operator on other units of this type of brake which had been dismantled as a result of hydraulic fluid having leaked onto the pressure plate.

Mode of failure of seal between Wet and Dry Zones in the original design sealing arrangement

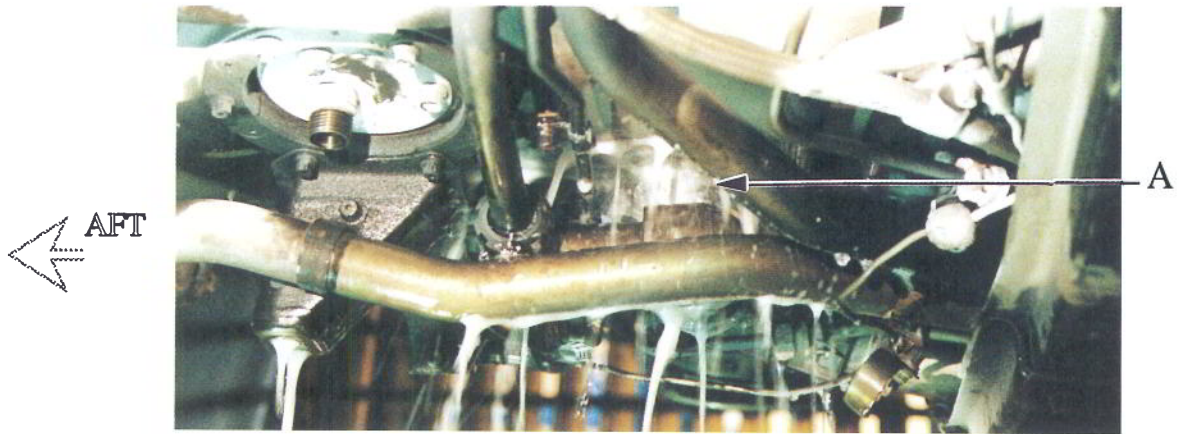
Plate 1

View of underside of engine from right side during test with 800 psi fuel pressure. Note spray of fuel issuing from HP fuel filter at top of outlet connection (Arrow A) and fuel froth dripping from compressor case and air pipe below engine.

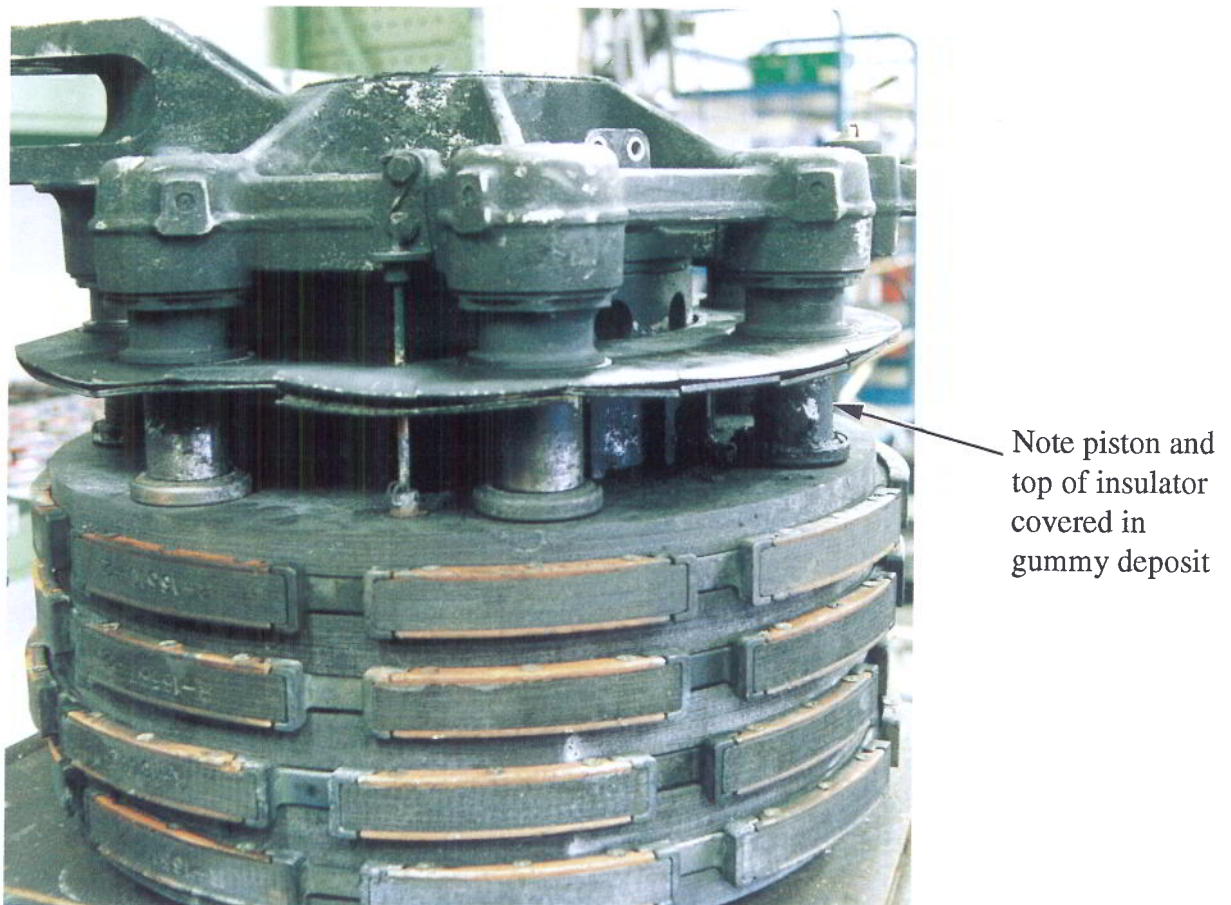
Plate 2

The brake unit which had been subjected to the fire was examined and it was seen that the exposed part of one of the actuator pistons was covered in a gummy residue (see Plate 2). Hydraulic pressure was applied to the unit and fluid immediately began to weep from the insulator foot of the actuator and run onto the pressure plate.

Brake pack assembly, as received.

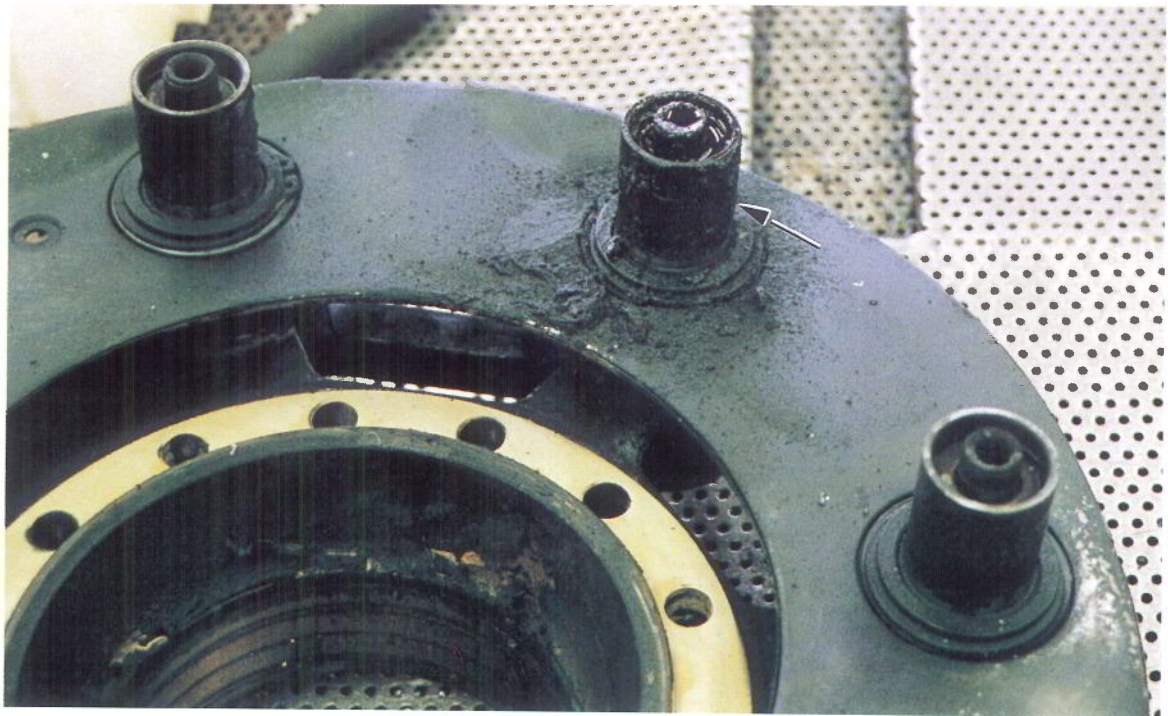
Plate 3

Three brake pistons with insulators removed.
Note middle piston - wet and covered with gummy deposits

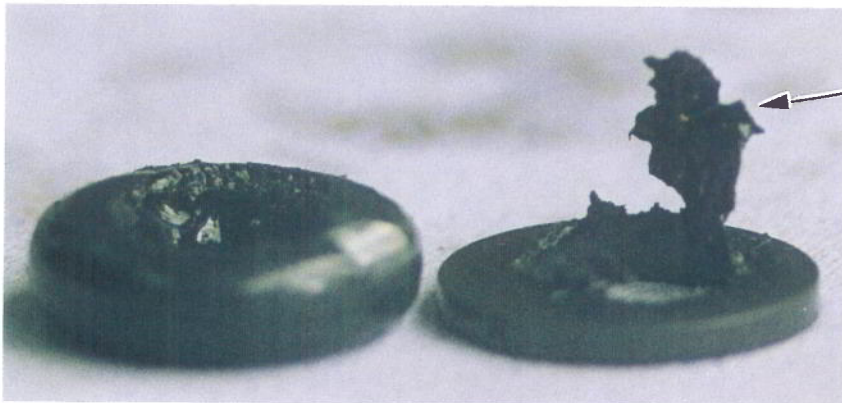
Plate 4

Note 'Feather' of washer
material drawn out.

Seal and dry-side back-up washer
from brake adjuster.

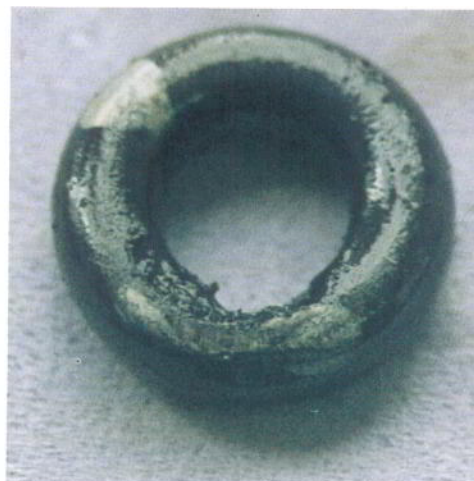
Plate 5

View of seal showing
area where material has
been pinched off between
adjuster rod and piston.
