ACCIDENT

Aircraft Type and Registration:	Thruster T600N 450, G-CBIO	
No & Type of Engines:	1 Jabiru Aircraft Pty 2200A piston engine	
Year of Manufacture:	2002	
Date & Time (UTC):	17 January 2012 at 1150 hrs	
Location:	Near Compton Abbas Airfield, Dorset	
Type of Flight:	Private	
Persons on Board:	Crew - 1	Passengers - 1
Injuries:	Crew - None	Passengers - None
Nature of Damage:	Fuselage tube, nose pod and nose landing gear leg, empennage, right wing, propeller and engine damaged	
Commander's Licence:	National Private Pilot's Licence	
Commander's Age:	63 years	
Commander's Flying Experience:	269 hours (of which 47 were on type) Last 90 days - 5 hours Last 28 days - 2 hours	
Information Source:	Aircraft Accident Report Form submitted by the pilot and further inquiries by the AAIB

Synopsis

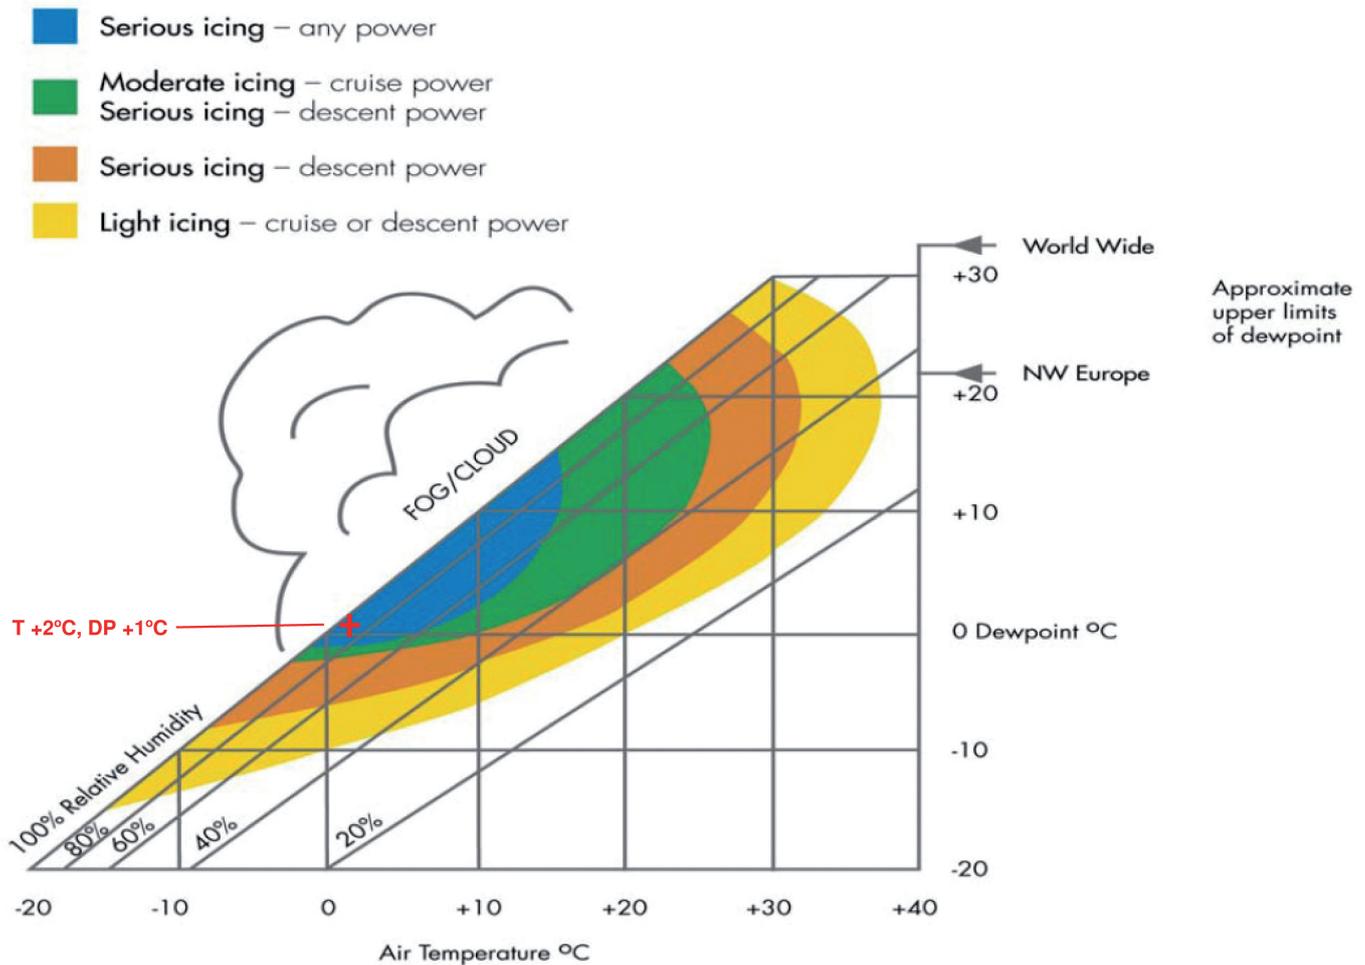
Figure 2
Carburettor icing chart

An aftercast was provided by the Met Office for the Compton Abbas area at the time the accident occurred. It estimated that, at 1,700 ft altitude, the air temperature was +2°C and the dewpoint was +1°C. These conditions were conducive to serious carburettor ice formation at any power setting (Figure 2).

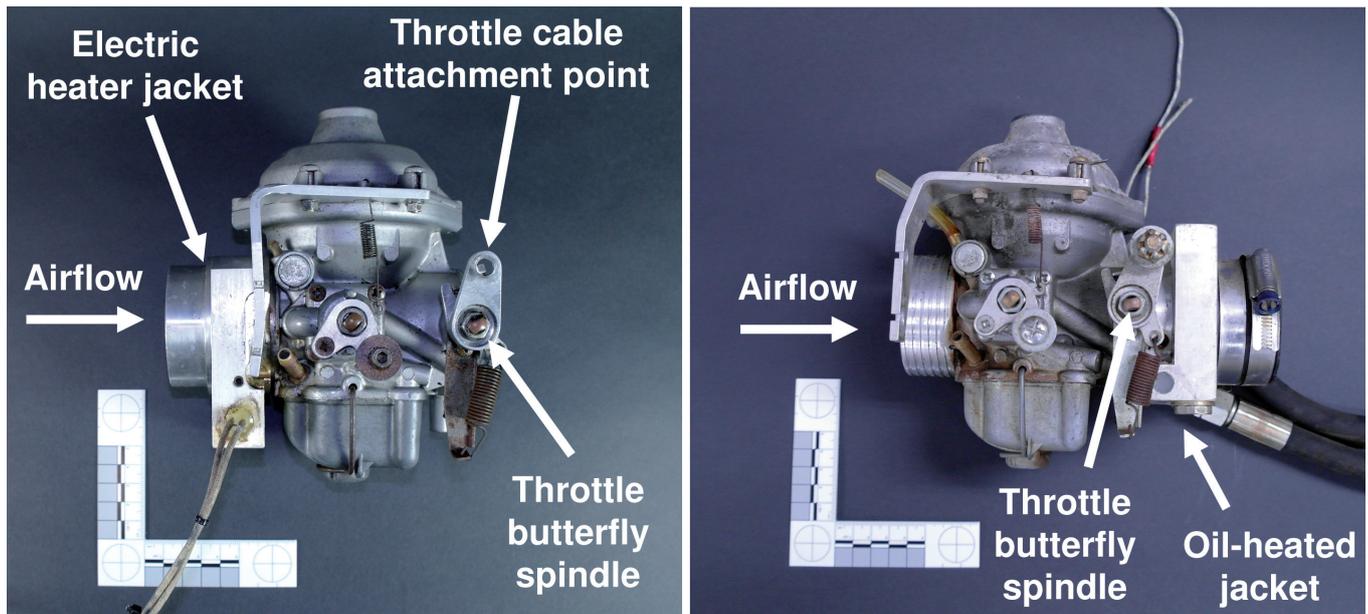
Figure 3

The aircraft was fitted with a carburettor heat system comprising an electrically heated jacket fitted to the inlet throat of the carburettor body, Figure 3(a). This differed from the production standard carburettor heat system installed when the aircraft was manufactured in 2002, in which hot engine oil is circulated through a hollow jacket attached to the exit throat of the carburettor body, in close proximity to the throttle butterfly Figure 3(b).

The ability of the electric heater jacket to warm the carburettor throttle butterfly valve was tested by cooling the entire carburettor in a refrigerator to 1°C and applying 12 Volts to the heater jacket electrical terminals. Thermocouples were attached to the electric heater jacket and the butterfly valve, allowing the temperature of both components to be monitored. The results showed that after three minutes of heat application, the heater jacket had reached a temperature of 30°C, whereas the butterfly valve temperature has risen by only 1°C, to 2°C. After six minutes the heater jacket had reached 45°C and the butterfly valve temperature had risen to just 6°C. The test was performed in static airflow conditions and

without fuel evaporation from the carburettor jet, both would cause a large cooling effect at flight conditions. Therefore the butterfly valve's small temperature rise measured during the test would be very significantly reduced in the conditions encountered during the accident flight.

(a) G-CBIO carburettor heat configuration

(b) Production configuration

Modified and production configuration carburettor heat arrangements

The vulnerability of the carburettor to icing was significantly increased by the installation of an unapproved electrical carburettor heat system. Testing conducted by the AAIB demonstrated that this

unapproved system was unlikely to be effective at melting ice within the carburettor.

The BMAA will issue a defect alert to their inspectors to highlight the issue of unapproved modifications in general, and remind inspectors of the approved type of Thruster T600N 450 carburettor heat system. The aircraft manufacturer will also amend the Thruster T600N 450 TADS to include details of the approved carburettor heat system on this aircraft.
