**No: 3/92**

**Ref: EW/G91/11/04**

**Aircraft Type and Registration:** Cessna 340, N592GC

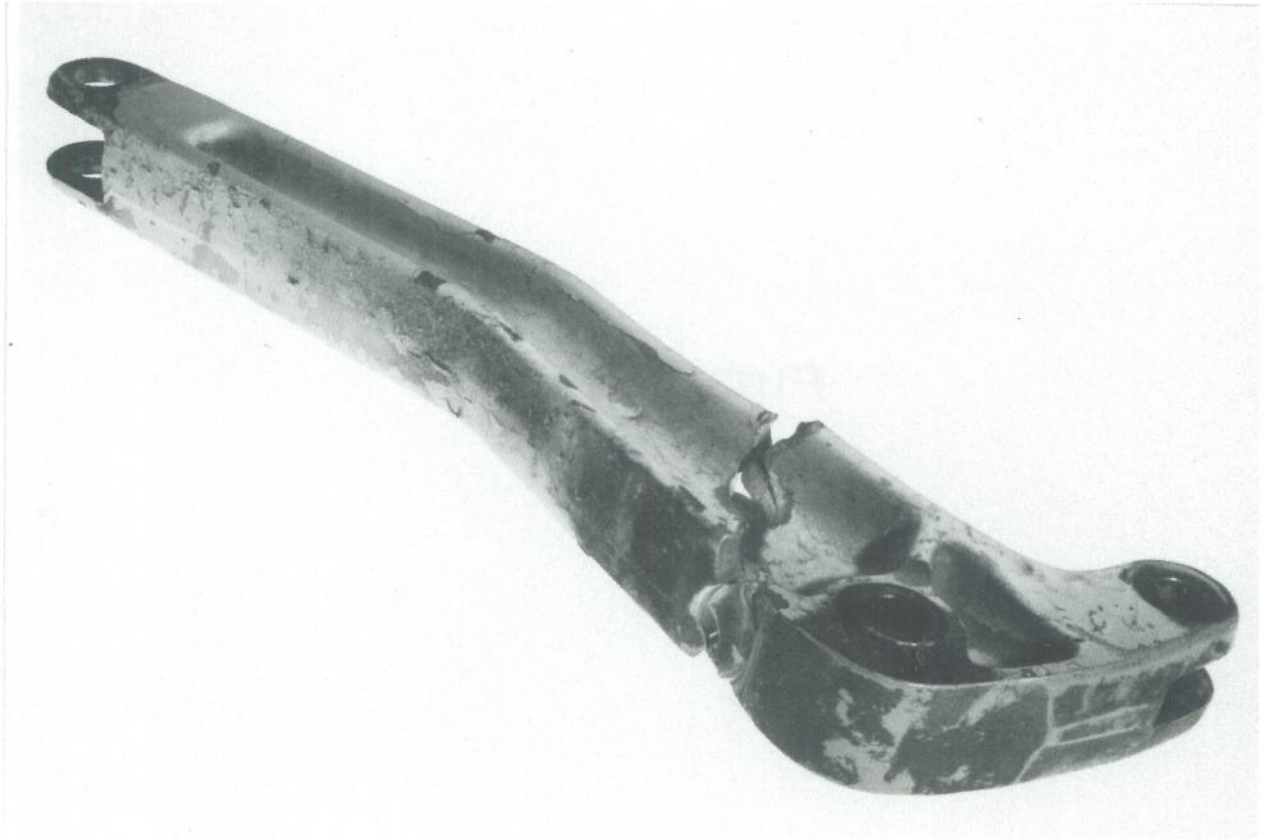
The pilot elected to make a gear down landing - anticipating the collapse of the right hand gear. Touchdown was fairly gentle, but it was immediately apparent that the right hand leg had not locked down. The aircraft slewed gently to the right onto the grass and came to rest on the right hand wing tip, 20 yards from the pre-positioned fire and rescue vehicles. The right main gear down lock assembly had failed at the bellcrank (see Fig 1 to 3 ).

The failure had initiated in fatigue and was followed by an overload failure, most probably during the first 'DOWN' selection. Frictional forces in the leg and attaching mechanisms were found to be excessively high, particularly at the door operating rod which had a seized spherical bearing. Additionally, when the replacement bellcrank was fitted, the down lock strut was difficult to operate and required the side brace lock link to be shortened. It was not possible to determine whether the excessive forces experienced with the new bellcrank before adjustment would have occurred when the operating mechanism was fitted with the old bellcrank.

Fig 1 Failed Bellcrank

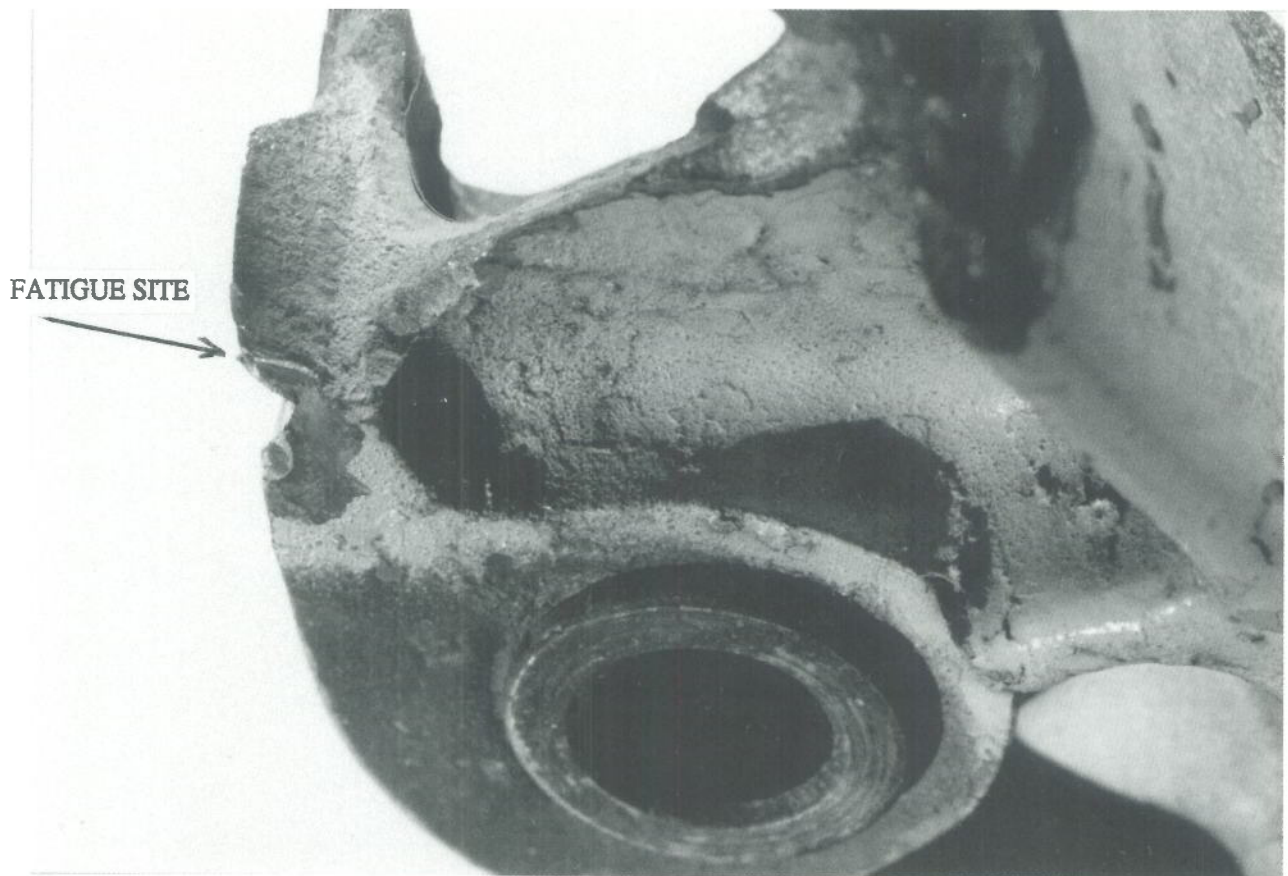
Fig 2 Area of Fatigue Damage

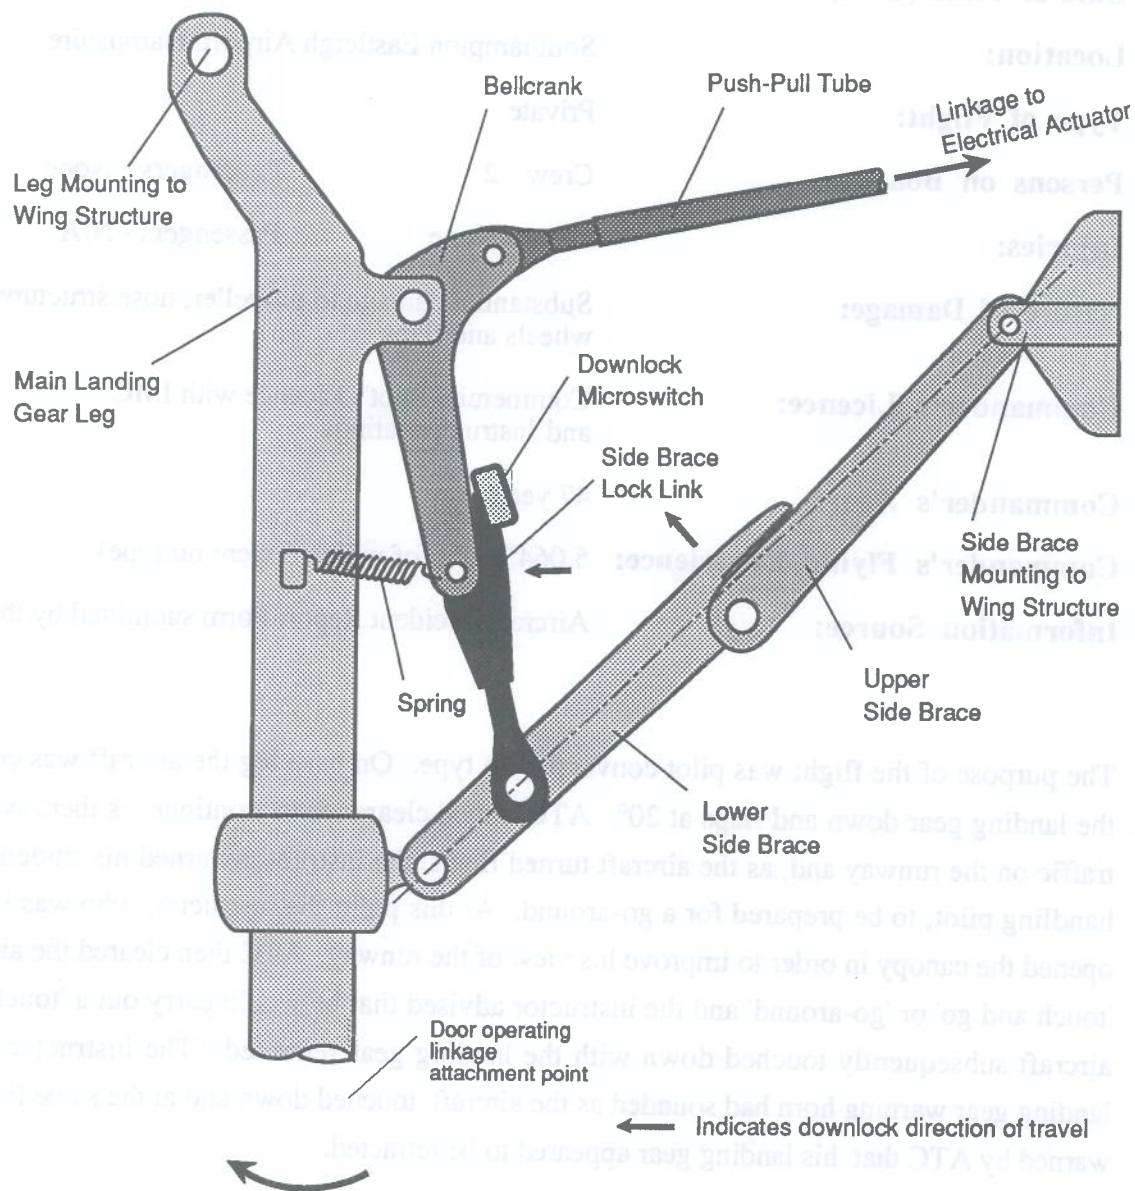
FIG 3 - MAIN LANDING GEAR SIDESTAY SCHEMATIC

The movement of the main gear is controlled by an actuator linkage joining the two legs, and the failure of the bellcrank allowed both legs to move independently. The linkage also operates; the gear doors,

the side brace and the lock strut, and works at a great mechanical disadvantage whereby frictional forces in the bearings can cause large stresses in the bellcrank.
