**INCIDENT**

<b>Aircraft Type and Registration:</b>	Piper PA-28-161 Cherokee Warrior II, G-BXAB	
<b>No &amp; Type of Engines:</b>	1 Lycoming O-320-D3G piston engine	
<b>Year of Manufacture:</b>	1984	
<b>Date &amp; Time (UTC):</b>	16 October 2005 at 0939 hrs	
<b>Location:</b>	Manston Airport, Kent	
<b>Type of Flight:</b>	Private	
<b>Persons on Board:</b>	Crew - 1	Passengers - None
<b>Injuries:</b>	Crew - None	Passengers - N/A
<b>Nature of Damage:</b>	Damage to both main landing gear spats; dents and skin punctures to left wing	
<b>Commander's Licence:</b>	Private Pilot's Licence	
<b>Commander's Age:</b>	49 years	
<b>Commander's Flying Experience:</b>	220 hours (of which 40 were on type) Last 90 days - 19 hours Last 28 days - 6 hours	
<b>Information Source:</b>	Aircraft Accident Report Form submitted by the pilot plus reports from ATC and the airport operator

**Synopsis**

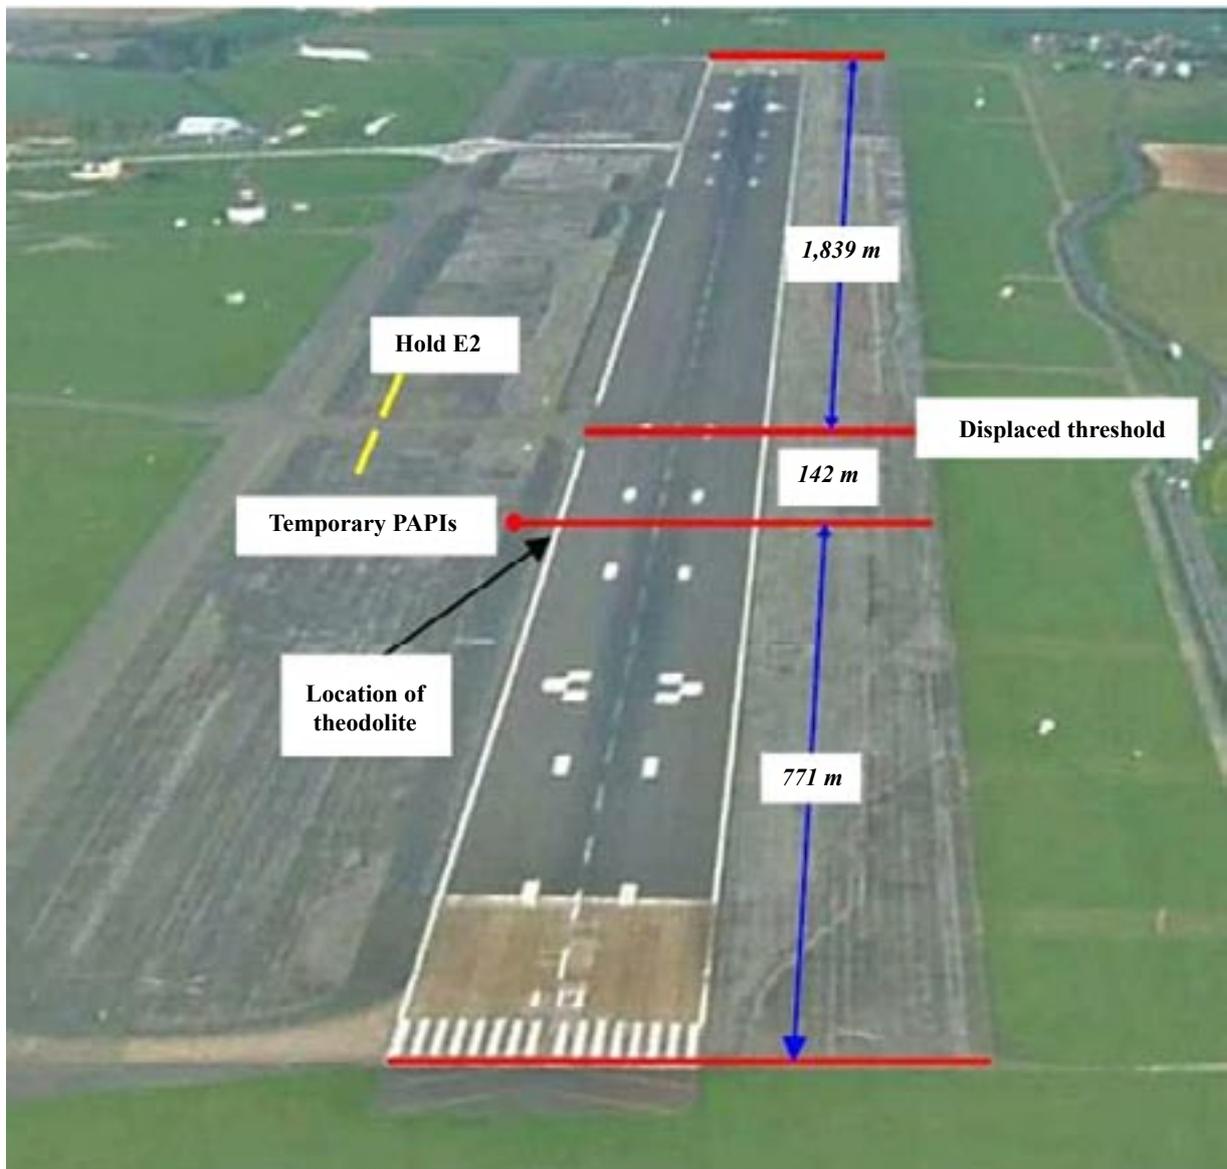
**Figure 1**

Manston Airport has a single, broad, asphalt and concrete runway, laid originally to provide a large landing area for damaged military aircraft. Currently Runway 10/28, which is 2,752 m long and 61 m wide, forms the central part of this area; it is marked in accordance with standards published in Civil Aviation Publication (CAP) 168 - *Aerodrome Licensing*. The temporary PAPI installation and associated survey activity was located at the left hand edge of Runway 10, 771 m east of the normal touchdown threshold. The displaced threshold was a further 142 m east of this position and identified by a pair of black and white marker boards placed in accordance with CAP 168. This resulted in an LDA of 1,839 m. (See Figure 1.)

Runway Overview
